WMSC Inspection Report 20250326B

Title: Rail Vehicle Operations Inspection – New Carrollton Yard

Location: New Carrollton Yard (D99)

Date of Inspection: 3/26/2025

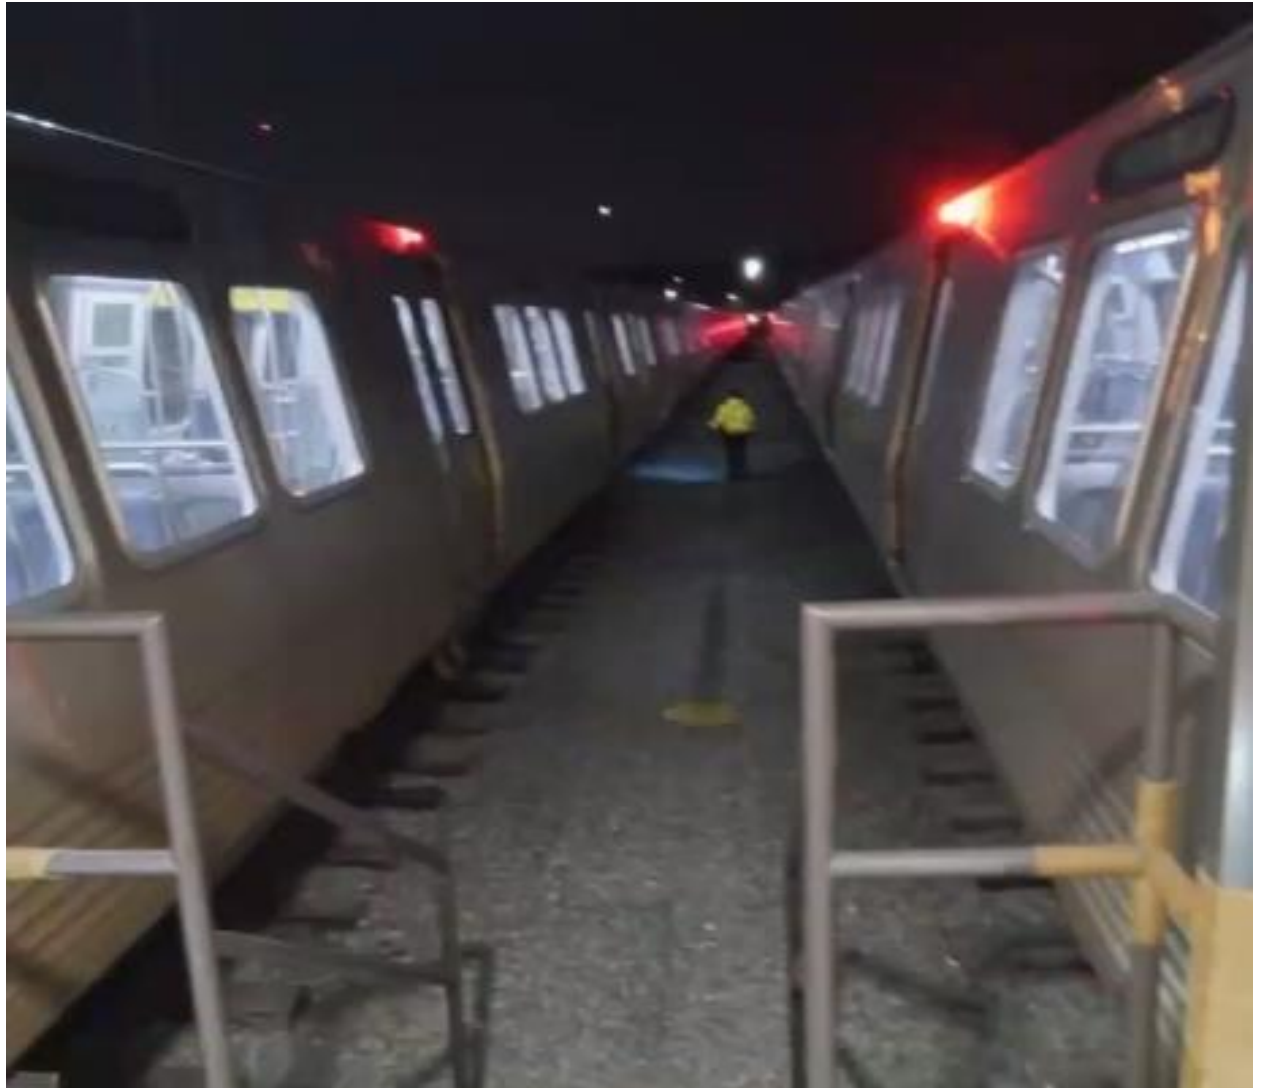
WMSC Inspector observed a rail vehicle operator wearing a backpack that blocked the Department of Safety approved Class 2 yellow safety vest in violation of MOR 18.1.7 (listed above). The improper use of the backpack obscured the reflective "X" located on the rear of the outer garment creating a safety hazard. (See Fig 1 on next page)

Hazard Rating: 2D

Fig 1 - RVO wearing backpack
