# WMSC Inspection Report 20250326A

Title: Observation of WMATA Track Inspection from New Carrollton to Landover, Track 1

**Location:** Track 1 D13 (New Carrollton) to D12 (Landover)

Date of Inspection: 3/26/2025

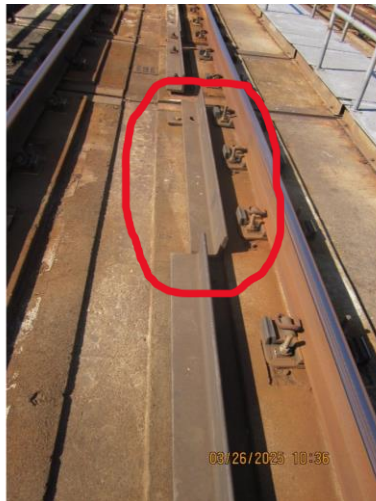
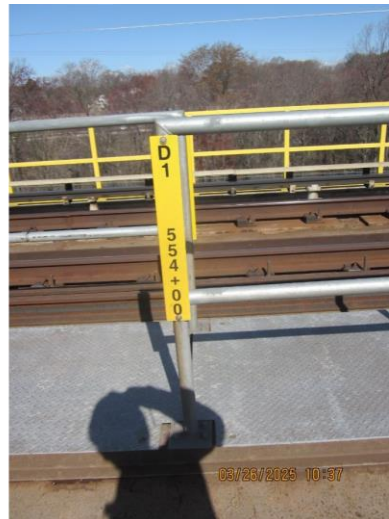
### Defect 1

WMSC Inspectors noted part of a flyover guardrail had been cut and the divided piece was left behind sitting in the right-of-way and not anchored in any way. This should be mitigated. (See fig 1 and 2)

Fig 1 and 2 - loose guardrail on flyover

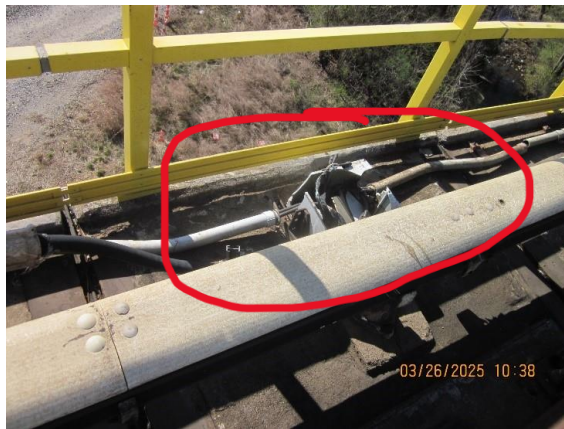
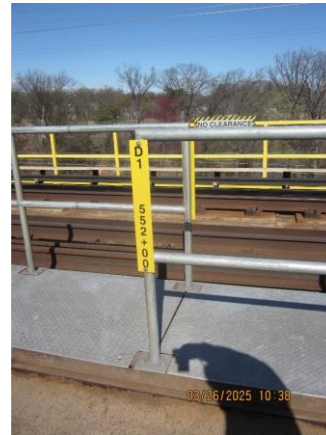
### Defect 2

WMSC inspectors noted a damaged junction box on the flyover near D1-552+00. WMSC Inspectors were unable to determine the function of the junction box at D1 552+00, but request WMATA to confirm that the damage is not creating a safety hazard. (See fig 3 and 4)

Fig 3 and 4 – damaged junction box and chain marker

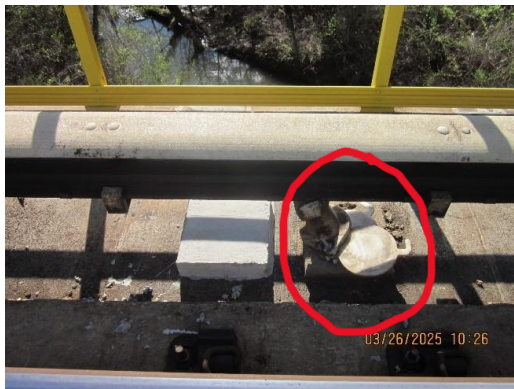
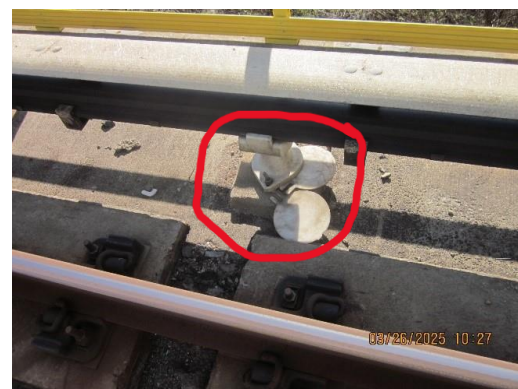
## Defect 3

WMSC inspectors noted several shims of the third rail insulators on the east end of the flyover (before chain marker D1 563+00) have come out from under the insulators. WMSC requests Track and Structures (TRST) to review the third rail geometry in this section and confirm that the insulators are secure. In typical service, these insulators are on the downhill portion of the flyover when eastbound trains would not necessarily be using power. However, should a situation require single tracking in this location there may be issues with westbound trains if these insulators are not properly supporting the third rail. (See figs 5 through 8)

Fig 5 and 6 – shims detached from under the insulators

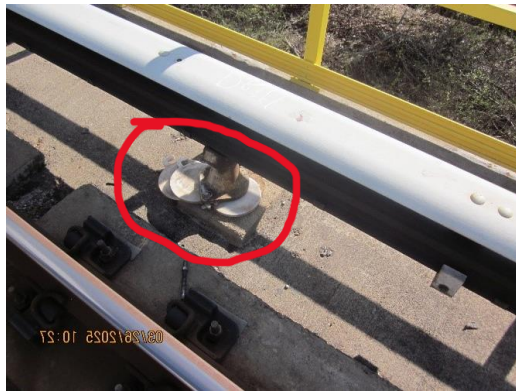
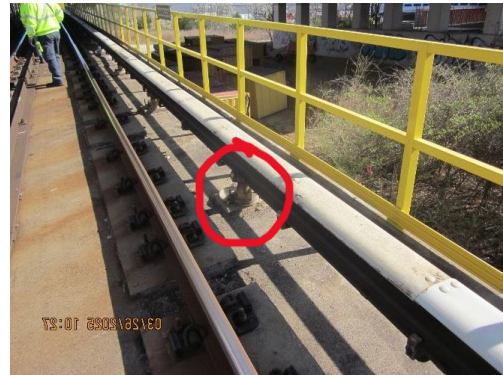
Fig 7 and 8 – detached shims

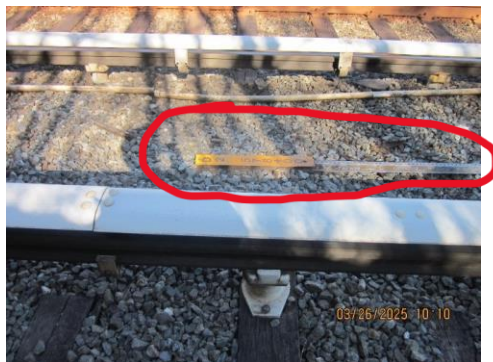
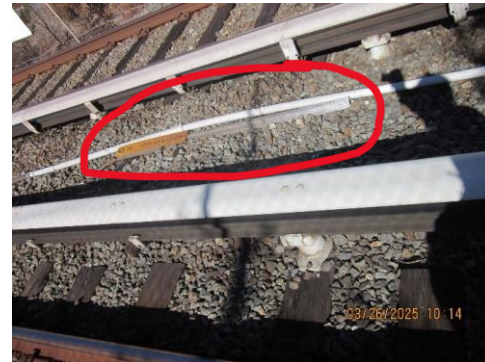
### Observation 2

There were some chain markers that were knocked down (See fig 9 and 10) and these damaged chain markers were reported and logged in Maximo by the track inspectors.

Fig 9 and 10 – knocked down chain markers

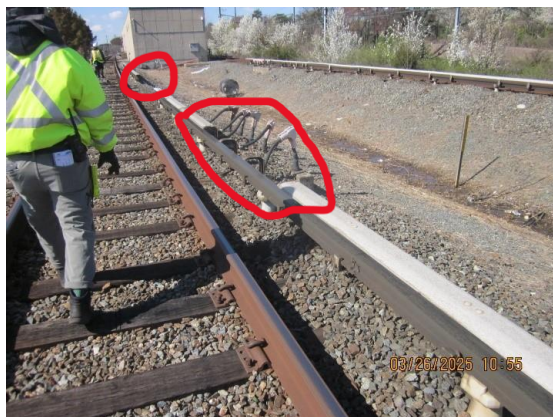
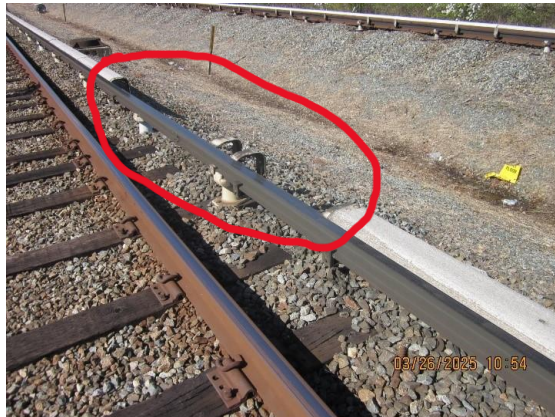
WMSC Inspectors noted a number of third rail coverboards were knocked off, removed or damaged, but again not clustered enough to warrant a defect. There were a number close together as Inspectors approached the Landover station. (See fig. 11 through 14) The TRST track inspectors confirmed that all of these items have been previously reported. There is no defect to report.

Fig 11 and 12 - damaged or removed third rail coverboards.

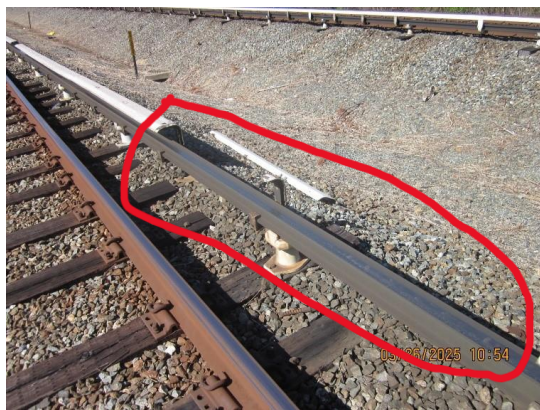
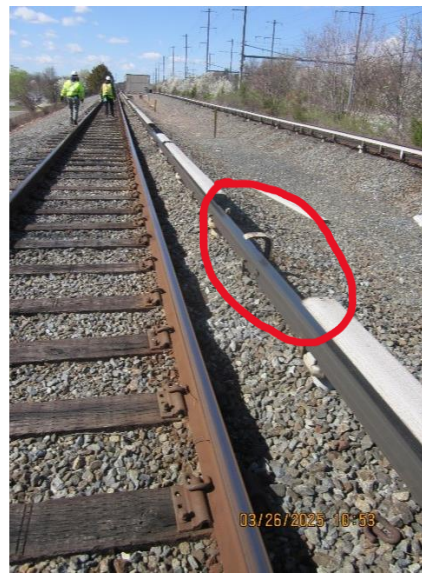
Fig 13 and 14 - more damaged or removed third rail coverboards.

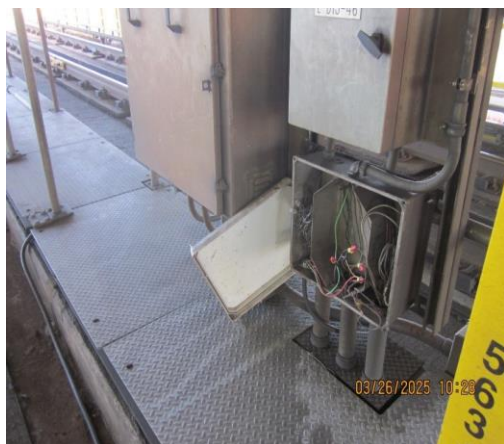
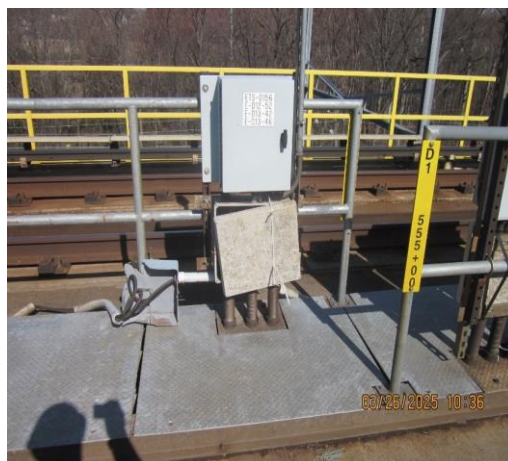
### Observation 4

WMSC was unable to determine if these ETS boxes were functional, but the boxes were obviously damaged; D1- ETS Box D157 CM 554+94 and D1- ETS Box D159 CM 562+94; (See fig 15 and 16)

Fig 15 and 16 – damaged ETS boxes
