**W-0365 Hazardous Materials Spill – near Rosslyn Station – August 7, 2024****Document Purpose**

**FINAL REPORT OF INVESTIGATION A&I E24620**

**Chain Marker C1 103+00 to 126+00 – Hazmat Spill**

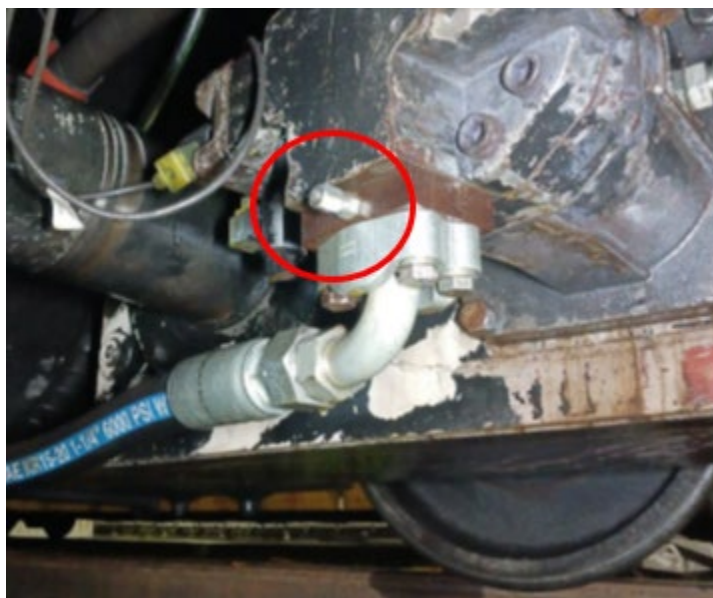
*Figure 1 - Field repair cap.*

The RMM Rail Grinder 8126 arrived at Alexandria Rail Yard. A post-inspection found that a 1/4" hydraulic hose had been removed from a hydraulic propulsion motor pressure port, which had been capped to prevent the further release of fluid.

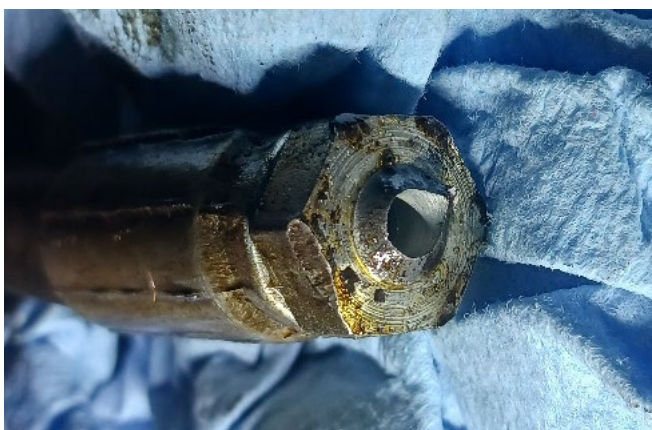
The removed hose assembly was located and examined. The 90° fitting that was connected to the pressure port was broken off. The 1/4" hose, assembled with end fittings, is rated to 5800 PSI working pressure with a 4:1 bursting pressure ratio. The RMM Rail Grinder drive circuit has a maximum operating pressure of 3900 PSI and a maximum relief setting of 4400 PSI.

*Figure 2 - Failed hose fitting.*

The probable cause of the Hazmat Spill on August 7, 2024, between CM C1 103+00 and C1 126+00 on track 1, was a result of a failed 1/4" hydraulic hose fitting connected to the B pressure port of Unit #1's hydraulic drive motor. The failure was due to externally applied stress to the hose. The pump supplying the motor continued operating as the propulsion circuit commanded until a low oil condition forced a stop.

The RMM Rail Grinder 8126 was removed from WMATA property and is not authorized to operate in the WMATA system without a major overhaul, a Contractor Inspection Program, and an ICS renewal inspection.

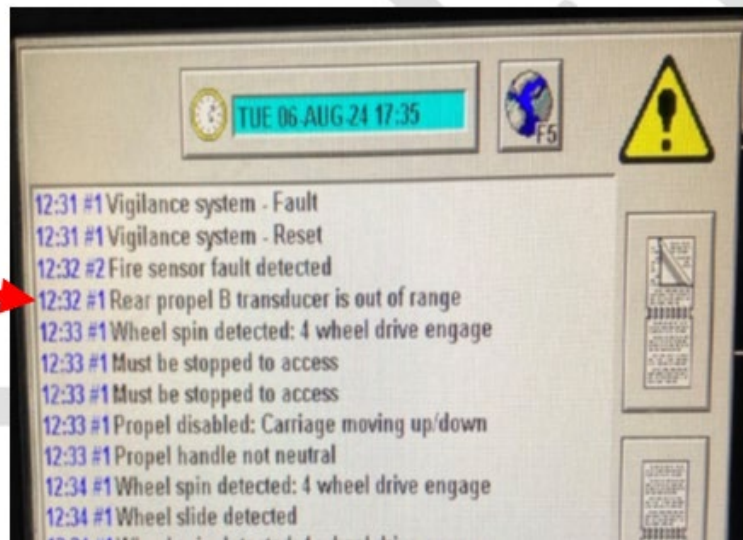
A review of RMM Rail Grinder 8126's historical data shows that the propel B transducer went out of range at 1232 hours. At 1240 hours, both transducers were out of range, and a low hydraulic oil condition was detected. The engine was shut down at 12:42 hours.

Figure 3 - Propel B transducer out of range as of 1232 hours.

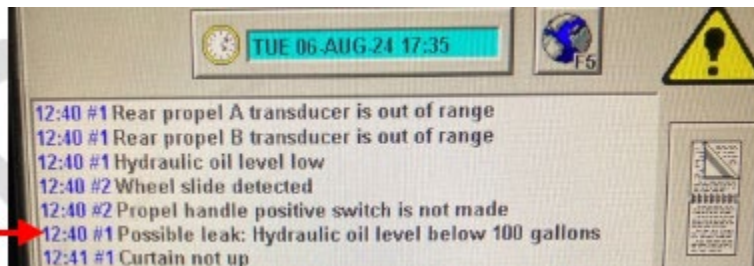
Figure 4 - Possible leak detected as of 1240 hours.
