**Improper Vehicle Movement
At or Near Dupont Circle and Pentagon stations
July 21, 2024, and August 17, 2024**

W-0366 – Dupont Circle Station – July 21, 2024 (E24568)

E24568 – Improper Rail Vehicle Movement – Dupont Circle

Pentagon Station – Improper Rail Vehicle Movement

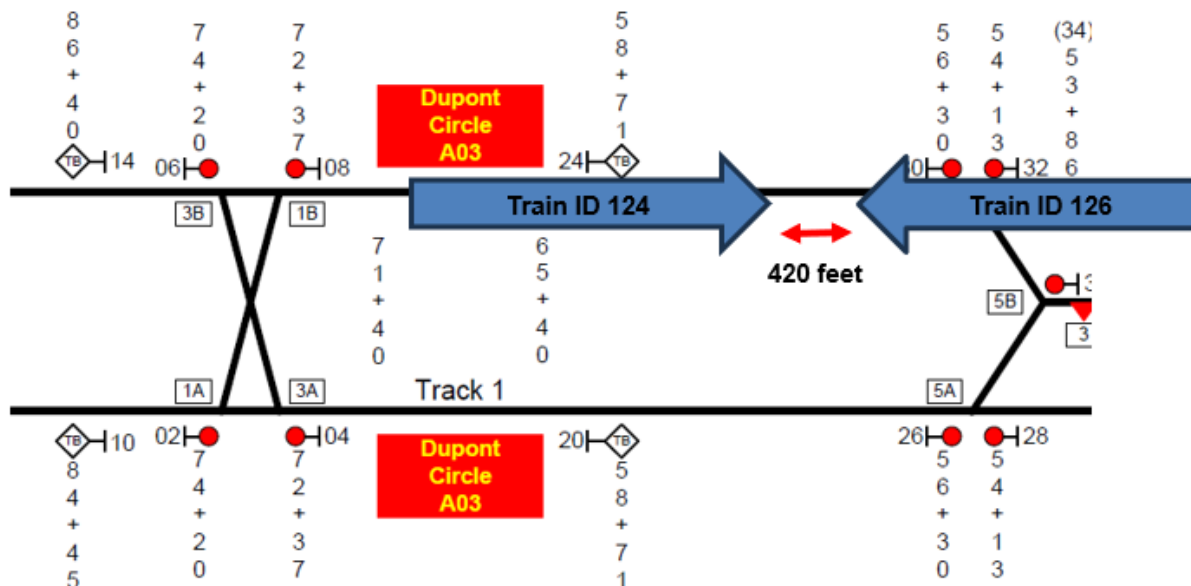
Field Sketch/Schematics

The above depiction is not to scale.

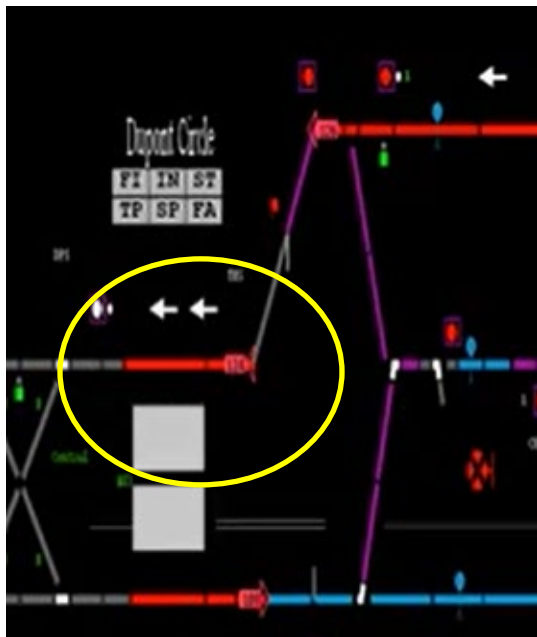
Figure 1 - The yellow circle depicts Train ID 124 at 17:58 hours, keyed up on the trailing end (the triangle is reversed).

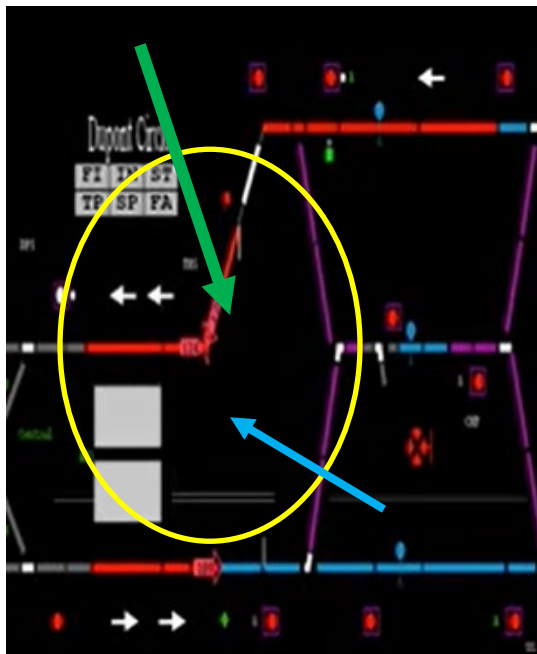
According to the data analysis from the Event Recorders on both trains, Train 124 stopped 420 feet away from the lead car of Train ID 126.

Figure 2 - (blue arrow) depicts Train ID 124 stopped with 420 feet of (blue arrow) Train ID 126.

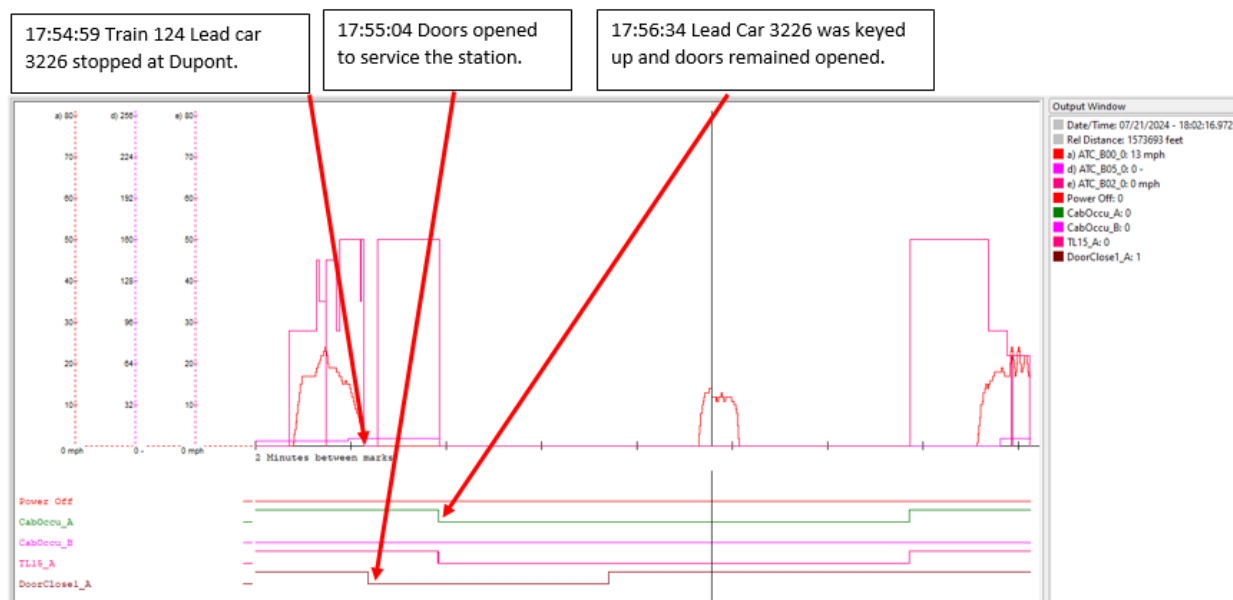
Figure 3 - Data analysis from Railcar 3226.

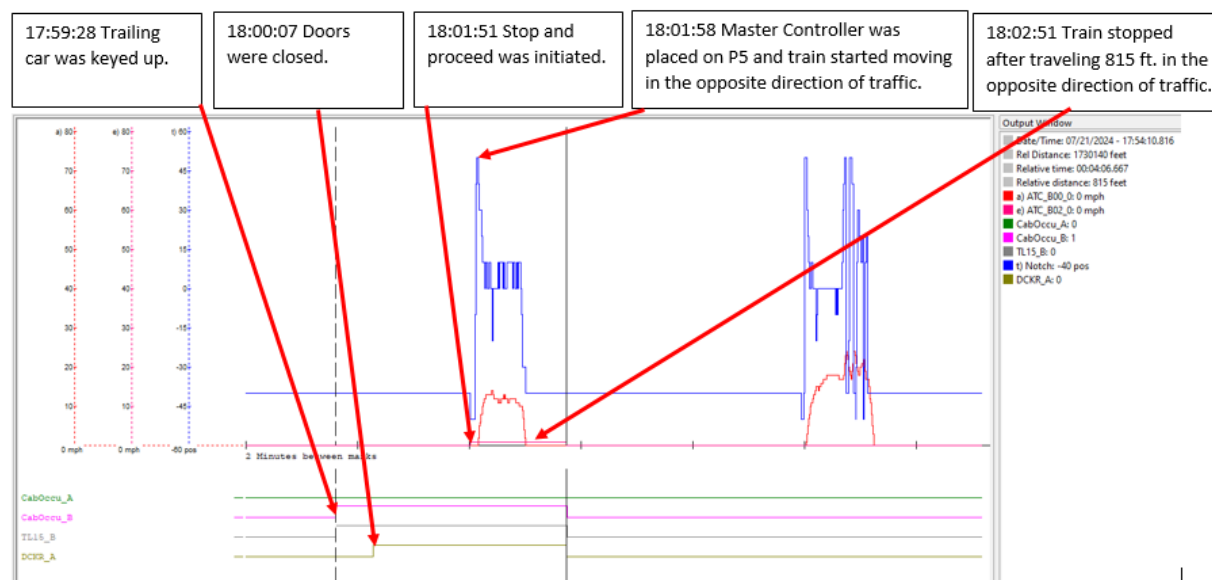
Figure 4 -Data analysis from Railcar 3245.

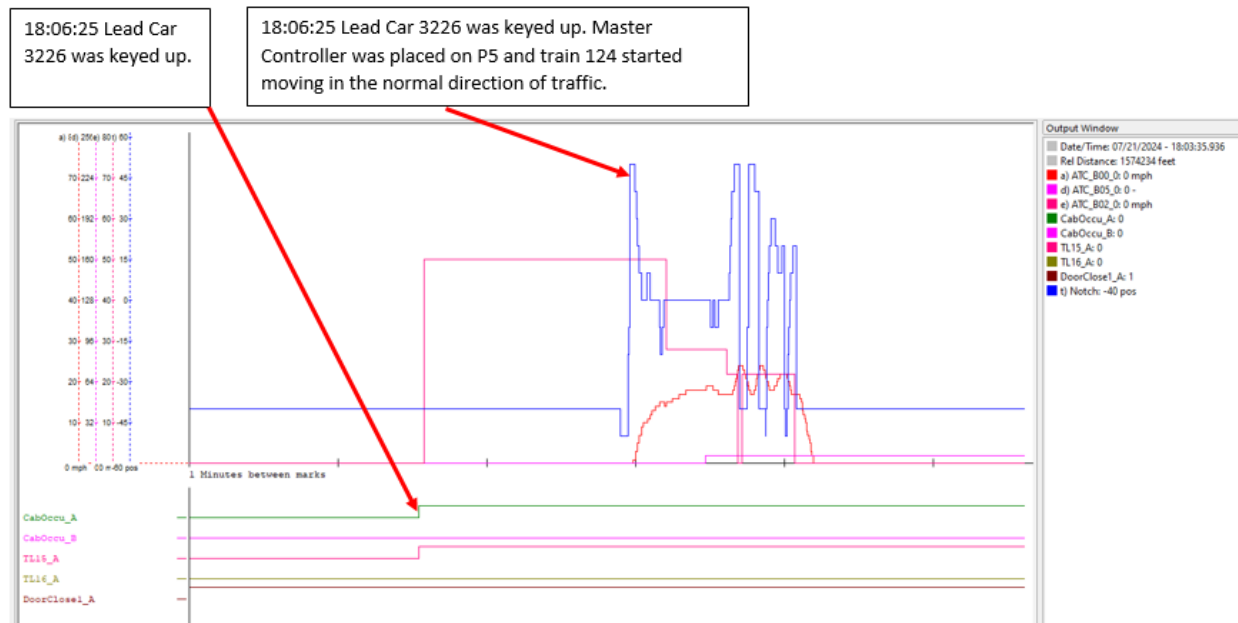
Figure 5 - Data analysis from Railcar 3226.

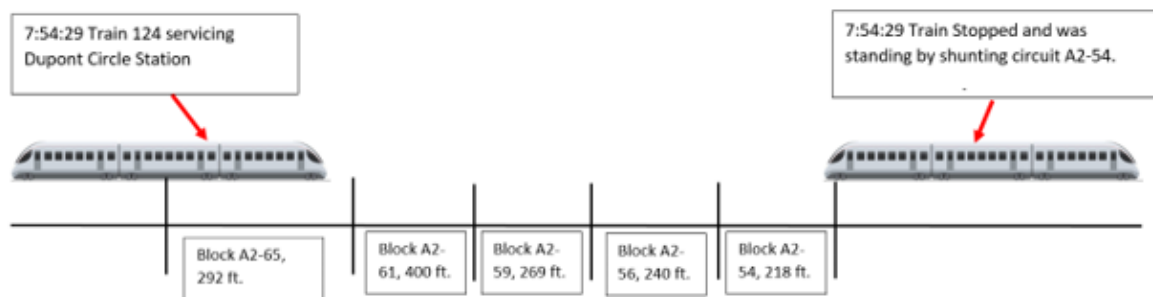
- Train 126 stopped 1232 feet from the end of train 124 and stood by.
- Train 126 remained stopped before, during, and after the incident.
- Train 124 moved 812 feet toward Train 126.
- Train 124 stopped 420 feet away from Train 126.
- Train 124 and Train 126 occupied adjacent ATC blocks (trains were never in the same block).

Figure 6 - Depicts Train 124 servicing Dupont and 126 standing shunting circuit A2-54 without speed commands, approximately 1232 feet away from the trailing end of Train 124.

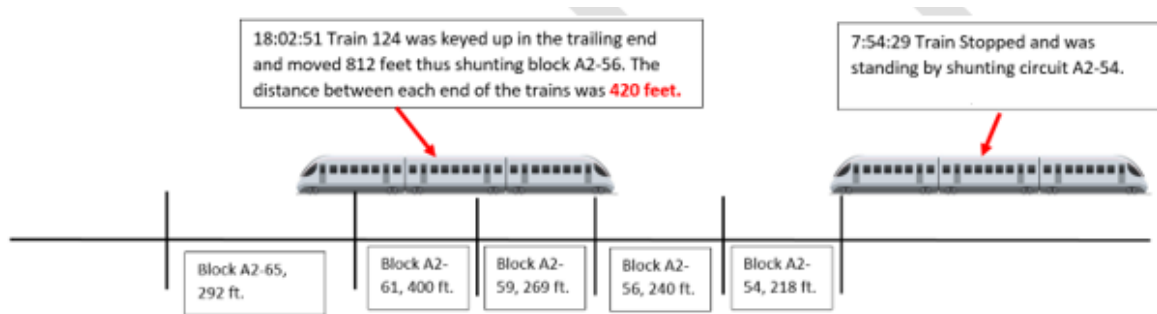
Figure 7 - Depicts Train 124 moved 812 feet in the towards Train 124. Train 124 shunted circuit A2-56 and was 420 feet away from train 126.

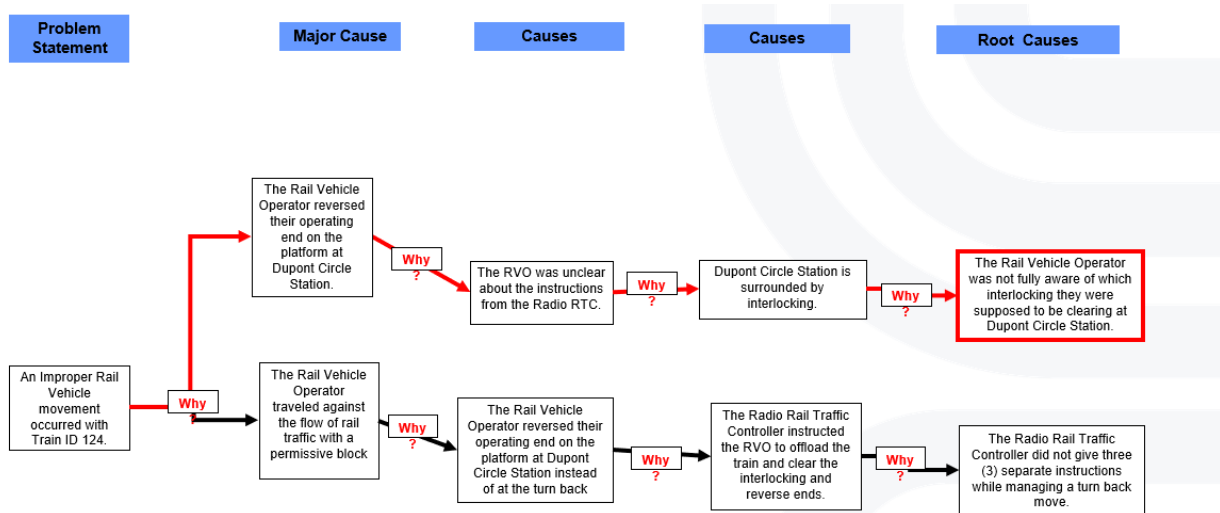
The probable cause of the Improper Rail Vehicle Movement event was the RVO of Train ID 124's misunderstanding of the directions provided by the Radio RTC. The RVO misinterpreted the instruction to clear the interlocking at Dupont Circle and reverse ends, instead proceeding against the flow of traffic head-on towards a revenue train. This miscommunication led to the improper movement of Train ID 124.

Figure 13 - Why Tree (Root Cause Analysis).

Corrective Action Code	Description	Responsible Party	Estimated Completion Date
118536_SAFE CAPS_MICC_001	Issue a staff notice to all Rail MICC personnel instructing that when a train's operating end moves in the opposite direction of travel, the RTC must verify and confirm that the RVO is correctly positioned at the proper operating end for the intended direction before authorizing movement. Operating directions will be identified by terminals (e.g., Largo direction).	MICC SRC	Completed
118536_SAFE CAPS_MICC_002	Conduct a boot camp session with RTCs to review the 'Improper Rail Vehicle Movement' incidents. Discuss new instructions, review similar cases, and encourage questions for better understanding.	MICC SRC	Completed
118536_SAFE CAPS_RTRA_001	Conduct a Safety Stand-Down with all RVOs to discuss and distribute "Safety Point to Adhere While Operating Rail Vehicles" (RTRA-101-01-00)	RTRA SRC	Completed

118536_SAFE CAPS_RTRA_002	A Personnel Directive, "Preventing Improper Direction of Travel After Offloads," with required actions, will be issued to RVOs. The directive will be explained to each RVO, and they will sign in acknowledgment upon receiving it.	RTRA SRC	Completed

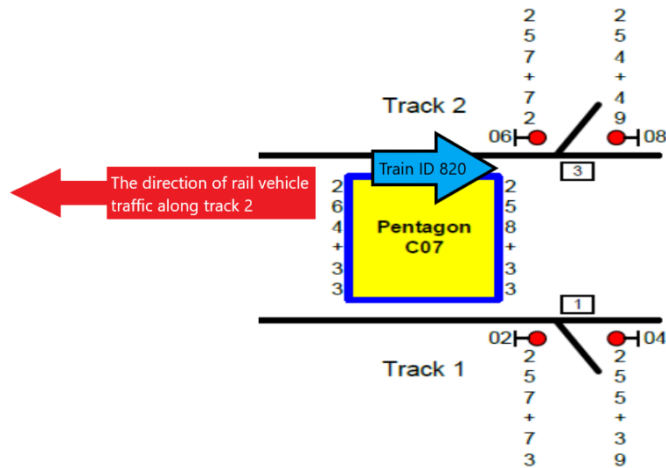
Figure 1 - depicts the direction Train ID 820 moved towards on track 2 at Pentagon Station.
The above depiction is not to scale.

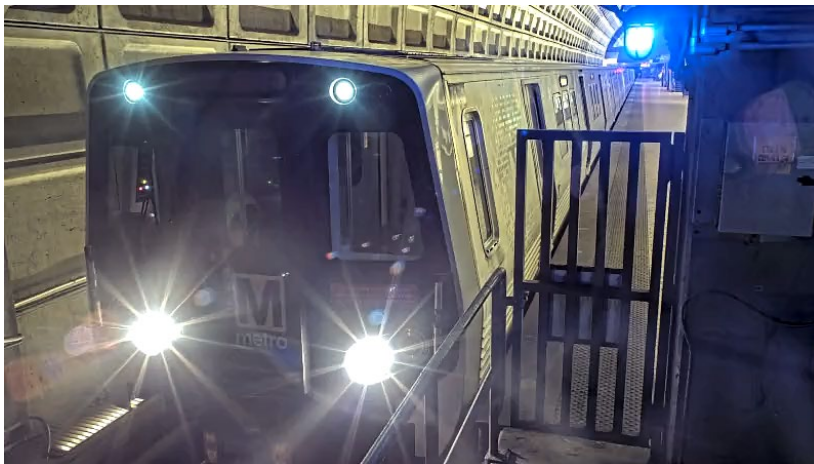
Figure 2 - Train ID 820 berthed at the 8-car marker at Pentagon Station on track 2.

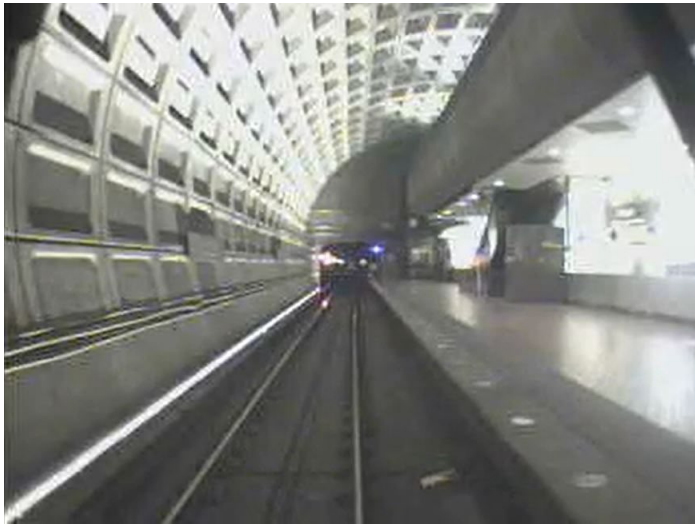
Figure 3 - Trailing car 7180 exterior camera as Train ID 820 berthed at the 8-car marker.

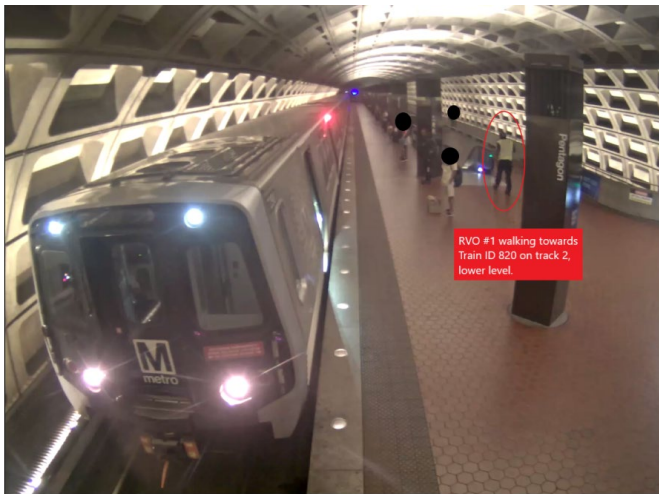
Figure 4 - Depicts RVO #1 walking to Train ID 820 on track 2, lower level.

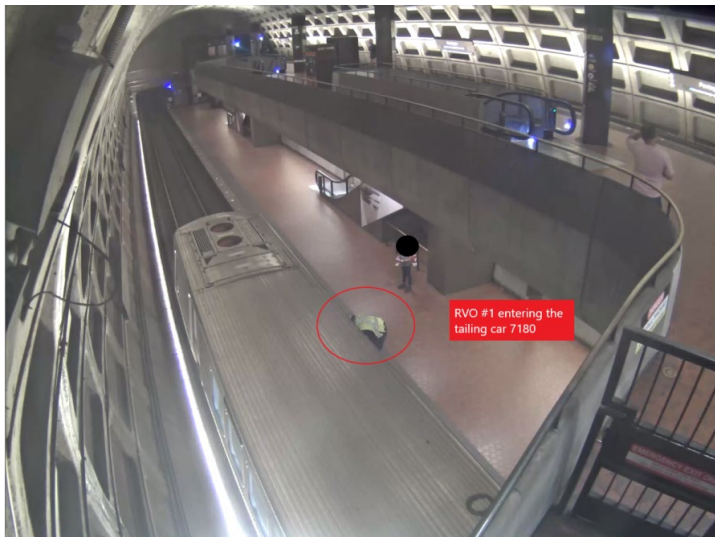
Figure 5 - RVO #1 entering the trailing car of Train ID 820.

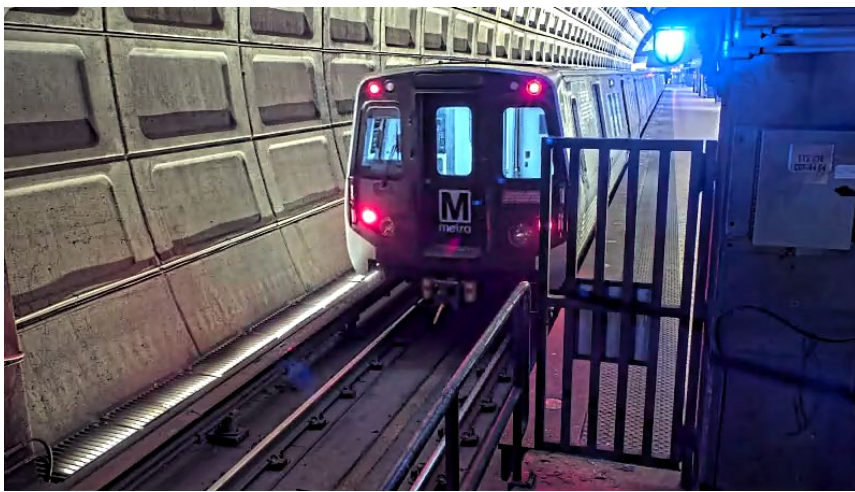
Figure 6 - Depicts RVO #1 moving Train ID 820 in the opposite direction of rail vehicle traffic, on track 2 of Pentagon Station.

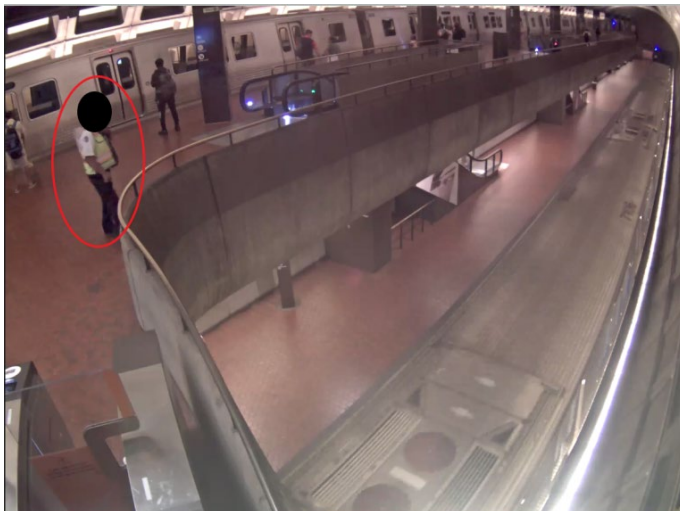
Figure 7 - Depicts ROS #1 informing the RTC of the train on track 2 moving in the opposite direction of normal rail traffic.

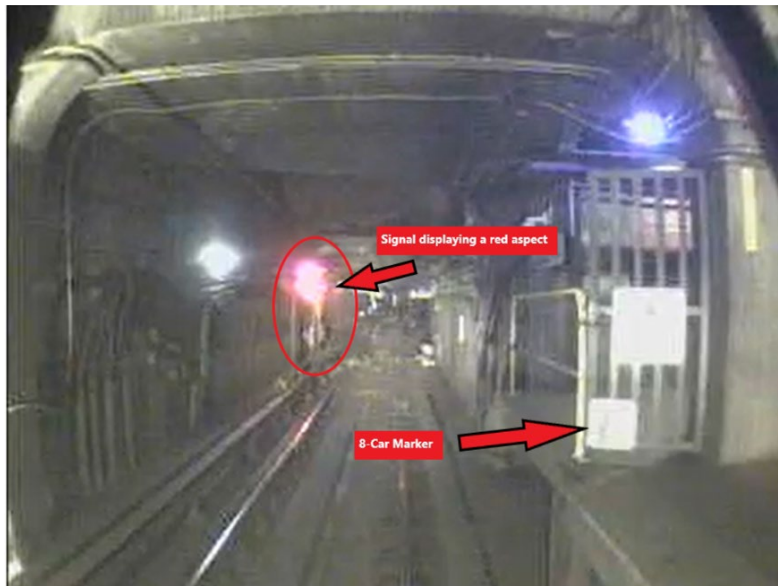
Figure 8 - Trailing car 7180 exterior camera as Train ID 820 stopped after moving in the opposite direction of rail traffic to the beginning of the platform.

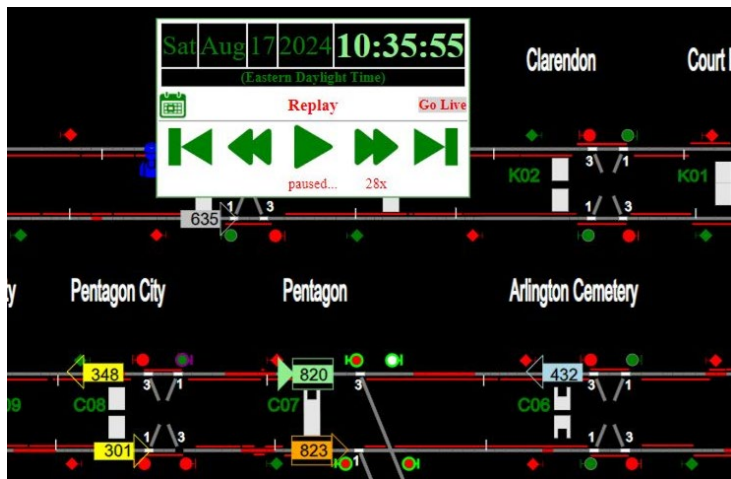
Figure 13 - Depicts Train ID 820 doors opening at 10:35:55 hours. RVO #1 boards the train at this time.

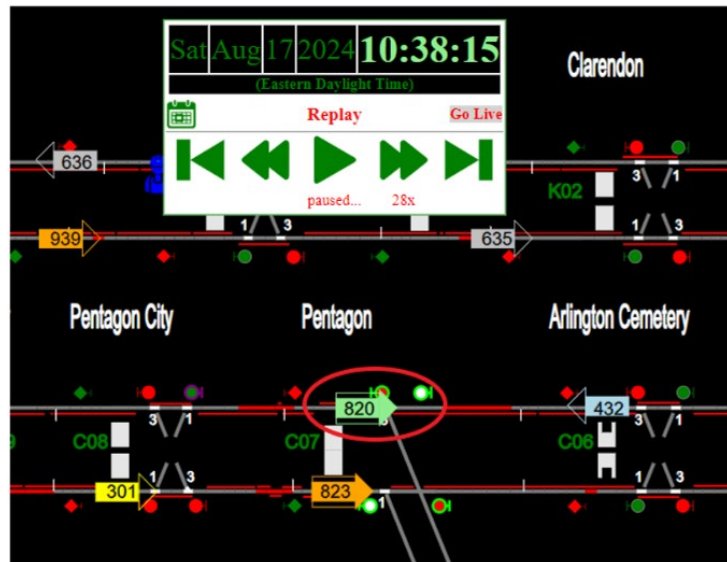
Figure 14 - Depicts Train ID 820 moving in the opposite direction of rail traffic.

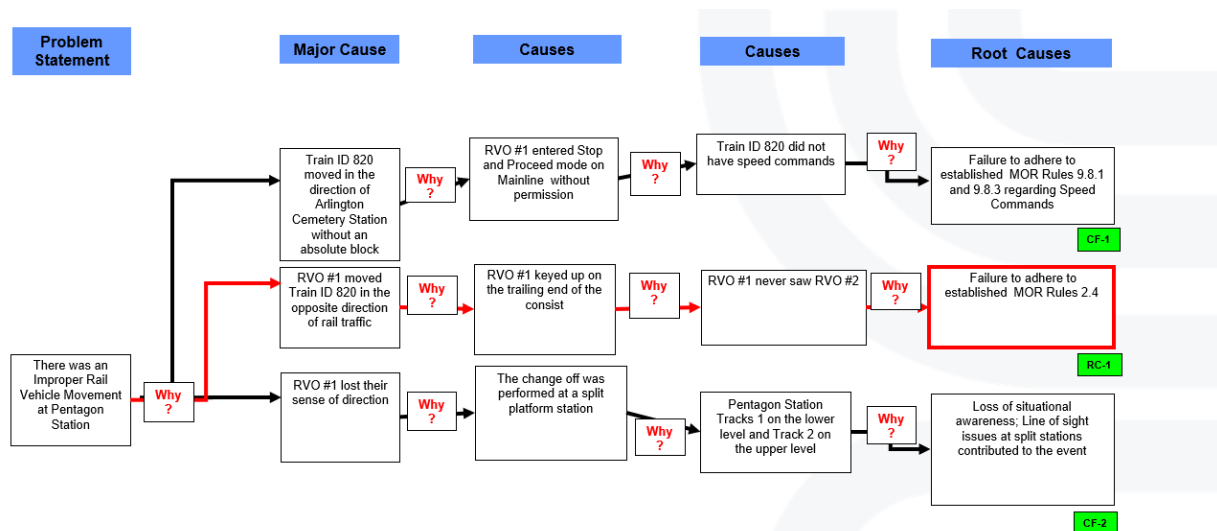
The probable cause of the improper rail vehicle movement at the Pentagon Station on August 17, 2024, was determined to be an improper handoff. The RVO failed to conduct a visual and verbal rail vehicle change-off, thereby entering the incorrect railcar. Contributing to the incident was the procedure in place for moving a train without speed commands was not followed. The RVO failed to contact the Button RTC, before entering “Stop and Proceed” mode and began moving the train in the opposite direction of rail traffic without permission or an absolute block.

E24652 - Improper Rail Vehicle Movement – Pentagon Station
