WMSC Inspection Report 20250427B

Title: Grosvenor-Strathmore Station Platform Hazards

Location: Grosvenor-Strathmore Station (A11)

Date of Inspection: 4/27/2025

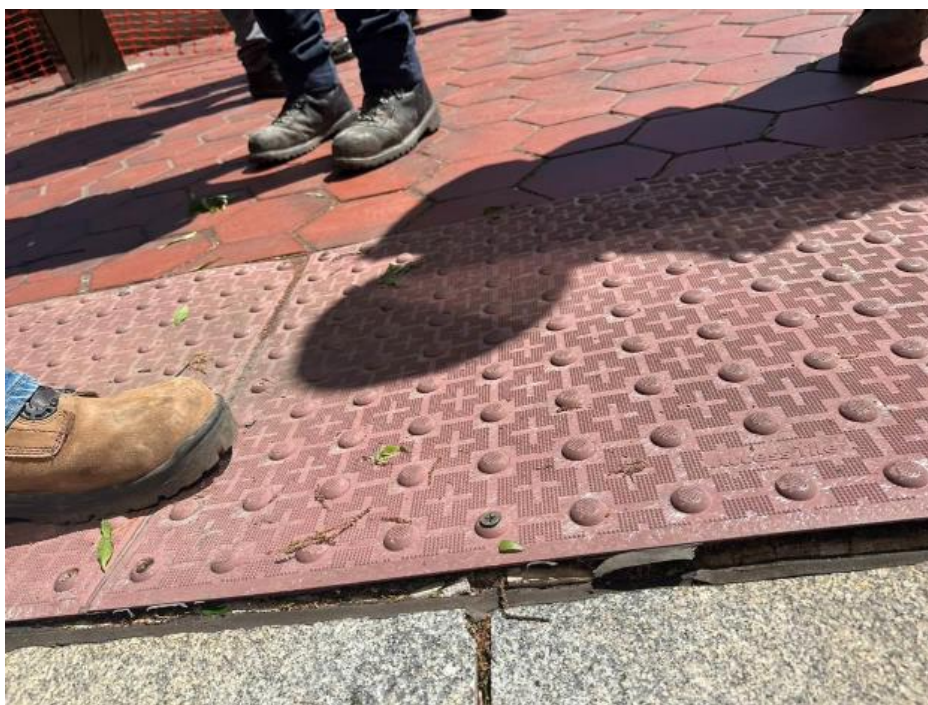
Grosvenor-Strathmore Station (A11) Platform, approximately at chain marker 566+50, Track One, the granite edge slopes towards the track causing a serious tripping hazard. Americans with Disabilities Act (ADA) warning tiles in the same area, are loose, buckled, and are not level with the granite edge. Please see photos below.

Hazard Rating: 3D

Fig 1 Tilt of granite edge, gap between granite and ADA warning tiles

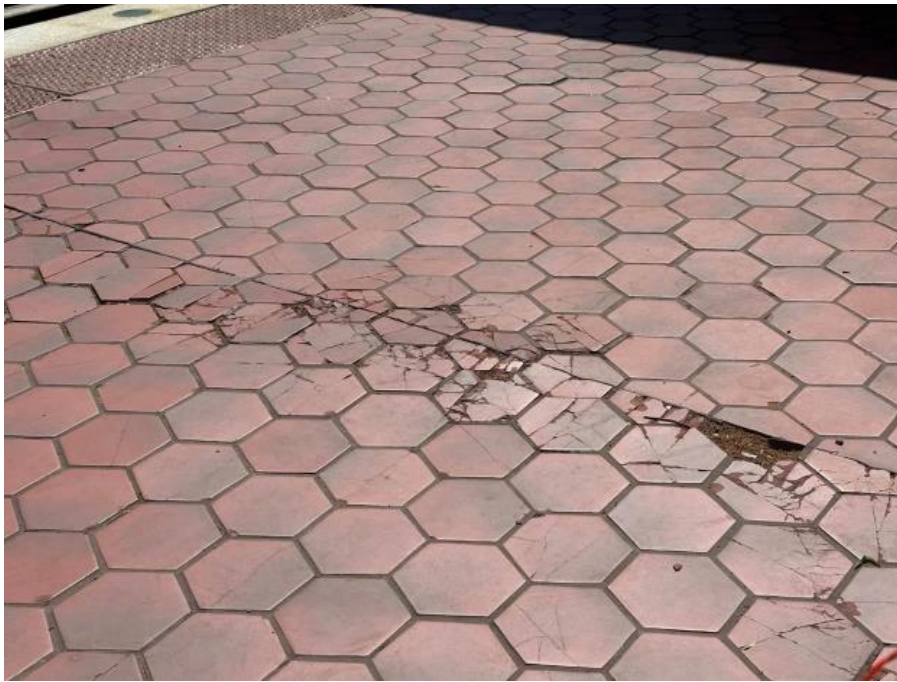
Fig 2 Loose and broken tiles

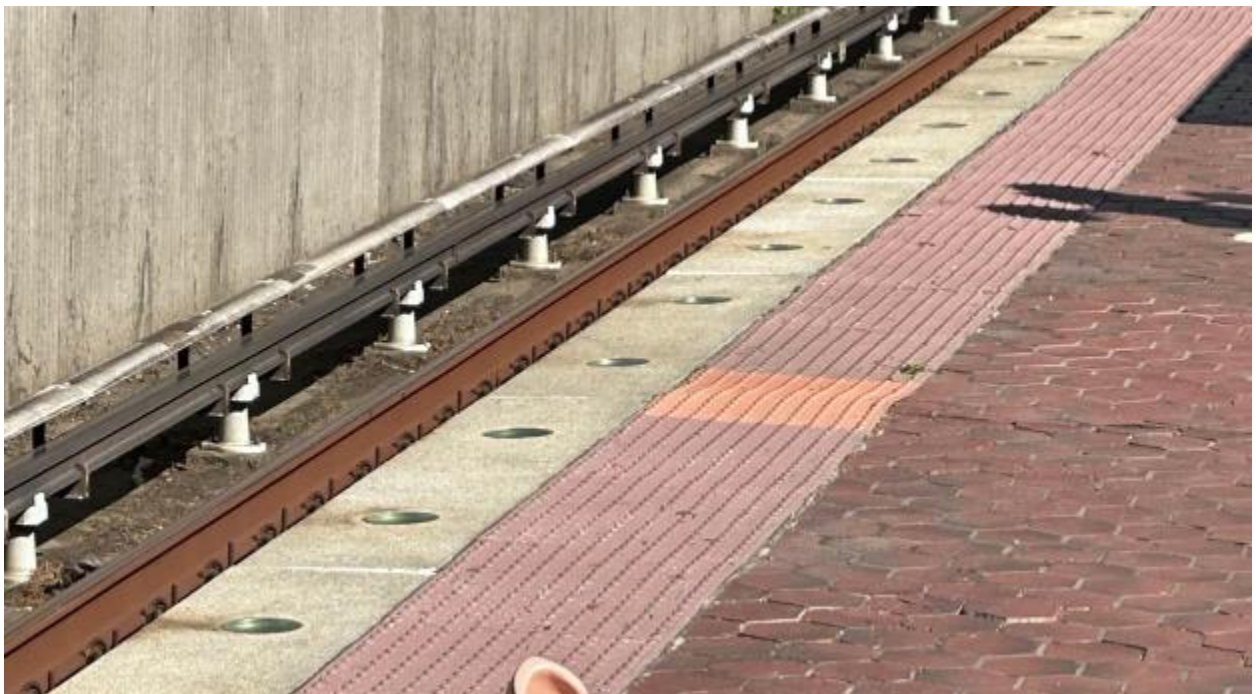
Fig 3 Buckled ADA warning tile

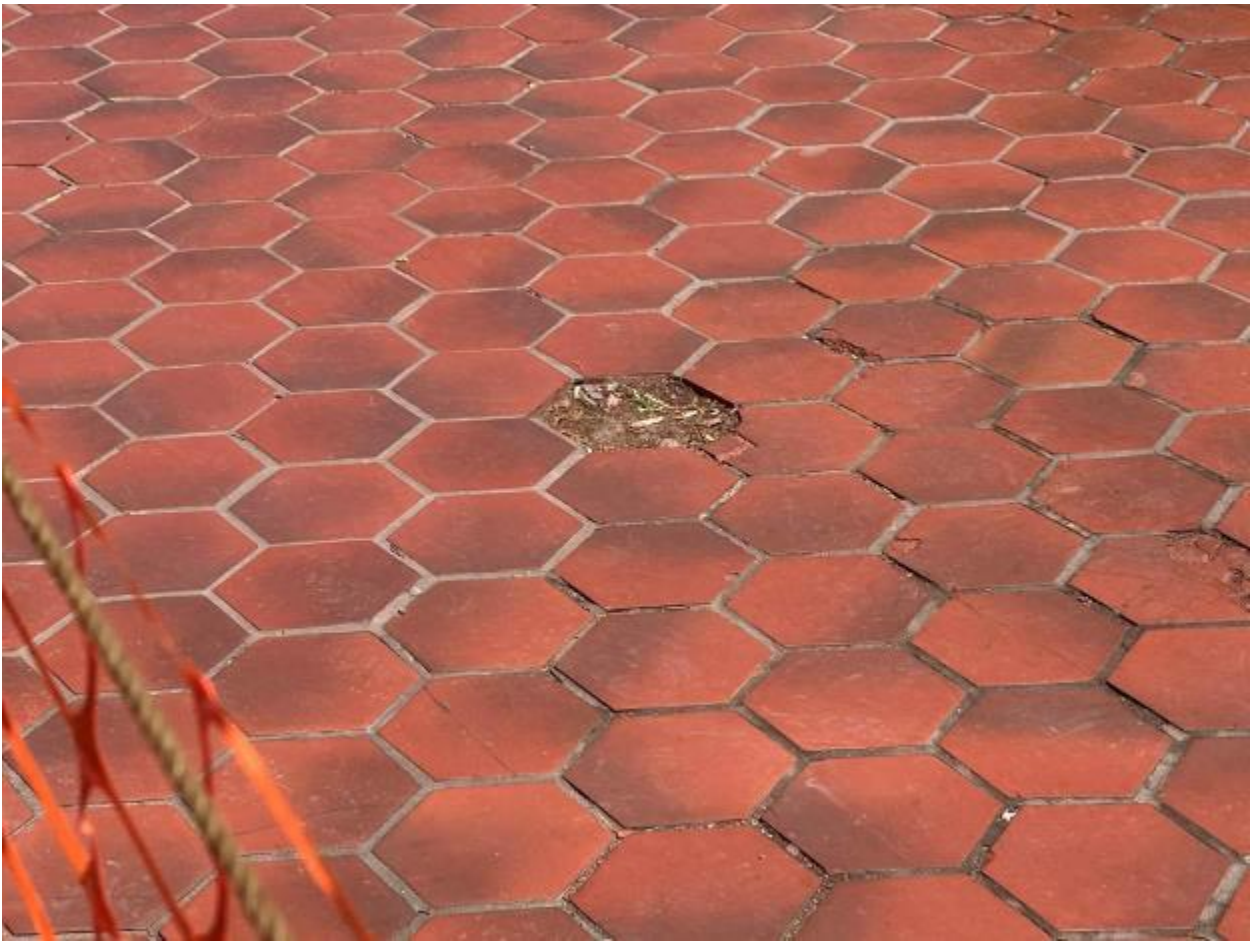
Fig 4 - missing tile
