**W-0368 – Employee Injury at West Falls Church Rail Yard – March 8, 2024****Document Purpose**

Washington Metropolitan Area Transit Authority
Department of Safety (SAFE)
Office of Safety Investigations (OSI)
FINAL REPORT OF INVESTIGATION A&I E24178

West Falls Church Yard – Employee Injury

March 8, 2024

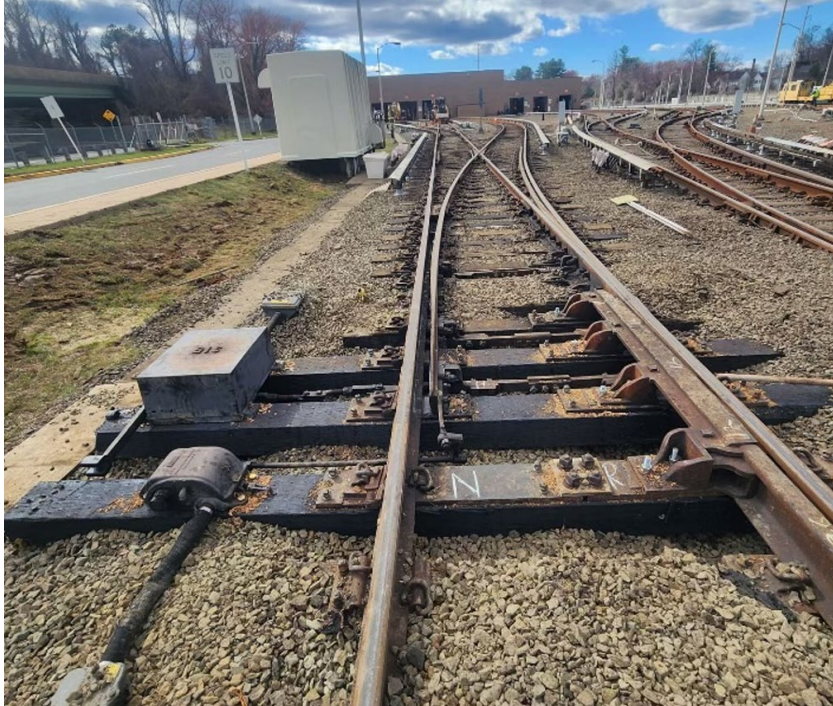
Image 1: West Falls Church Yard Switch 315

At 08:40 hours, the Closed-Circuit Television (CCTV) determined that an ATCM Mechanic, who was adjusting the crib heater at Switch 315, injured their index and middle fingers on their right hand when the switch moved, pinning their fingers between the switch-point and running rail.

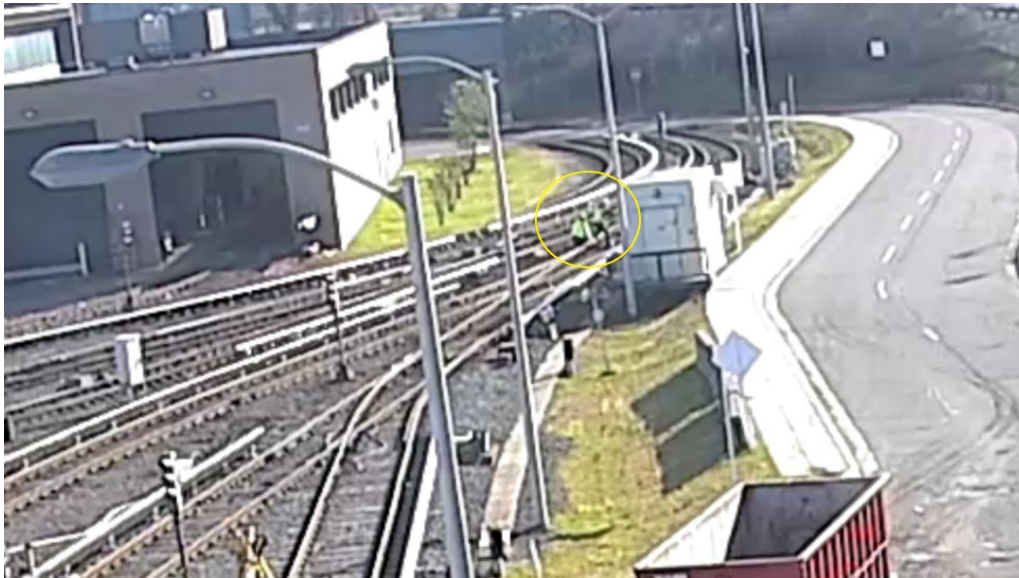
Image 2: ATCM work crew, render aid to the ATCM Mechanic behind the white, temporary structure at 08:40 hours.
