**W-0370 – Loss of Communication near Friendship Heights Station – May 9, 2024****Document Purpose**

Washington Metropolitan Area Transit Authority
Department of Safety (SAFE)
Office of Safety Investigations (OSI)
FINAL REPORT OF INVESTIGATION A&I E24361

Signal A08-02 – Operator Removed from Service (Fatigue)

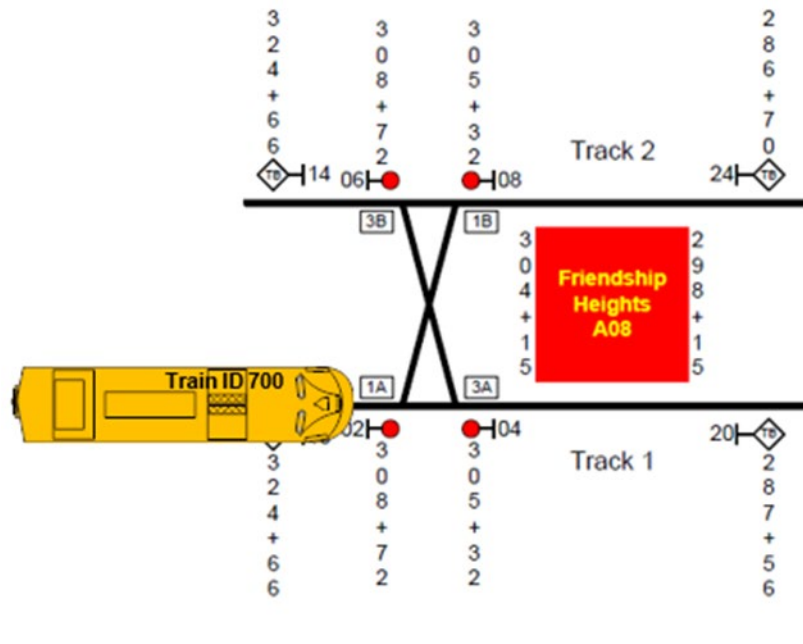
Field Sketch/Schematics

Signal A08-02, Chain Marker A1 311+00

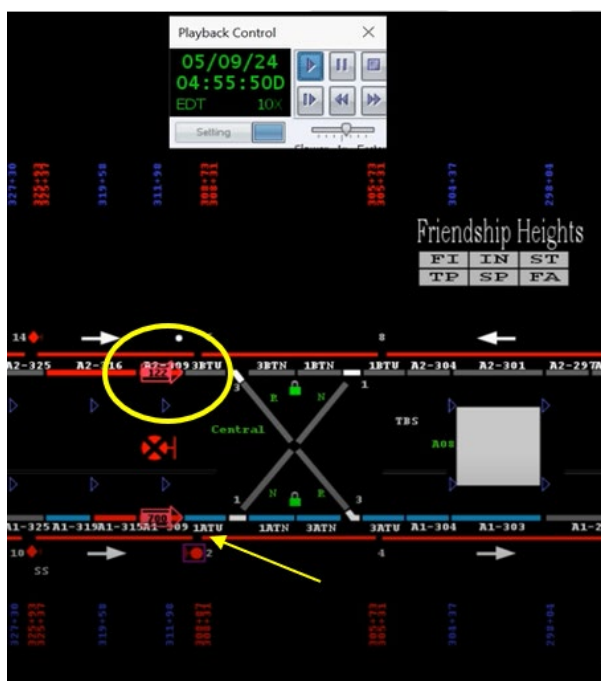
At 04:53, the Rail Transportation Supervisor arrived at Friendship Heights Station and was instructed to stand by as Train ID 122 would be single tracking around Train ID 700 and attempt to contact the RVO. Train ID 122 was unsuccessful in contacting the RVO of Train ID 700 and could not see the train's lead cab due to the concrete wall.

Figure 1 - Yellow circle Train 122 as it passed (arrow) Train ID 700

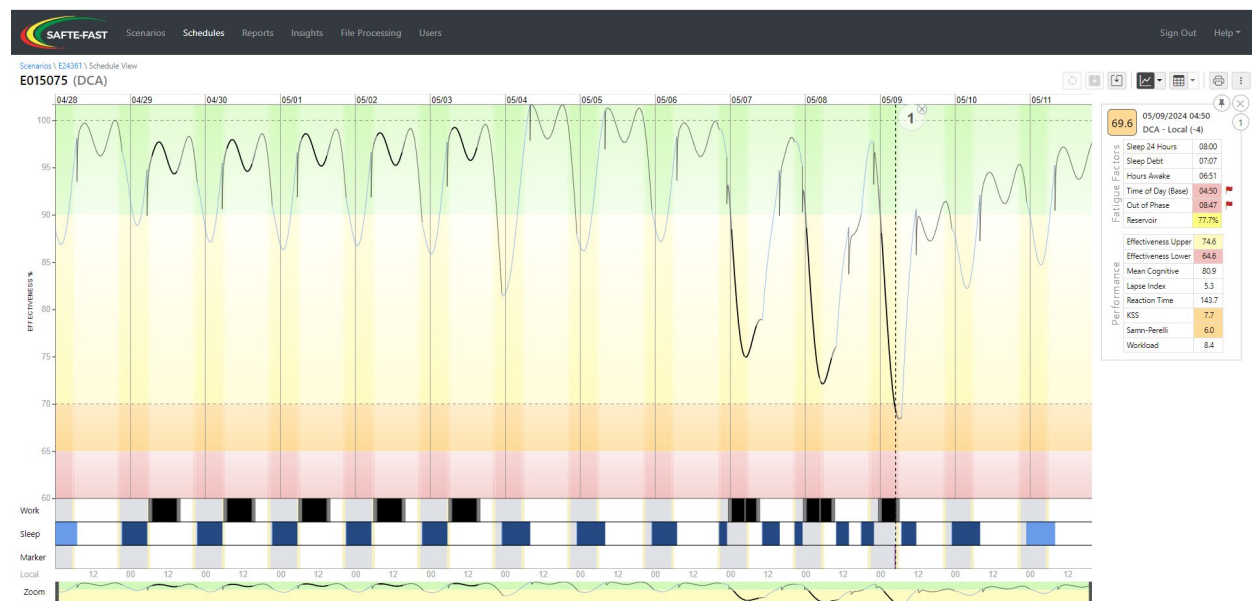
A biomathematical fatigue modeling application (SAFTE-FAST WebSFC) was used to further evaluate fatigue risk factors that may have been present in the Train Operator's schedule. The analysis was based on the Train Operator's work schedule, reported sleep from the day before the incident, and reported habitual sleep durations. The estimated performance effectiveness at the time of the incident was 69.6%. Specifically, the analysis identified the circadian effects of night work as a factor contributing to an increased risk of fatigue at the time of the incident.

Modeling analysis output shows estimated performance effectiveness during the incident work shift and for the week leading up to the work shift, based on the employee work and reported sleep schedule. Estimates were based on the Train Operator's work schedule, reported sleep from the day preceding the incident, and reported habitual sleep durations (8 hours a day). Bold portions of the modeled curve show work (in black) and sleep times (in blue). Effectiveness is shown on the vertical axis, with colored fields in the chart background signifying ranges of effectiveness scores including high effectiveness (>90%) in green, and low effectiveness (<65%) in red. Time is shown on the horizontal axis. Markers for work and sleep times are shown in the lanes above the time of day on the horizontal axis.

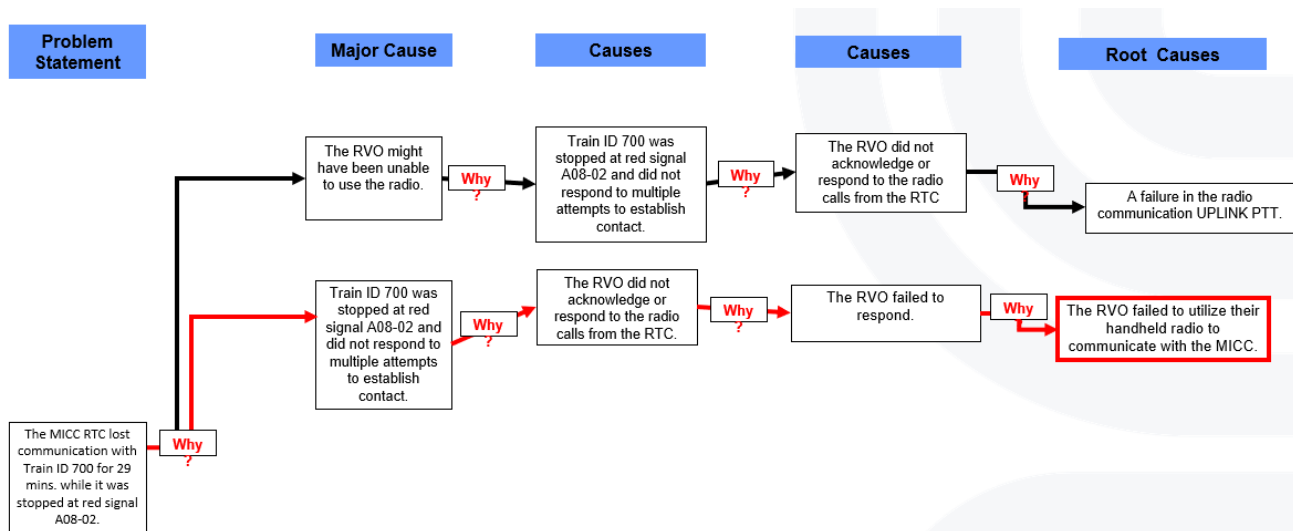
Figure 5 -Root Cause Analysis.

The probable cause of the communication loss was the RVO's failure to communicate. Specifically, the RVO failed to utilize their handheld radio to communicate with the MICC and alternate sources of communication, such as the Emergency Trip Station (ETS) phone. Additionally, operator fatigue likely contributed to the initial probable cause of the communication loss.

Corrective Action Code	Description	Responsible Party	Estimated Completion Date
116972_SAFE CAPS_COMR_ 001	Complete a Comprehensive Radio Communication System (CRCS) Belowground HEAD-END and LINE Bi-Directional Amplifier (BDA) alignment.	COMR	Completed
116972_SAFE CAPS_RTRA_ 001	RTRA will have the RVO complete a fit for duty evaluation by OHAW.	RTRA	Completed
