WMSC Inspection Report 20250602

Title: TCR (TCR) Inspection

Location: B01, F01, F02, F03, C07, C08, C09, C10, C11, C12, C13

Date of Inspection: 6/2/2025

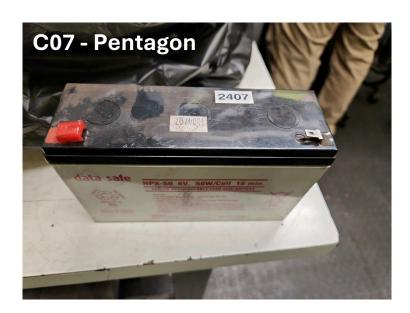
Defect 1

During inspection, a lead acid battery was found that did not have the metallic leads guarded and was stored within metal lockers often neighboring accelerants such as paper and chemicals. Such batteries that encounter other metals can cause sparks that could lead to a fire. This condition was observed at C07 Pentagon Station and immediately reported to ATCM Assistant Director who was on site during the inspection. At the time of discovery, the battery was removed from the metal cabinet and the leads taped, and the battery removed for proper disposal from the TCR.

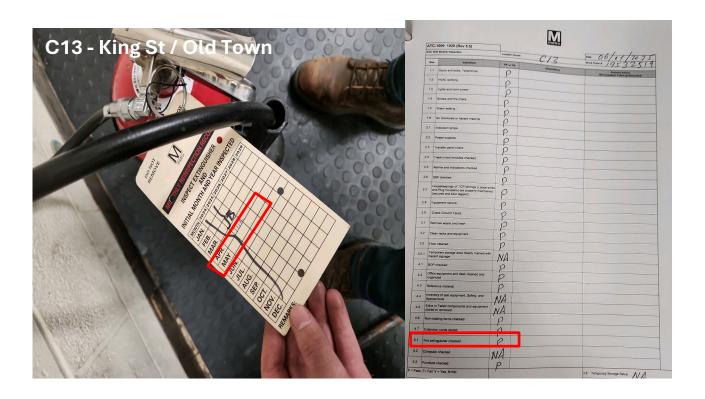
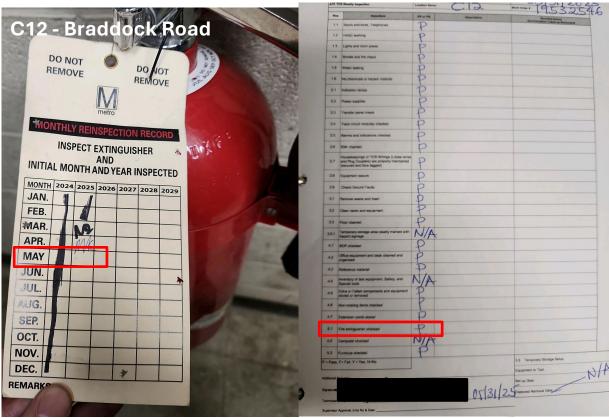
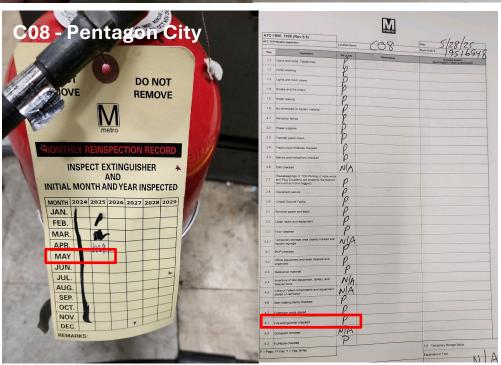
ATC-1000 (Instructions for Testing and Inspection of ATC Apparatus and System) 1020 Procedure for Train Control Room (TCR) Weekly Inspections Procedure, Step 5.1.4 instructs that WMATA mechanics performing this preventative maintenance must "verify the extinguishers has an inspection tag and that tag has been initialed by a WMATA Approved Fire Personnel for the current or previous month of the inspection."

Each visited TCR had an extinguisher available in the room. At three TCR locations, the present fire extinguisher's hang tag had not been initialed as having the condition checked/confirmed for the month of May. Upon review of the 1020 TCR inspection forms, each location's most recent check indicated "Fire Extinguisher checked" as "P" passing, but the extinguisher's tag had not been signed off. The locations in question were C13 King St – Old Town (last inspected 6/1/2025), C12 Braddock Rd (last inspected 5/31/2025), and C08 Pentagon City (last inspected 5/28/2025).

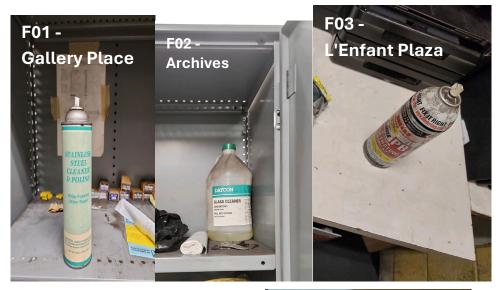
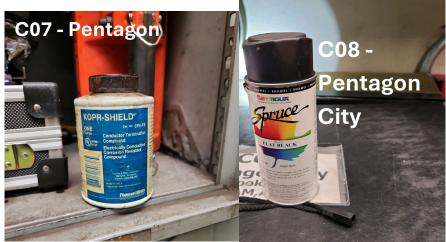
ATC-1000 (Instructions for Testing and Inspection of ATC Apparatus and System) 1020 Procedure for Train Control Room (TCR) Weekly Inspections Procedure, Step 1.6 instructs that WMATA mechanics performing this preventative maintenance must "ensure that no hazardous material or any type of chemicals are stored in the TCR."

In 5 of the 11 TCRs (F01, F02, F03, C07, C08) hazardous material or chemicals were observed in the room that included combustibles, flammables, and corrosives.

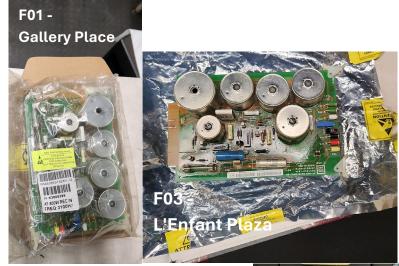
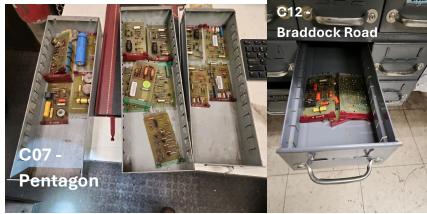
Various model power amplifier and printed circuit boards were found at the F01 – Gallery Place, F03 – L'Enfant Plaza, C07 – Pentagon, C12 – Braddock Road, and C13 – King St-Old Town Train Control Rooms. These power amplifiers and printed circuit boards are vital pieces of equipment that are used during testing, verification, and repairs to the train control system. The power amplifier and circuit boards were not in anti-static jackets, not tagged, and were not removed from the TCR as required by ATC-2000 System Integrity Maintenance Practices for defective and unused equipment. The boards found during this inspection were removed by ATCM Assistant Director.

2004.11 Yellow Tags – Defective and Unused Equipment When defective ATC equipment is identified, or un-used stock is found during routine maintenance the following actions are required:

- Yellow tags shall be completed and applied to any defective equipment removed from service or any unused stock or equipment found at the location. The tag information shall include the 3MS WO number, location ID, date, stock number, description of the defect, technician name, and call number.
- The defective or unused equipment shall be returned to the field office (or other location designated by the ATCM Supervisor), for pick-up and transport to the SMNT Shop and Material Support (SAMS) facility.
- Whenever items are pulled from stock and not used, they shall be promptly tagged and returned to SAMS for testing and return to the storeroom.

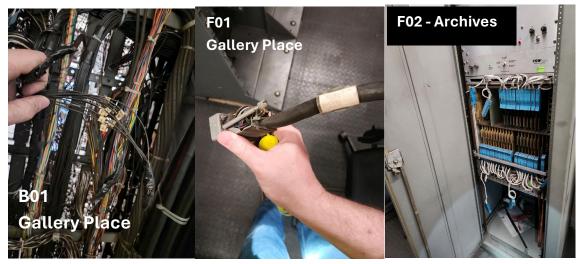
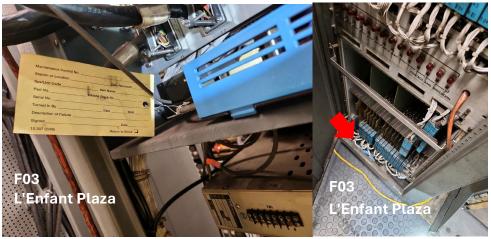
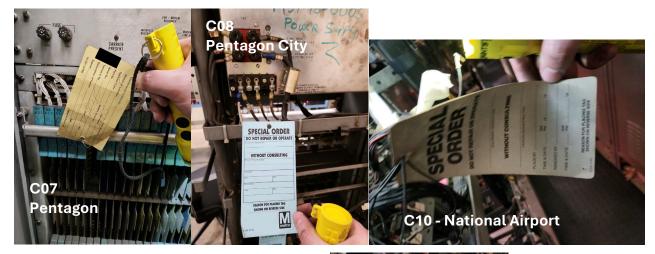
Several TCR locations were identified as having cable jumpers and various copper interconnect cable heads hanging from racks that were improperly tagged or missing the required blue tag to indicate their status at B01, F01, F02, F03, C07, C08, C10, C12, and C13.

As outlined in the ATC-1000 (Instructions for Testing and Inspection of ATC Apparatus and System) the 1020 Procedure for Train Control Room (TCR) Weekly Inspections Procedure, Step 2.7.2 instructs that WMATA mechanics performing this preventative maintenance ensure the following: "Unterminated loose wires must be properly secured, and blue tagged. The blue tag should be properly filled out. Unterminated Loose wires without blue tags must be reported to the ATC Supervisor for investigation and documentation. Any deficiency must be corrected as soon as possible."
