## **Improper Door Operation**

### **Glenmont, Silver Spring, Braddock Road and Innovation stations**

**May 9, 2024, September 1, 2024, September 3, 2024, September 23, 2024 and September 24, 2024**

# Improper Door Operation – Glenmont Station

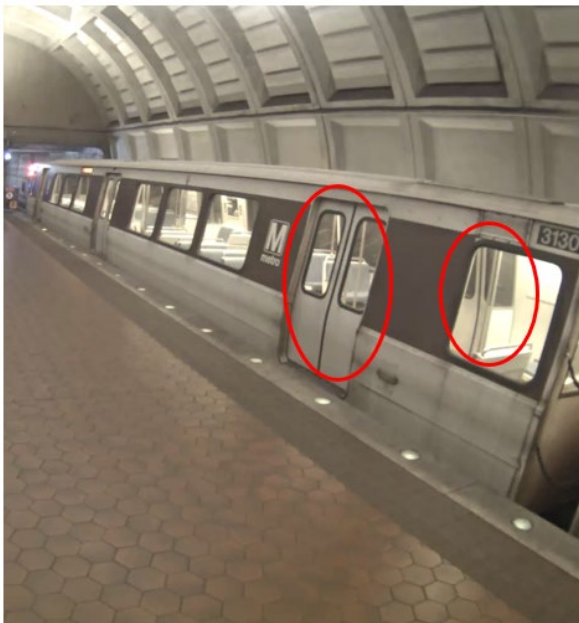
Image 1 – At 16:07:15 hours, Train ID 108 (Lead Car 3130) arrived and stopped at Glenmont Station. The doors were not opened.

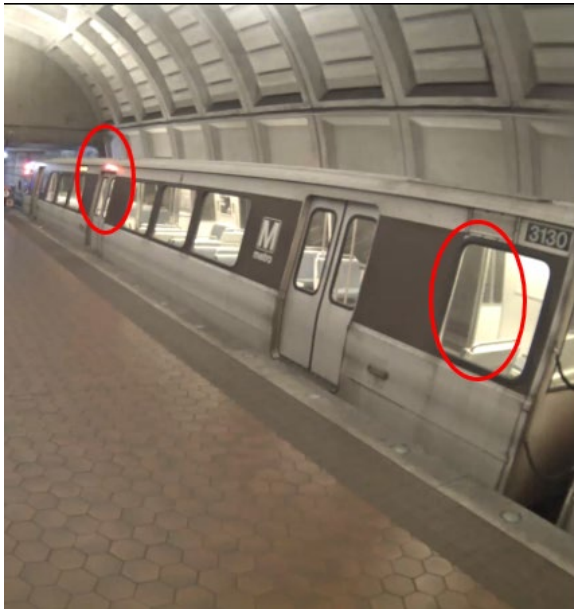
*Image 2 – At 16:07:18 hours, Train ID 108 door lights were illuminated. The non-platform side doors were opened.*

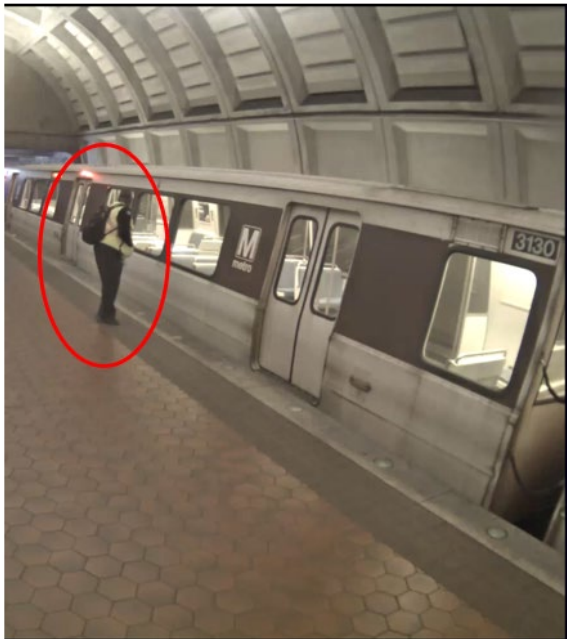
*Image 3 – At 16:10:03 hours, the RTRA Supervisor noticed the door lights were illuminated, noticing the non-platform side doors had been opened.*

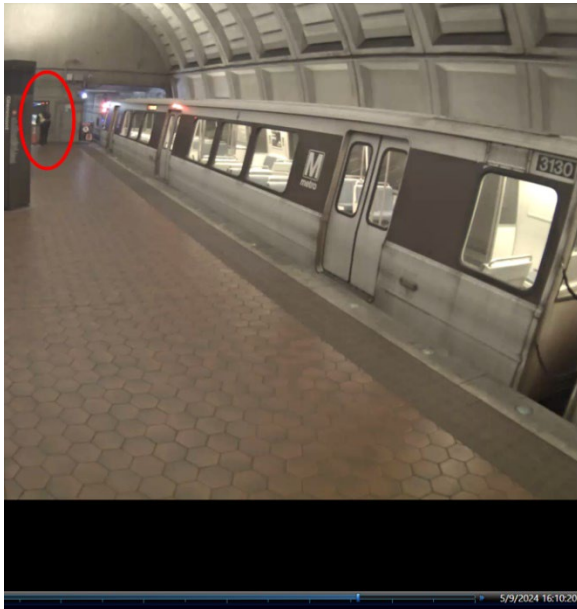
*Image 4 – CCTV: At 16:10:03 hours, the RTRA Supervisor advised the Terminal Supervisor of the incident.*

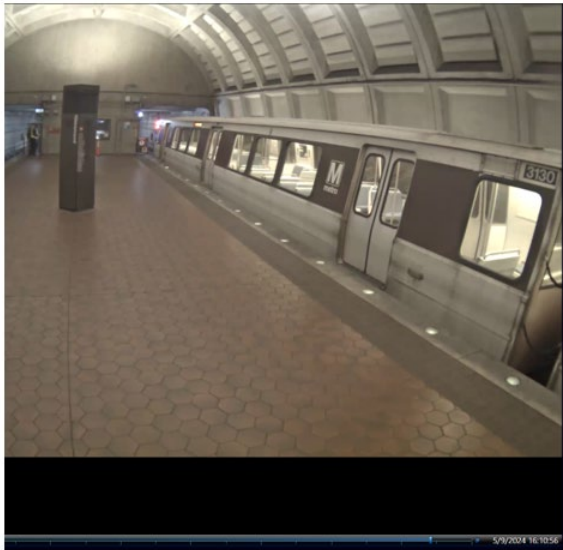
*Image 5 – At 16:10:56 hours, the non-platform doors were closed.*

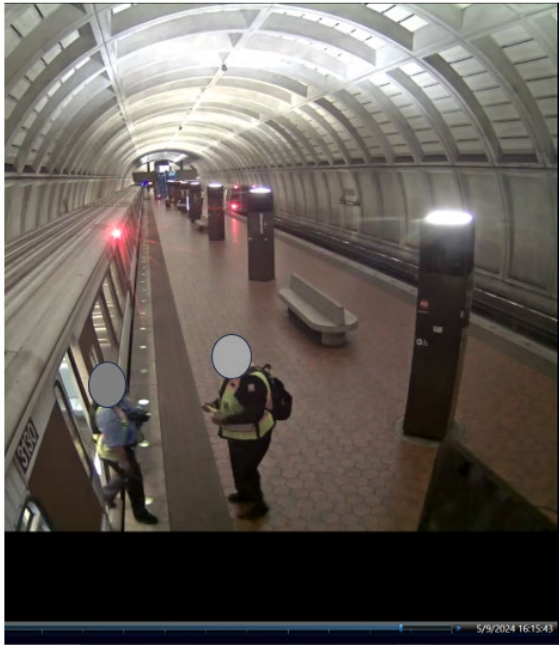
Image 6 – At 16:15:43 hours, the Train Operator was removed from service.

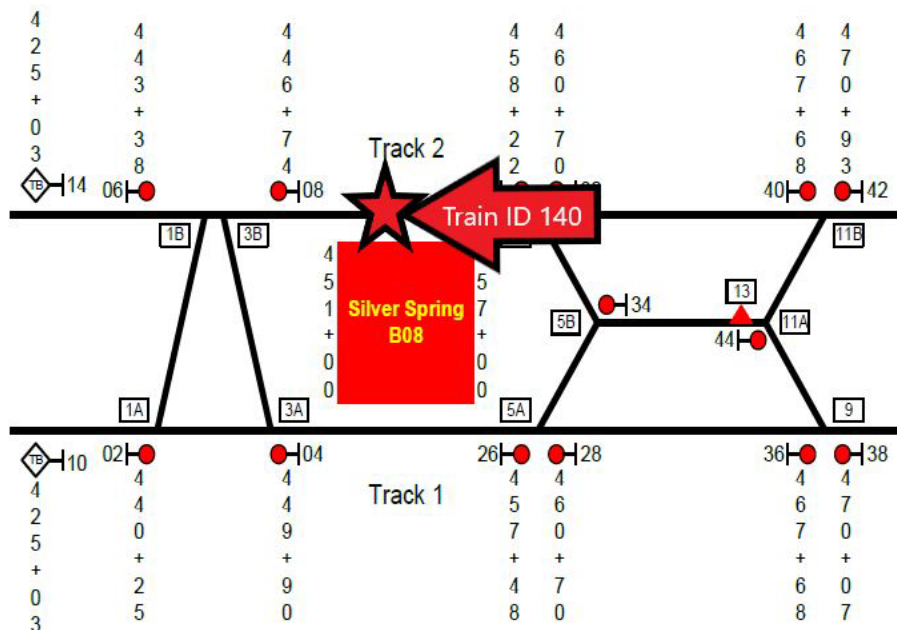
Figure 1 - depicts the location where Train ID 140 stopped short on the Silver Spring Station, Track 2, and opened doors outside of the platform limit.

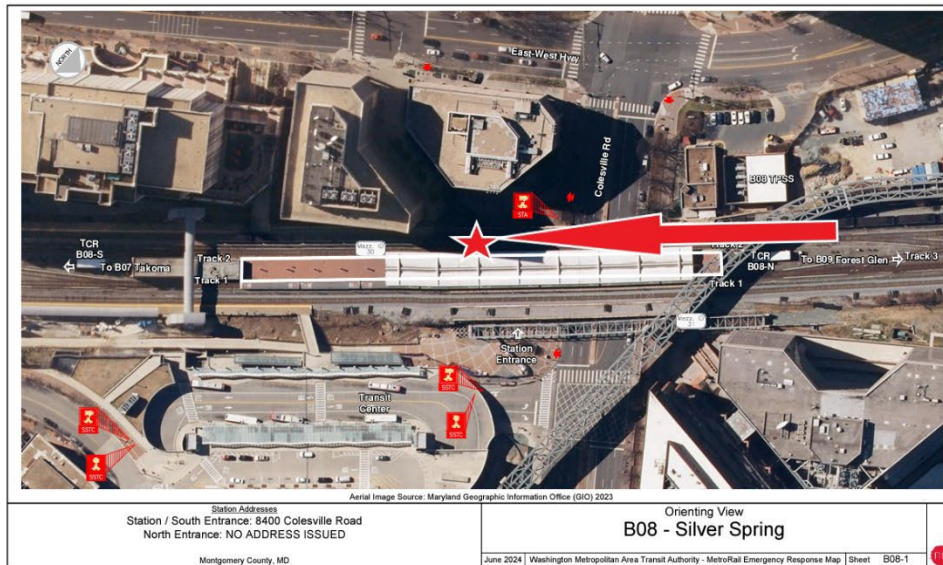
Figure 2 - aerial view depicting the location where Train ID 140 stopped short on the Silver Spring Station, Track 2, and opened doors outside of the platform limit.

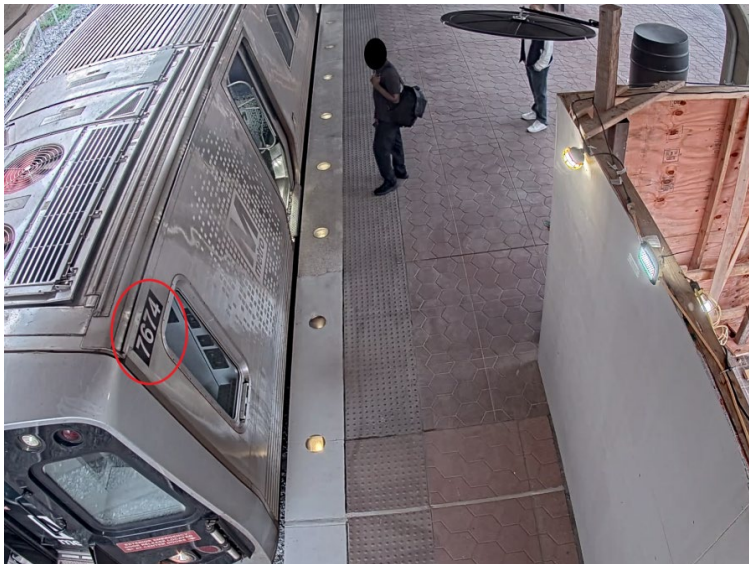
*Figure 3 - depicts Train ID 134 opening the platform side doors before visually verifying all cars were on the platform.*

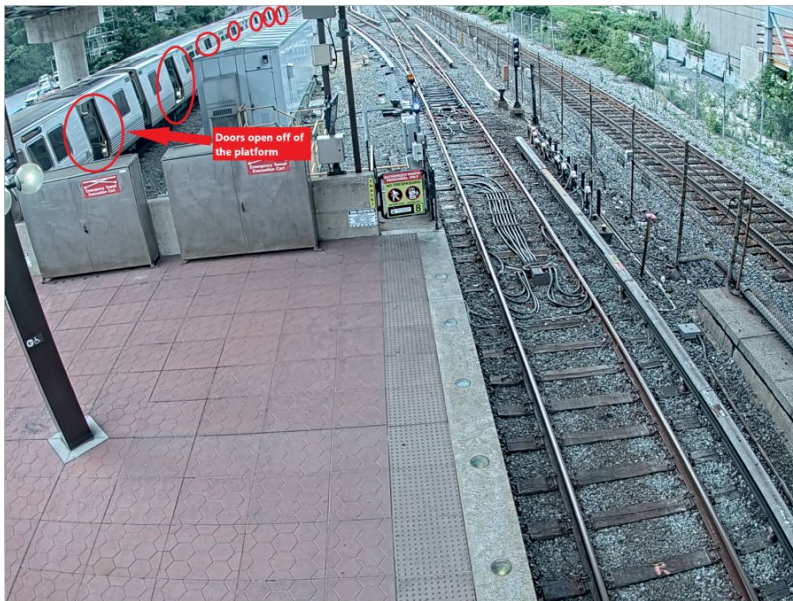
Figure 4 - depicts 2.5 cars outside of the platform limits with doors opened at 17:53 hours.

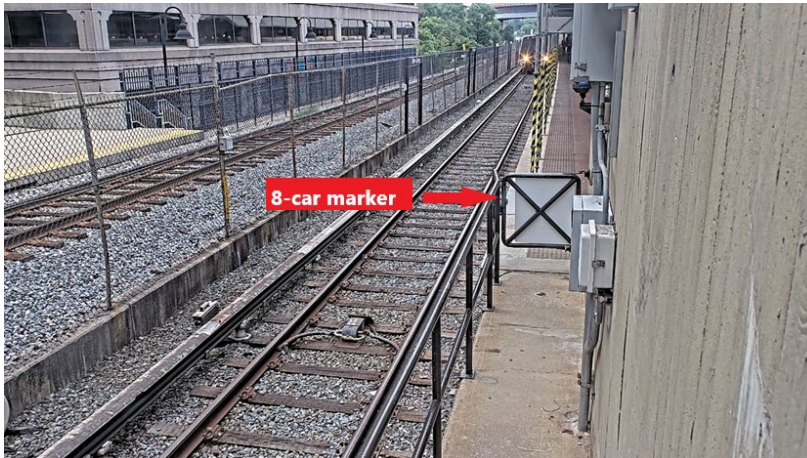
The probable cause of both improper door operation incidents at the Silver Spring Station on September 1, 2024, was an obstructed line of sight to the 8-car marker blocked by scaffolding on the platform.

Figure 5 - depicts the obstructed line of sight to the 8-car marker due to scaffolding poles on the platform.

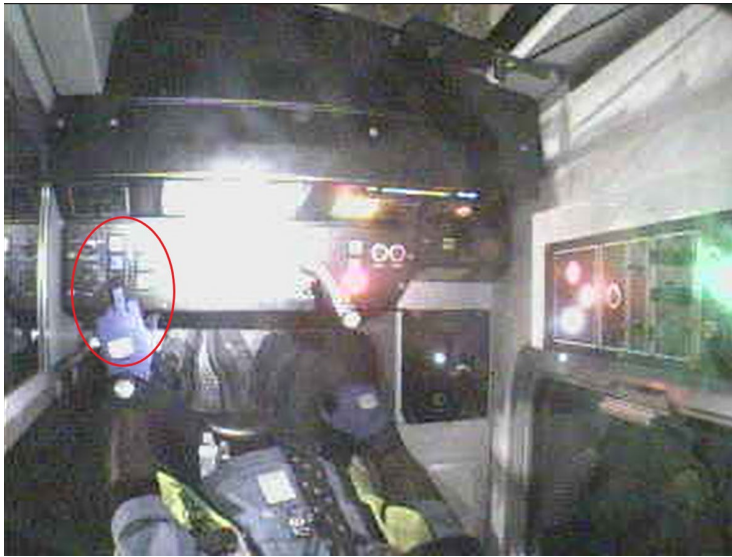
*Figure 6 - Car 7674 CCTV cab-facing camera depicting the RVO attempting to initiate Automatic Door Operation.*

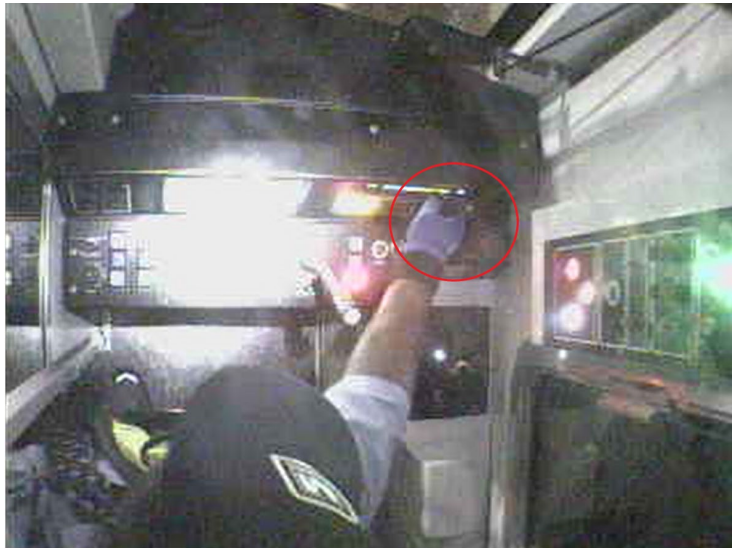
*Figure 7 - depicts the Train Operation acknowledging Manual Door Operation on the platform side of the consist.*

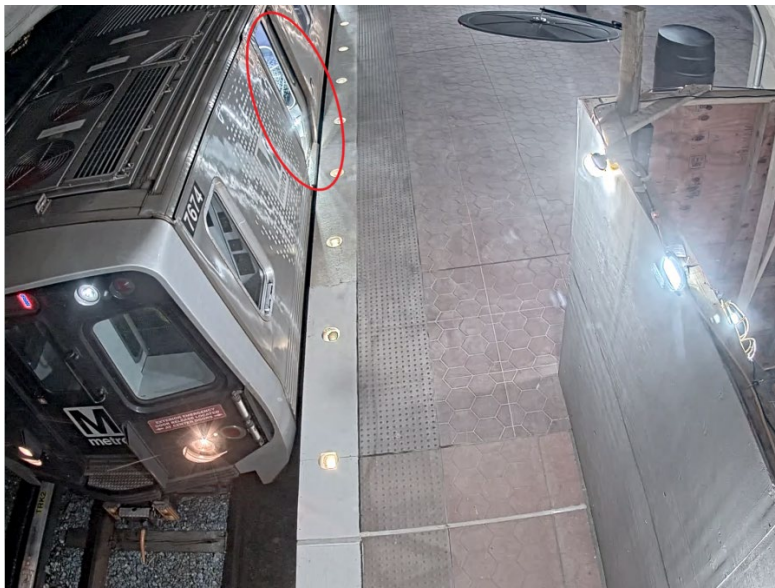
Figure 8 - depicts Train ID 140 doors opening before the RVO visually observing the platform.

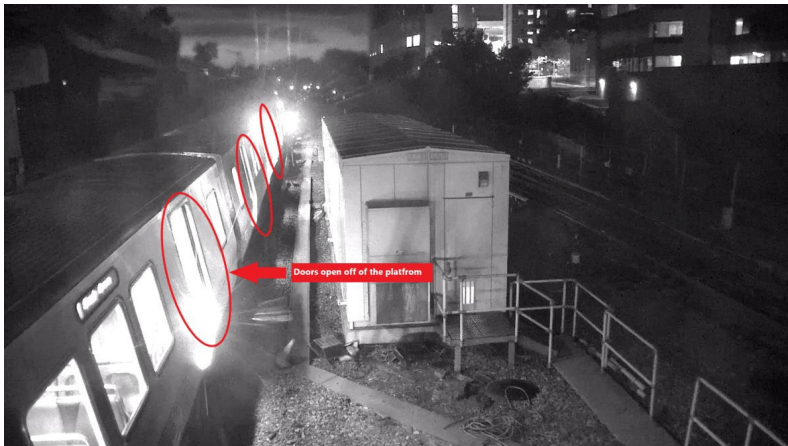
Figure 9 - depicts Train ID 140 trailing car doors opened off the platform at 20:30 hours.

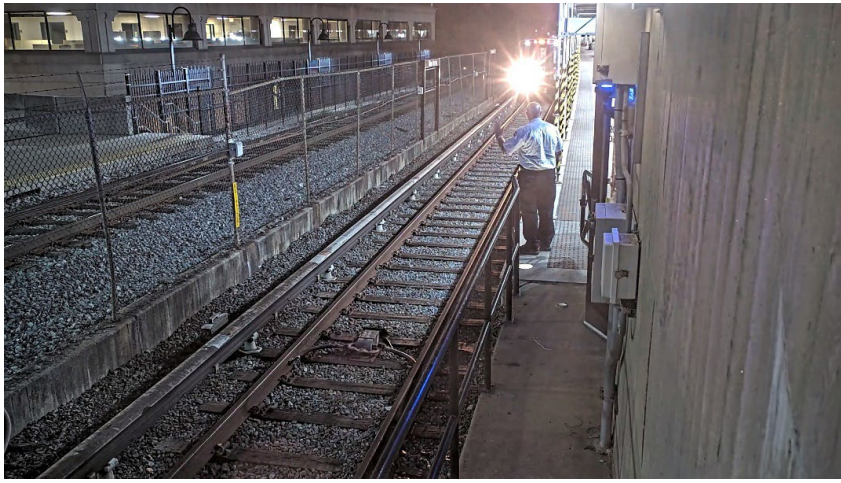
*Figure 10 - depicts the Rail Supervisor waving down Train ID 140 as the train approached.*

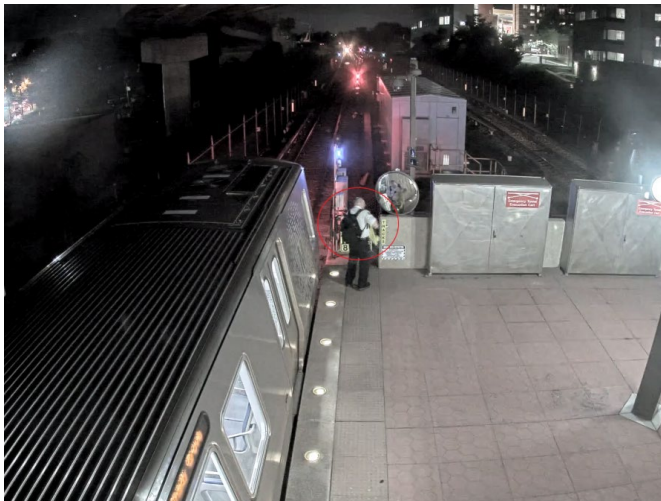
*Figure 11 - depicts the Rail Supervisor placing a safety vest over their backpack.*

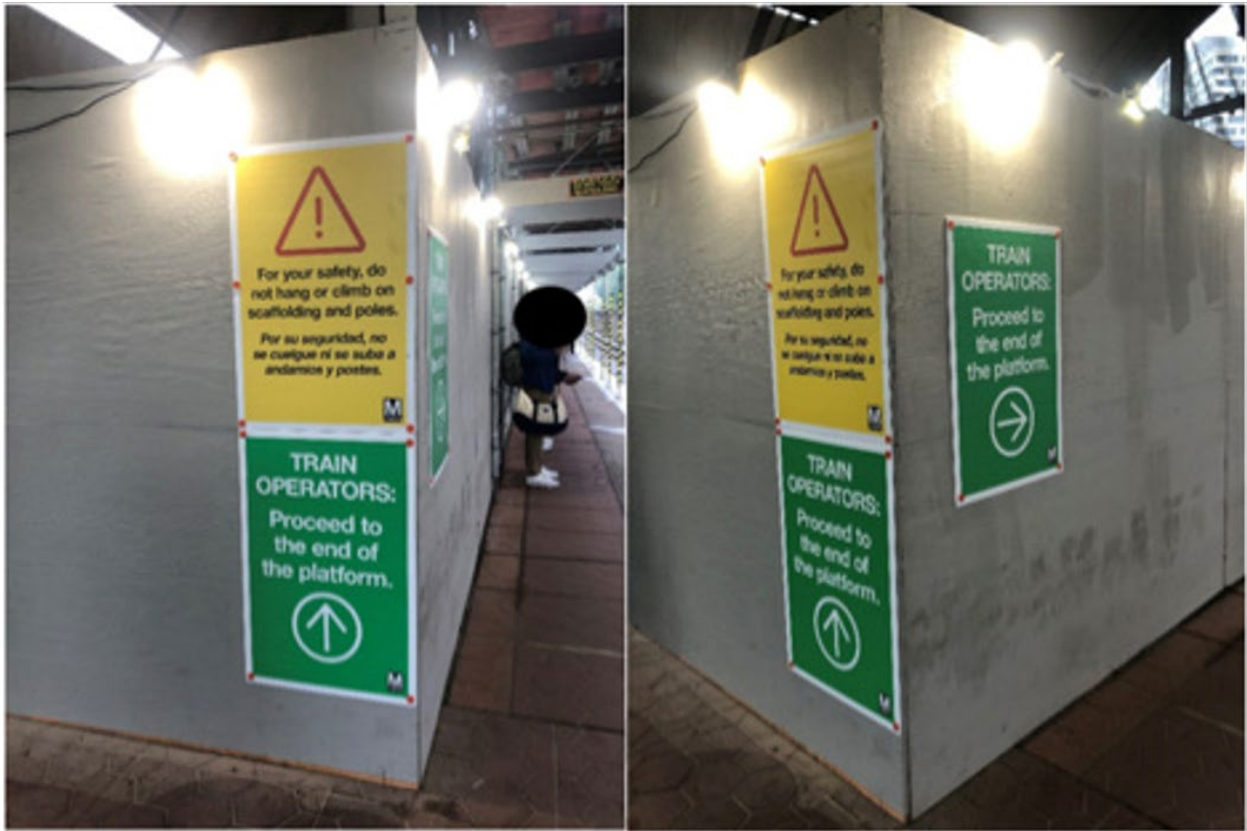
Figure 17 - Depicts signage at Silver Spring Station scaffolding instructing RVO's to continue to the end of the platform.

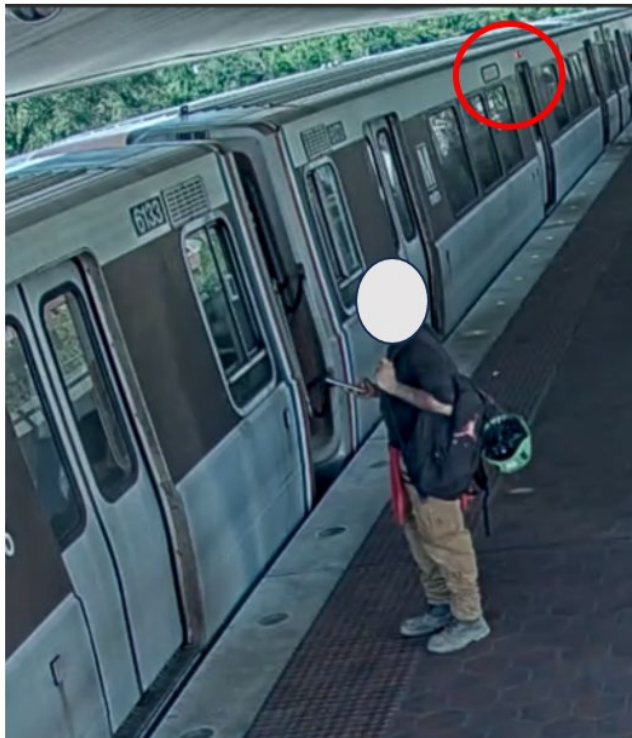
16:20:43 - Door lights illuminated; the platform side doors were not open.

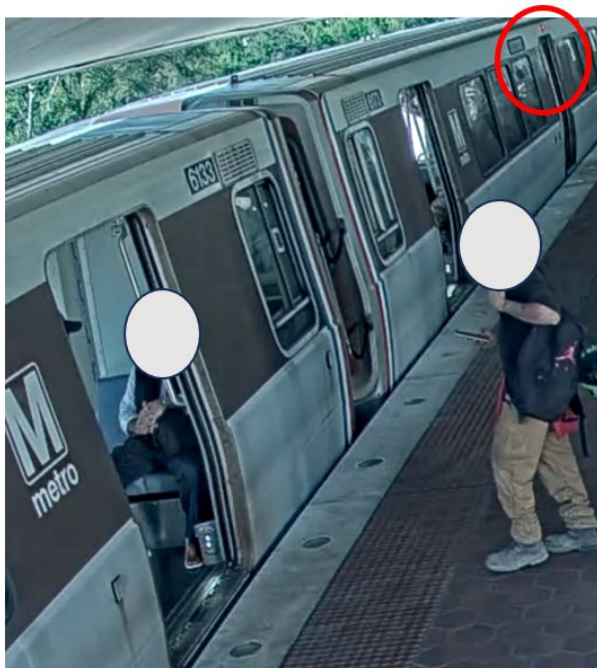
16:20:55 - Door lights illuminated; the platform side doors were open.

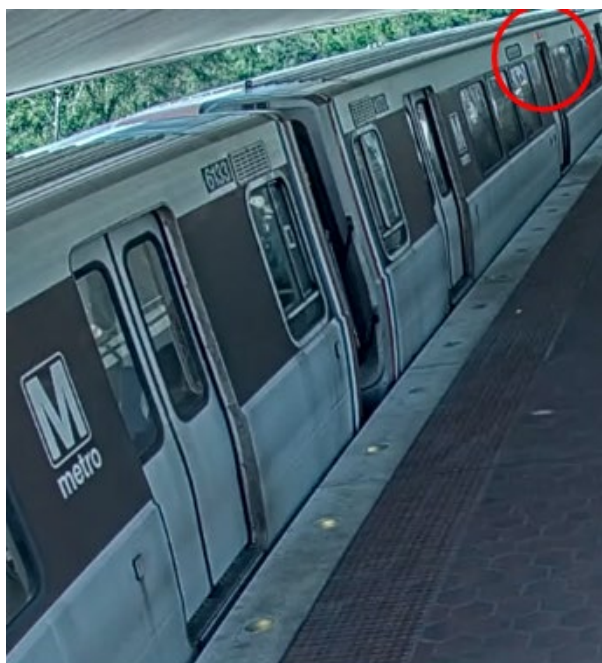
16:21:09 – the platform side doors were closed, but the door lights were still illuminated.

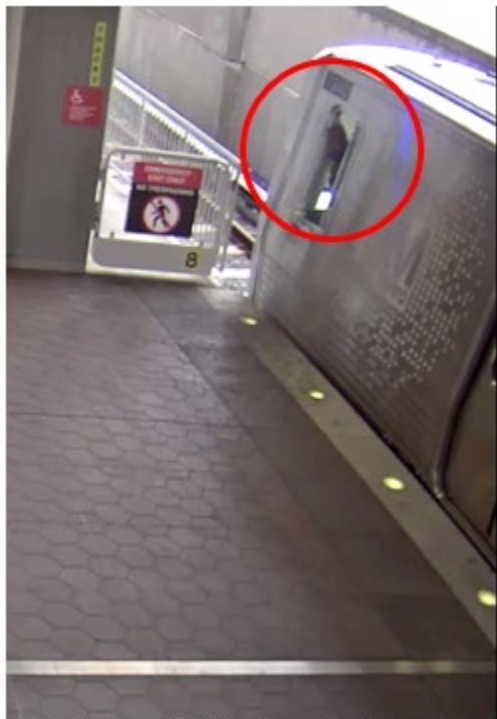
11:14:48 hours - RVO looked out from the cab and noticed the platform side doors were not opened.

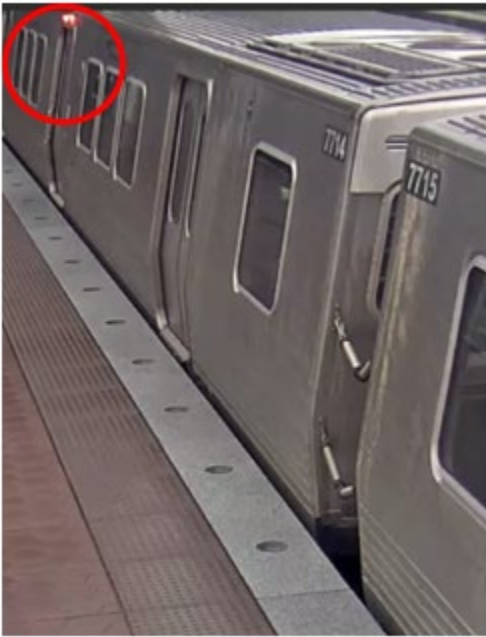
11:15:25 open door lights were illuminated.

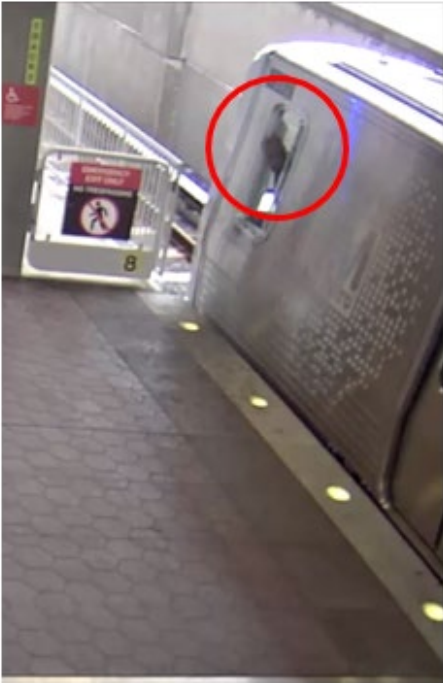
11:15:30 hours - RVO looked again and noticed the platform side doors were not opened.

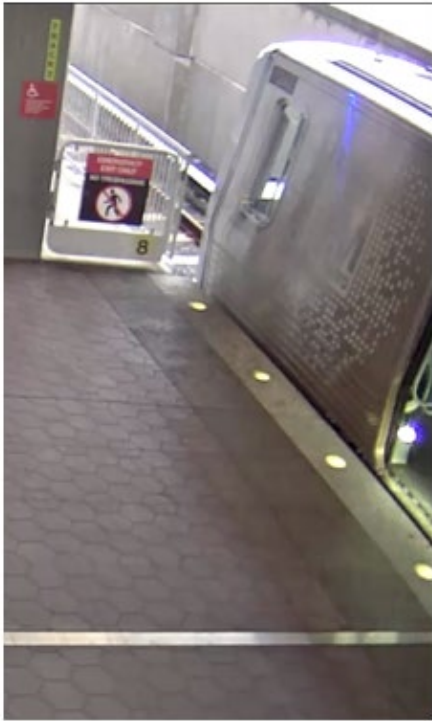
11:15:35 hours - platform side doors were opened.

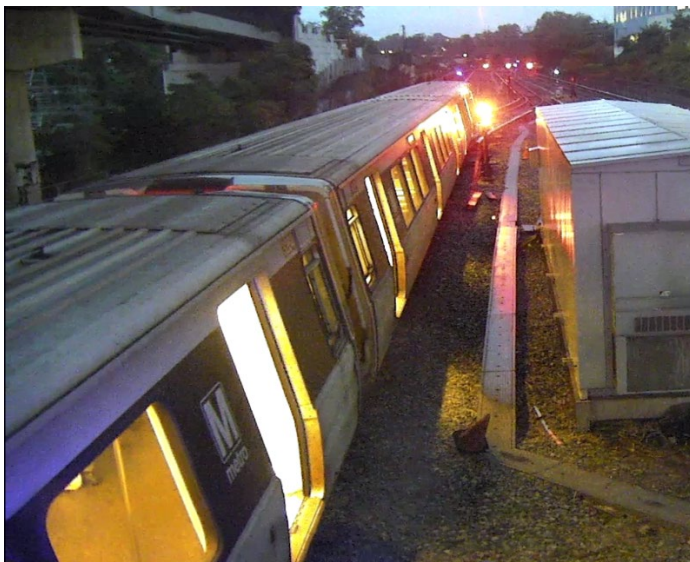
*Figure 1 - (CCTV) railcars 3152 and 3153 doors open outside the platform limits.*

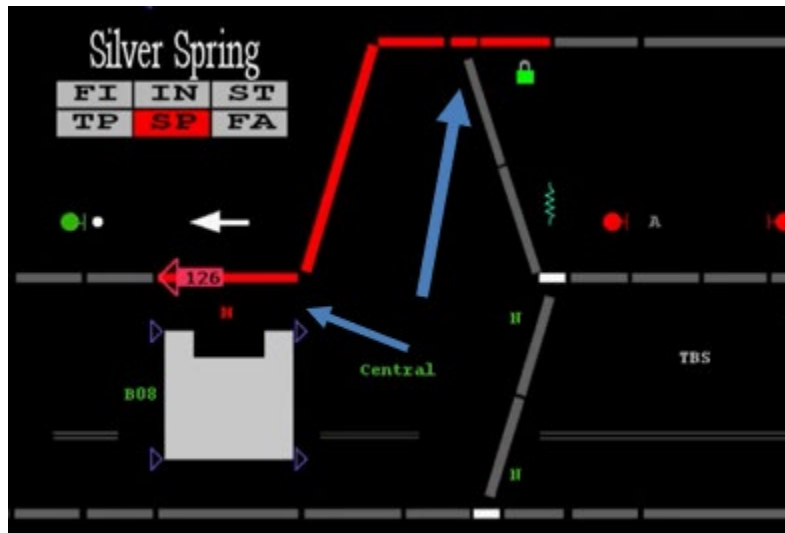
Figure 3 (Blue arrows) depicts incident Train ID 126 occupying the interlocking with a platform door operation.

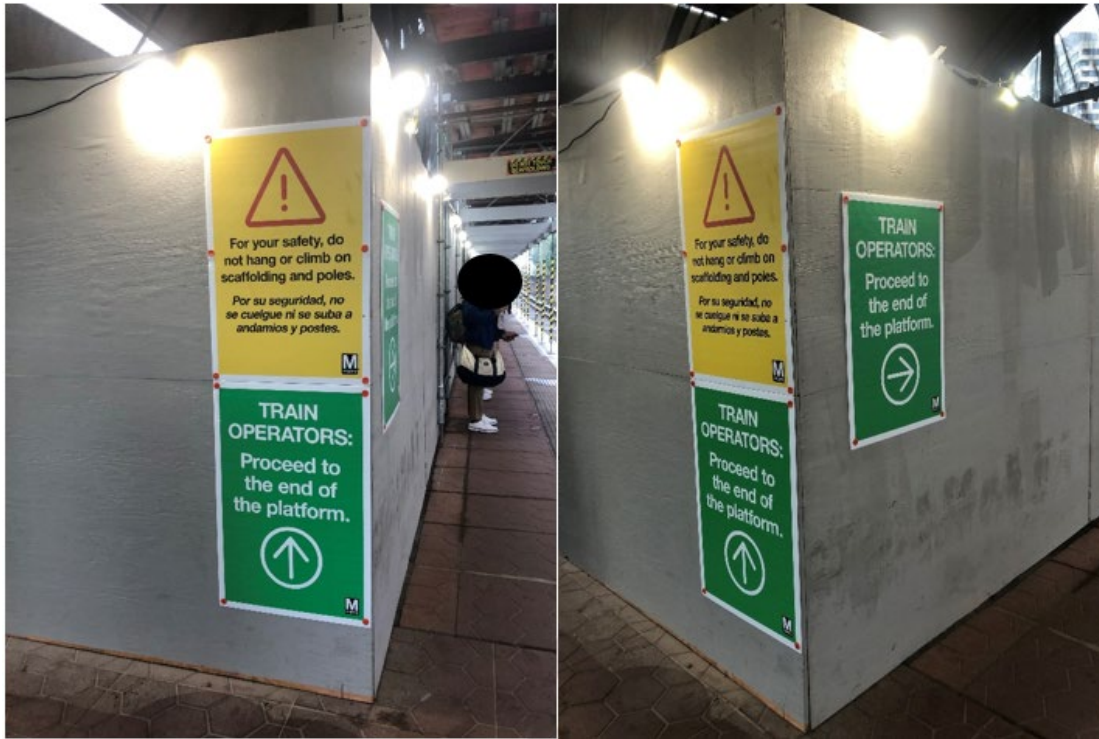
Figure 11 – Inbound signage at the beginning of the platform scaffolding.

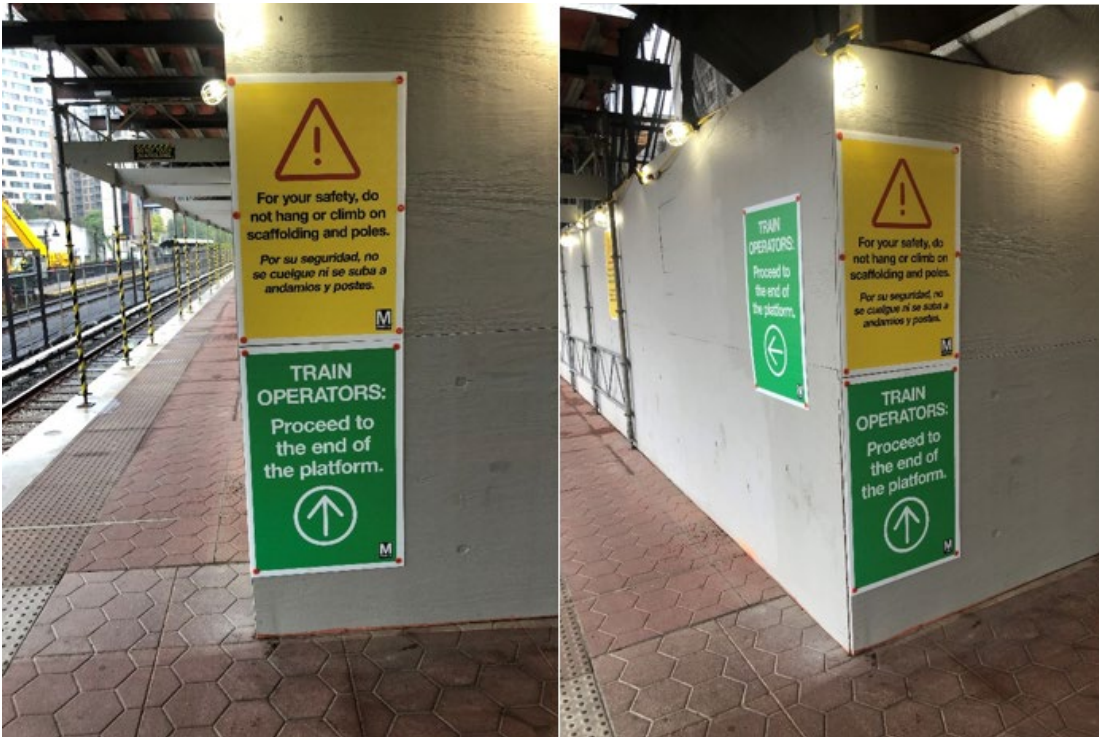
Figure 12 - Outbound signage at the beginning of the platform scaffolding.
