**W-0383 Collision – Landover Station – August 25, 2024****Document Purpose**

**FINAL REPORT OF INVESTIGATION A&I 24677**

## Landover Station, Track 2 – Collision.

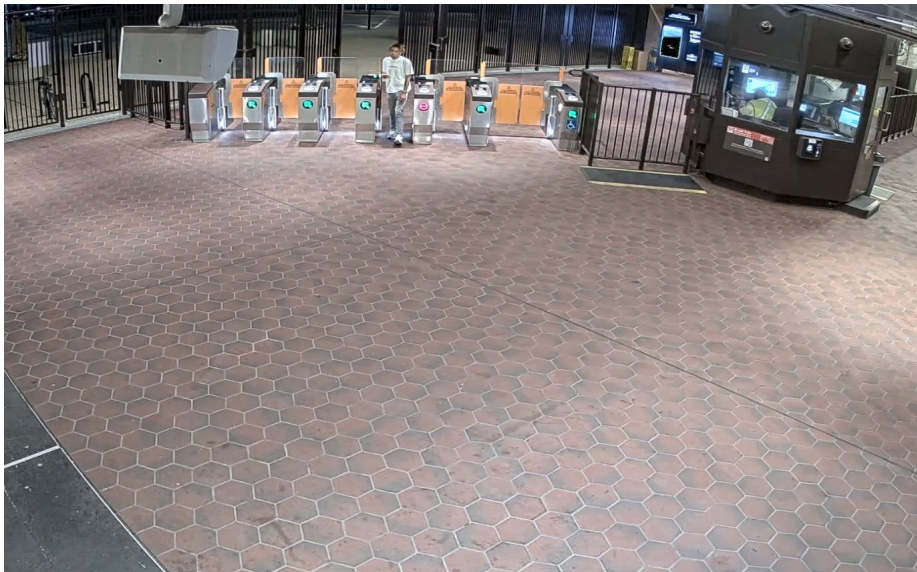
*Image 1 - Customer entering Landover Station.*

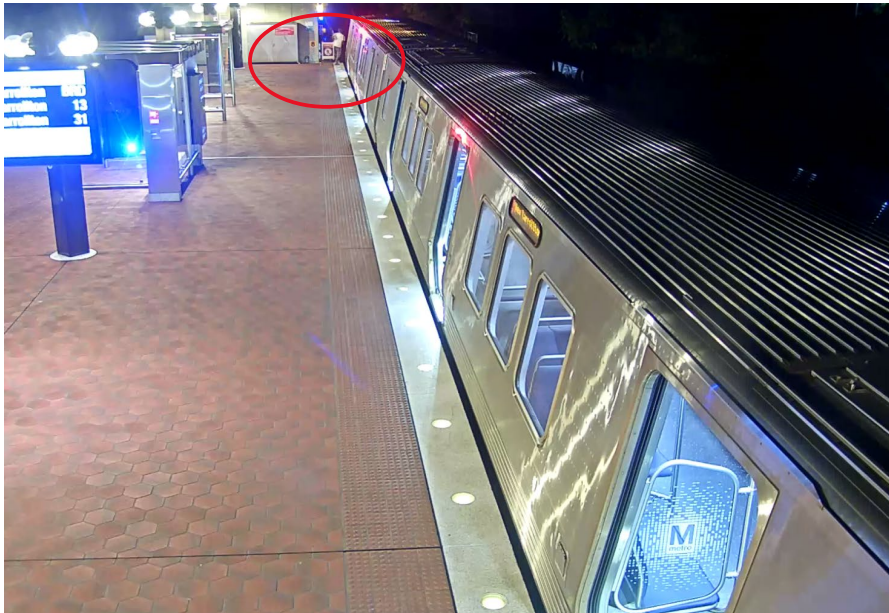
*Image 2 – Customer seen jumping onto the roadway at Landover Station, track 1.*

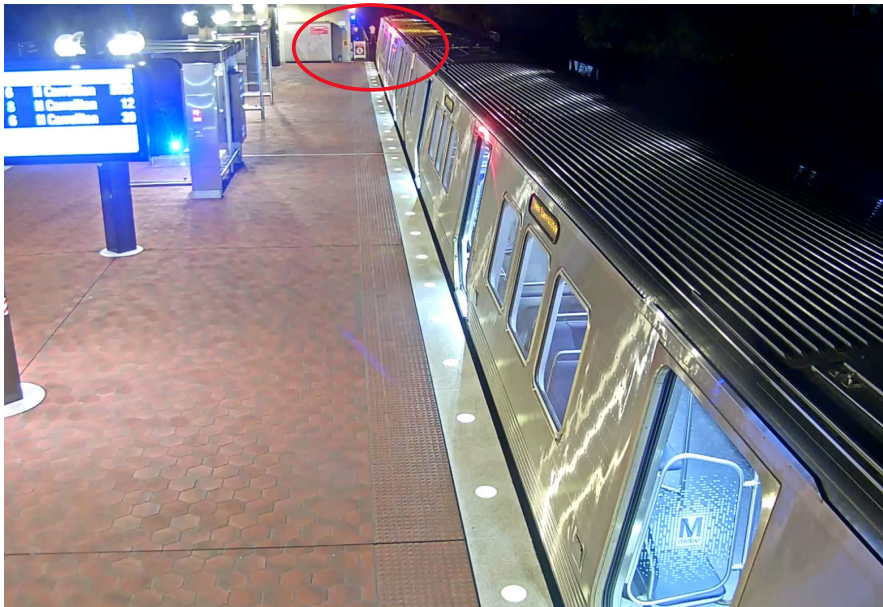
*Image 3 – Customer on the roadway at Landover Station on track 1.*

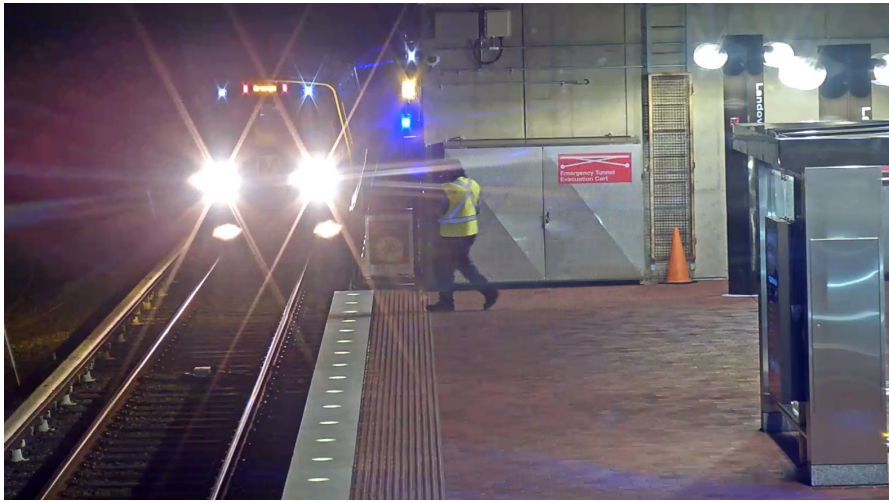
Image 4 – Train ID 924 impacted the customer on the roadway at 23:21 hours.

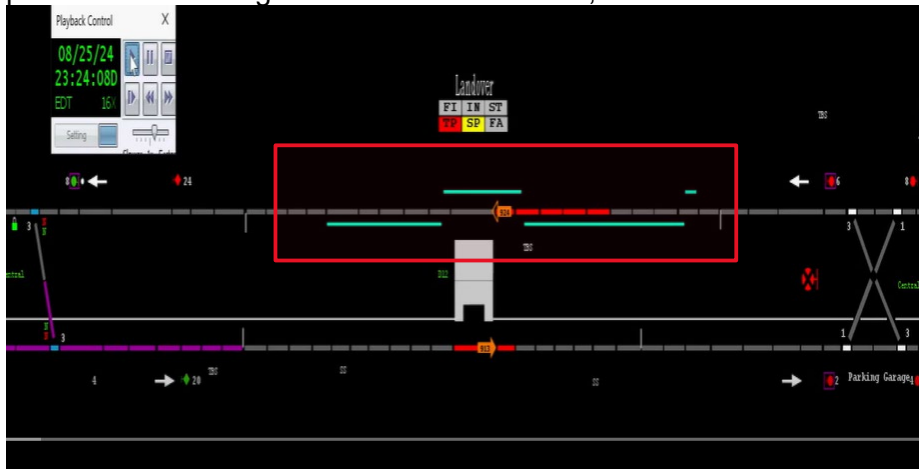
Figure 1 – Third Rail Power was de-energized at Landover Station on track 2.

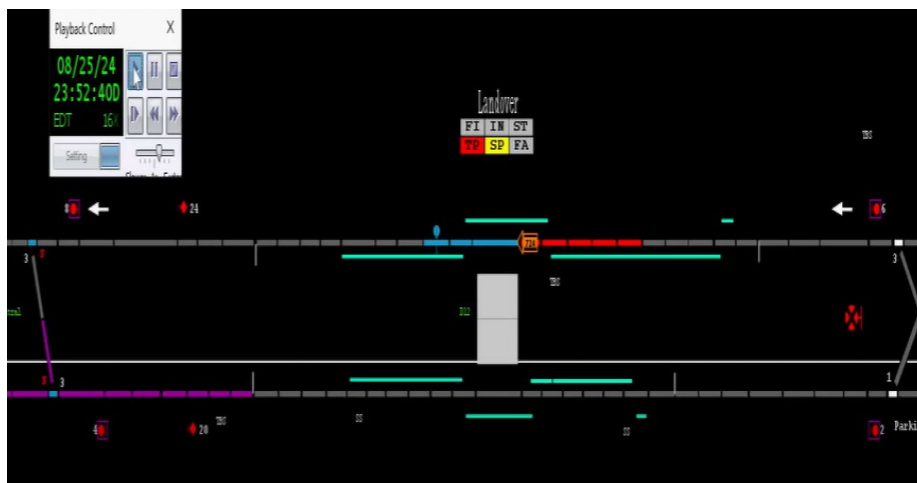
Figure 2 – Depicts third-rail power de-energized at Landover Station both tracks 1 and 2.

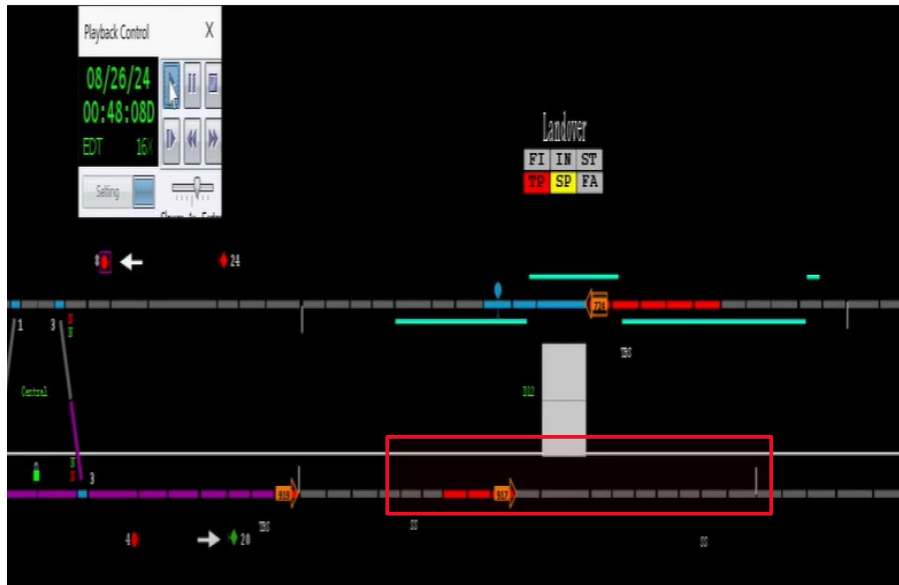
Figure 3 – Power re-energized track 1. Train ID 917 first train to service.

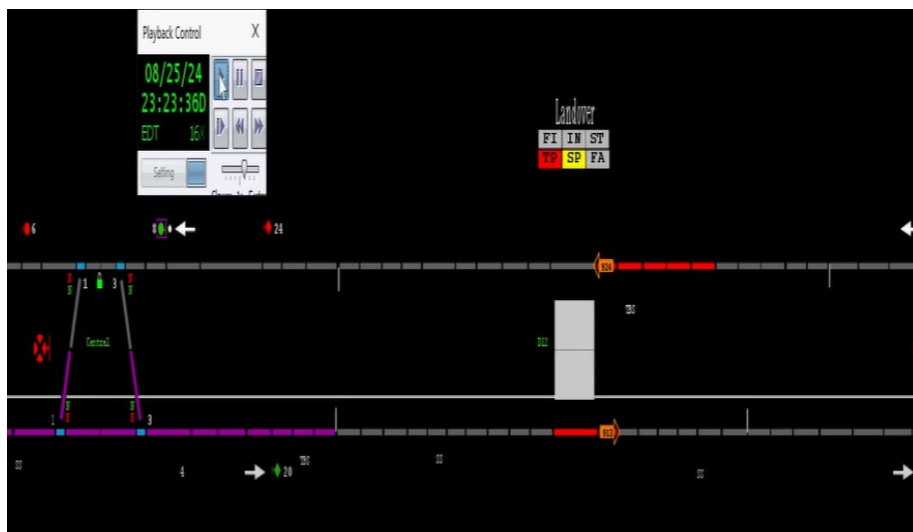
*Figure 4 – Depicts Train ID 924 stopped outside of Landover Station on track 2.*

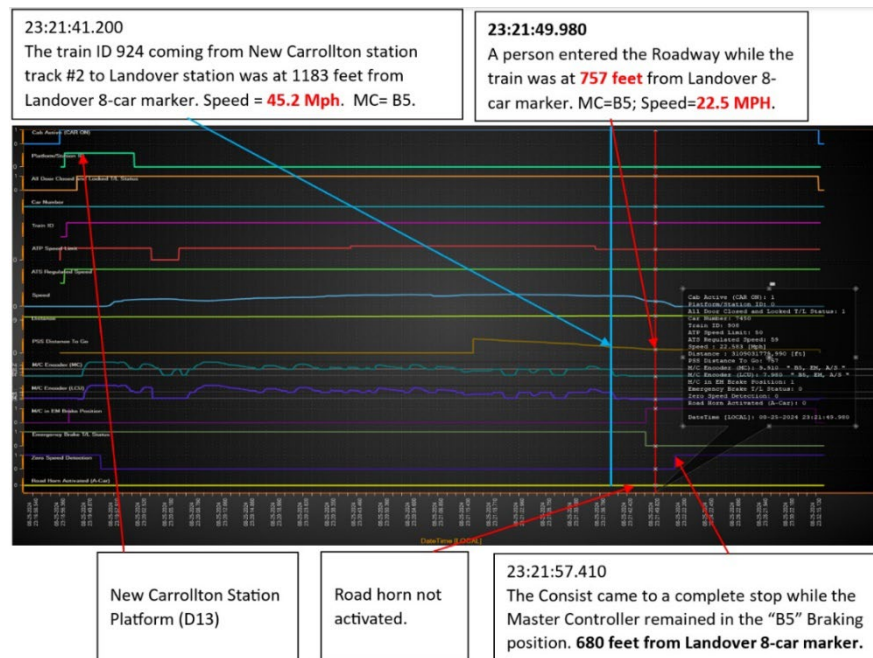
## A- 7450 ER GRAPH

Based on the VMDS and ER data, there was no fault observed with the train that contributed to the cause of this incident. The train performed as commanded.

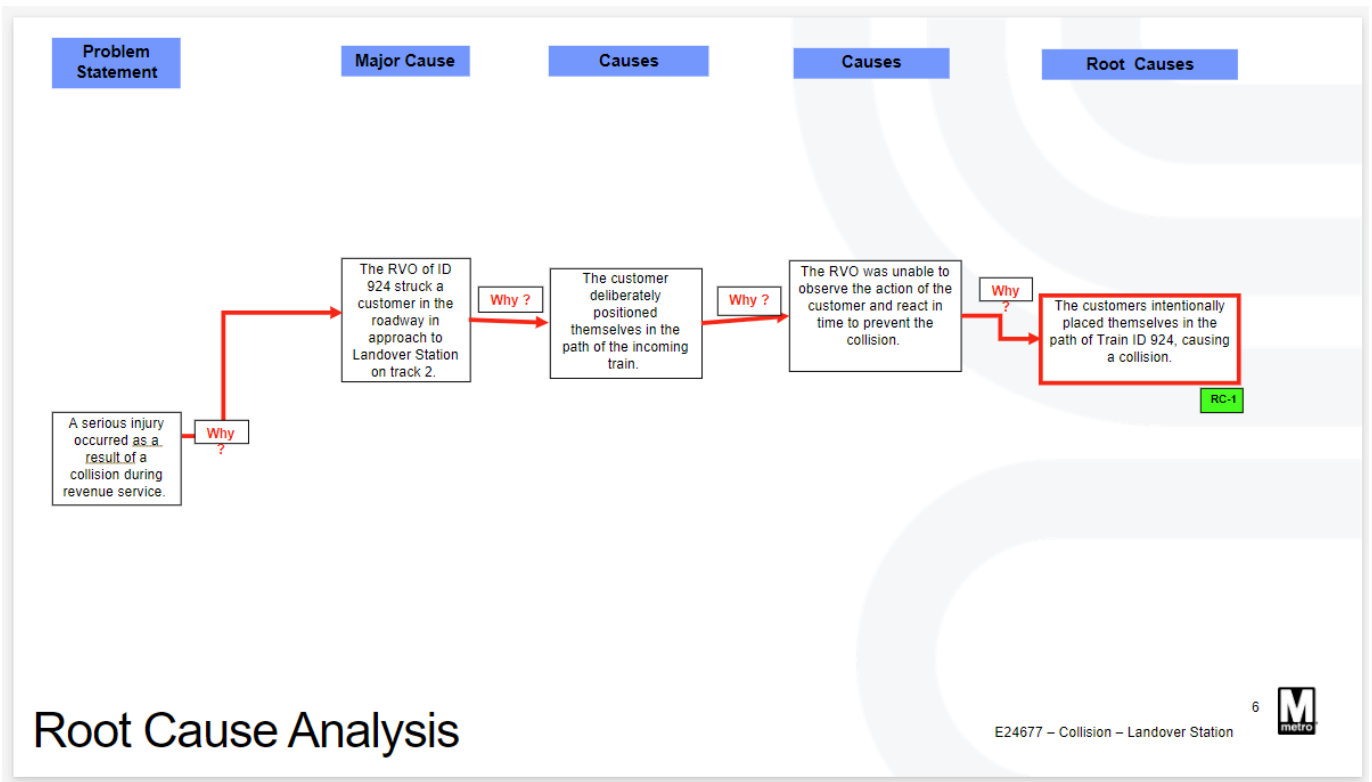
## Appendix F – Why Tree Analysis

The probable cause of the collision event at Landover Station on Sunday, August 25, 2024, was the intentional action of the customer who trespassed onto the roadway and was subsequently struck by the train.
