## WMSC Inspection Report 20250625B

Title: Shady Grove Yard (A99) Service and Inspection Shop Bonding Cables Re-inspection

Location: Shady Grove Yard (A99) Tracks 2N and 3N

Date of Inspection: 6/25/2025

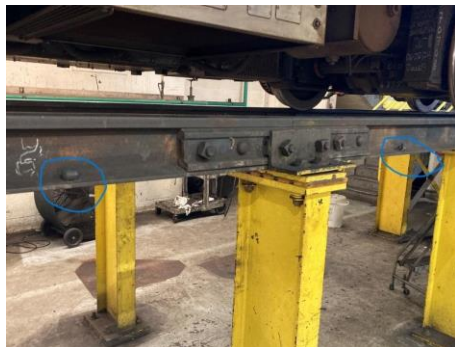
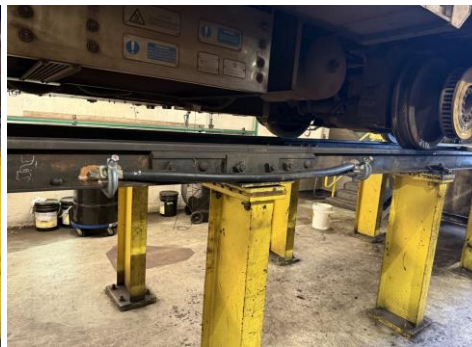
### Mitigated Defect 1

Track 2N, replacement bonding cable.

**Hazard Rating: 2D**

Photo 1: Showing the missing bonding return cable and the installed bonding cable on track 2N

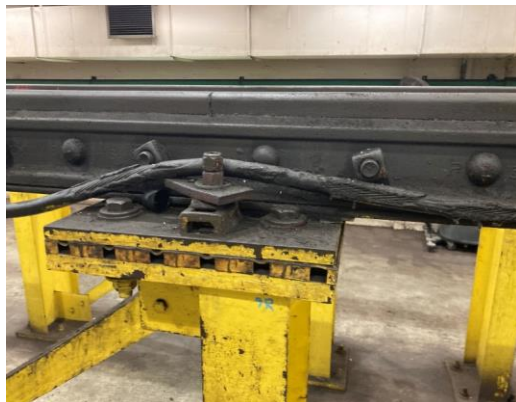
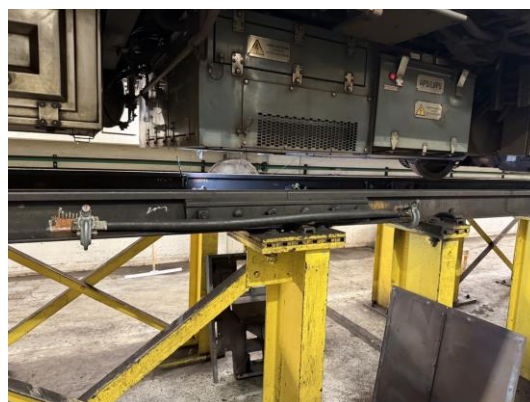
### Mitigated Defect 2

On Track 3N, a deteriorated bond cable was replaced.

**Hazard Rating: 2D**

Photo 2: Bonding cable with insulated cover showing deterioration and replacement bonding cable on track 3N.

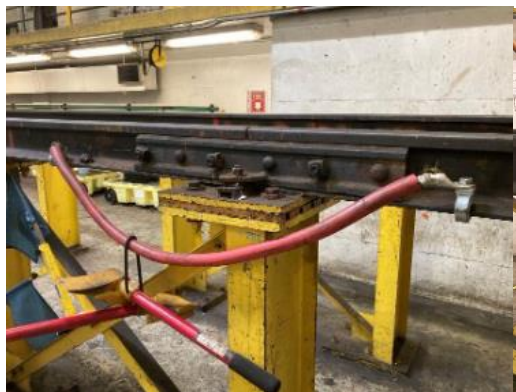
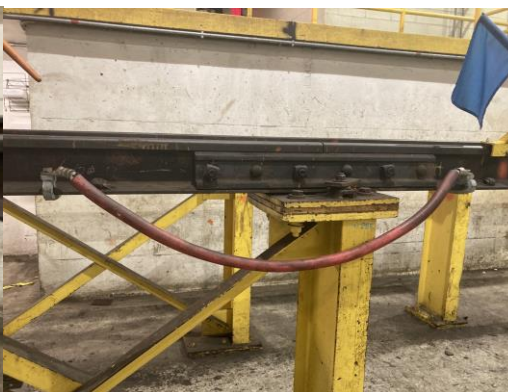
### Mitigated Defect 3

On track 3N, bond cable with clamps showing that wheel chocks were removed.

**Hazard Rating: 3D**

Photo 3: Wheel chocks were removed from cable on track 3N

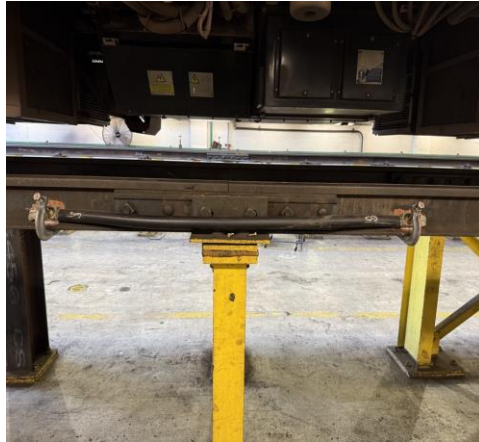
### Mitigated Defect 4

Track 3N, a different location with replacement bonding cables.

**Hazard Rating: 2D**

Photo 4: Replacement of second missing cable on track 3N

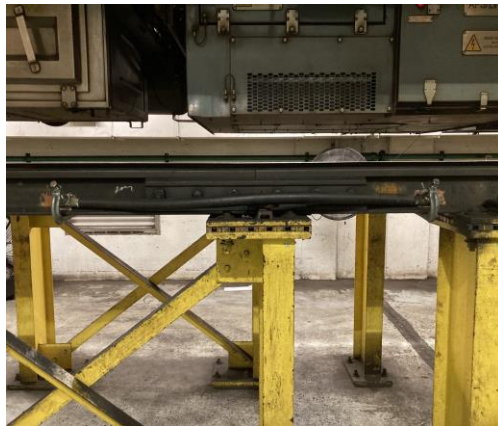
### Mitigated Defect 5

Track 3N, a different location with replacement bonding cables.

**Hazard Rating: 2D**

Photo 5: Replacement of third missing cable on track 3N
