## WMSC Inspection Report 20250627

Title: Shady Grove S&I Shop Torque Wrenches

Location: Shady Grove Yard Service & Inspection Shop (A99)

Date of Inspection: 6/27/25

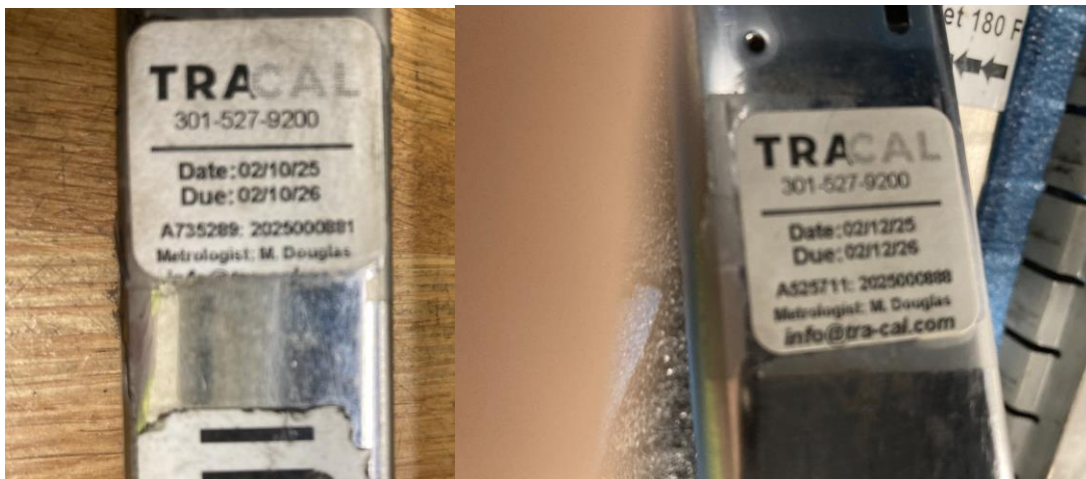
Photo 1 (left) Asset 735289 SN 2720. Photo 2 (right) Asset 525711 SN 65846.

Below are examples of the calibration stickers on the torque wrenches:
