WMSC Inspection Report 20250708

Title: Metro Operating Rulebook (MOR) Inspection

Location: Shady Grove Yard (A99)

Date of Inspection: 7/9/2025

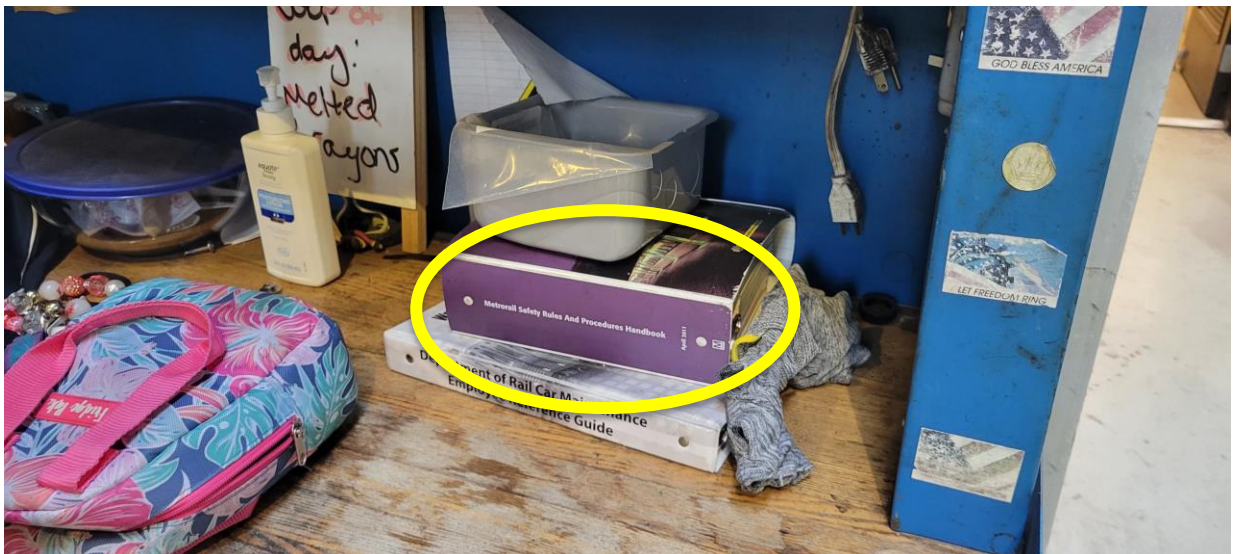
Additionally, the WMSC Inspector found an outdated copy of the Metrorail Safety Rules and Procedures Handbook (MSRPH), dated April 2011, in the Shady Grove Service and Inspection (S&I) building. This was immediately mitigated by the WMATA Department of Safety representative who removed the outdated rulebook. Additionally, the MOR located at the Service and Inspection (S&I) office was last updated September 1, 2023, and lacked updated bulletin orders and safety orders.

The inspector found a copy of an outdated Metrorail Safety Rules and Procedures Handbook (MSRPH) (dated April 2011) in the Shady Grove Service and Inspection (S&I) building. According to the current Metrorail Operating Rulebook (MOR) which states "This Metrorail Operation Rulebook supersedes and replaces all previous versions of the Metrorail Safety Rules and Procedures Handbook...", the MSRPH was to be removed from all work areas. This was remediated onsite by a member of the Department of Safety.

Photo 1. 2011 MSRPH circled.

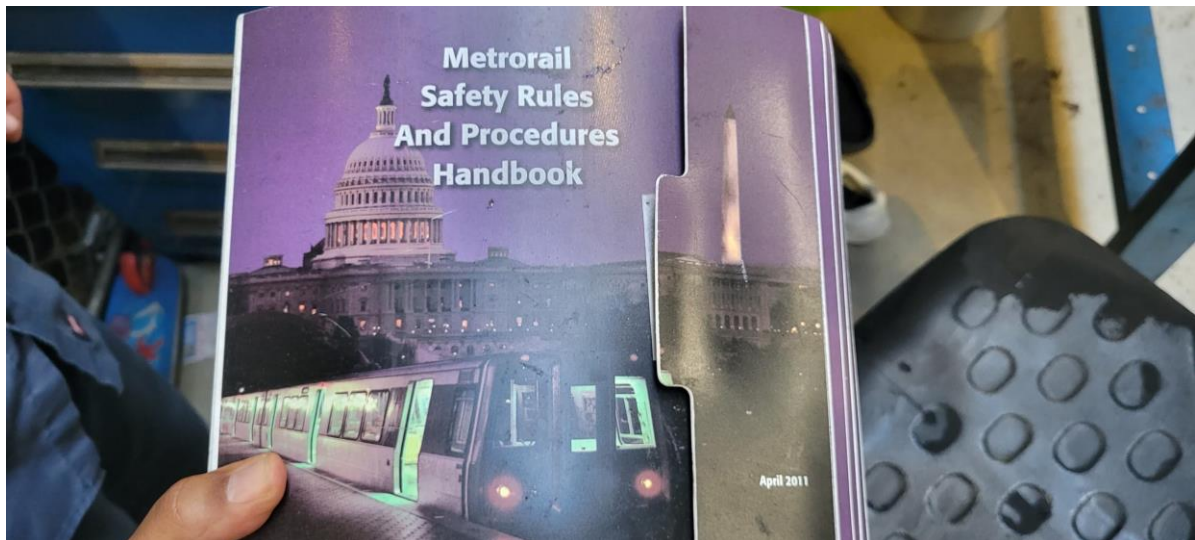
Photo 2. 2011 MSRPH.

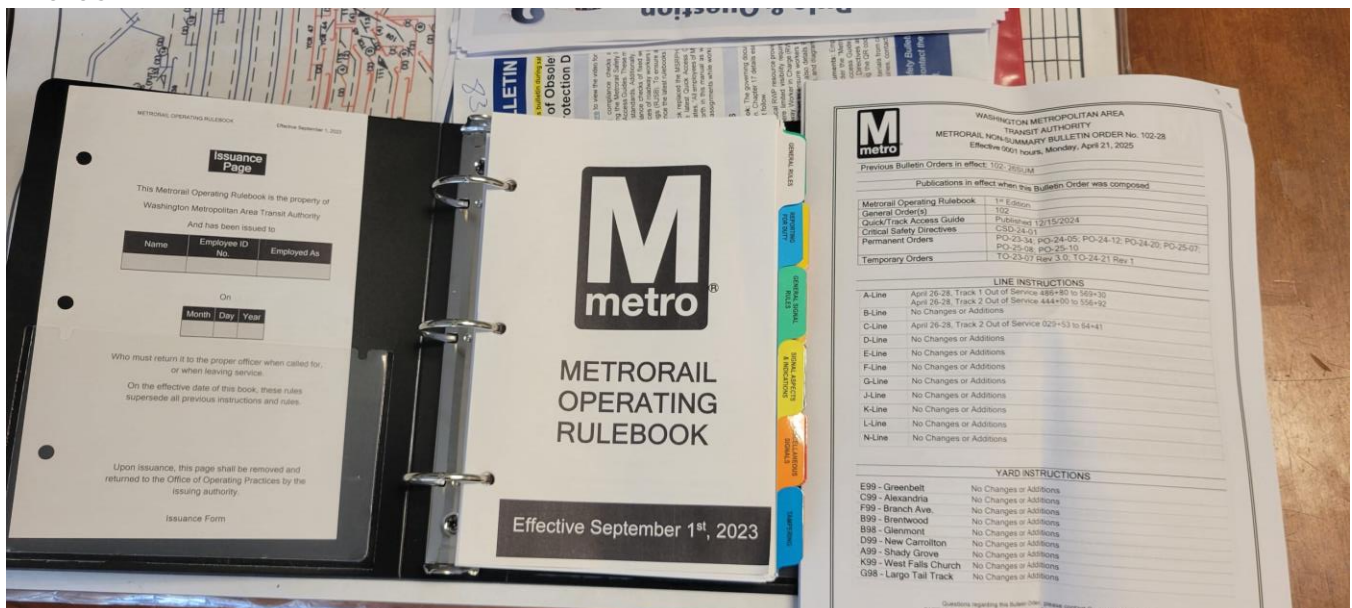
The WMSC Inspector identified that copies of the MORs were not fully up to date in the specified locations. That is, none of the MORs inspected at the three locations at Shady Grove Rail Yard (the tower, station terminal, and breakroom) were equipped with the latest bulletin and safety orders.

Photo 3. Outdated MOR from the tower.

After concluding the inspection, the WMSC Inspector conducted a debrief with onsite Metrorail Department of Safety personnel, in accordance with Program Standard Section 6.F.1. As a result of the debrief, the Department of Safety stated the Shady Grove Division management would be notified, and the Metrorail Operating Rulebooks at these locations would be updated with the bulletin and safety orders immediately.

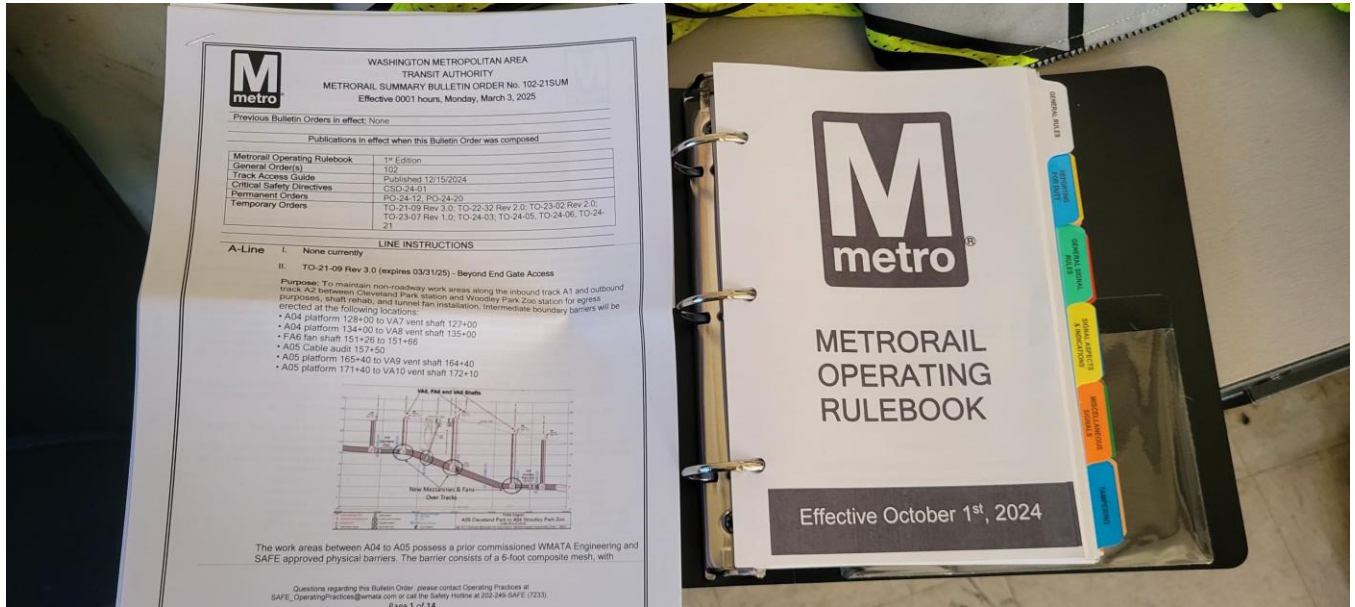
Photo 4. Outdated MOR from the terminal.

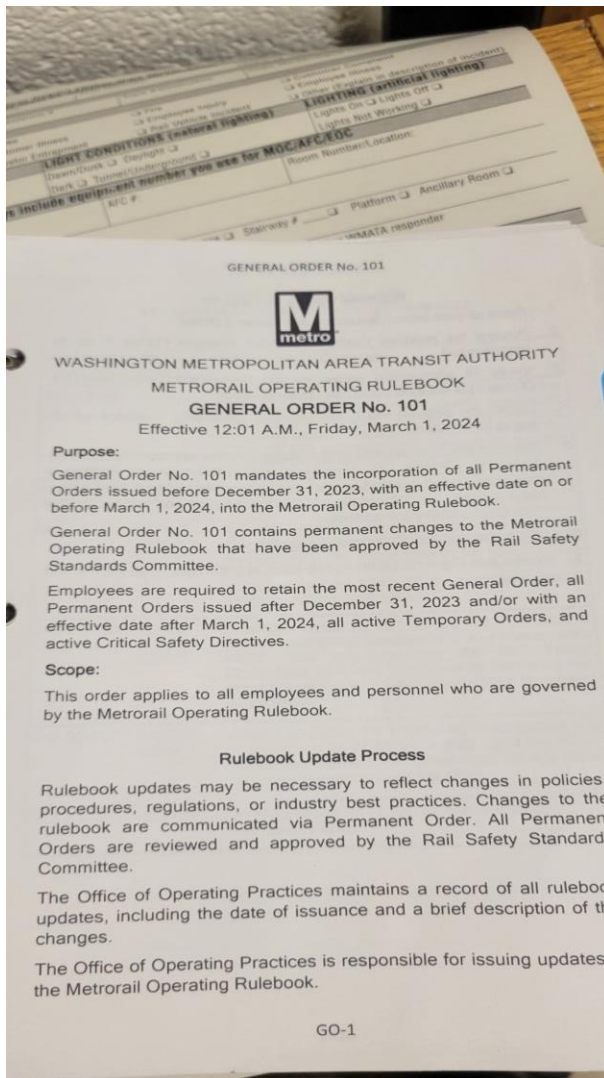
Photo 5. Outdated MOR from the breakroom.

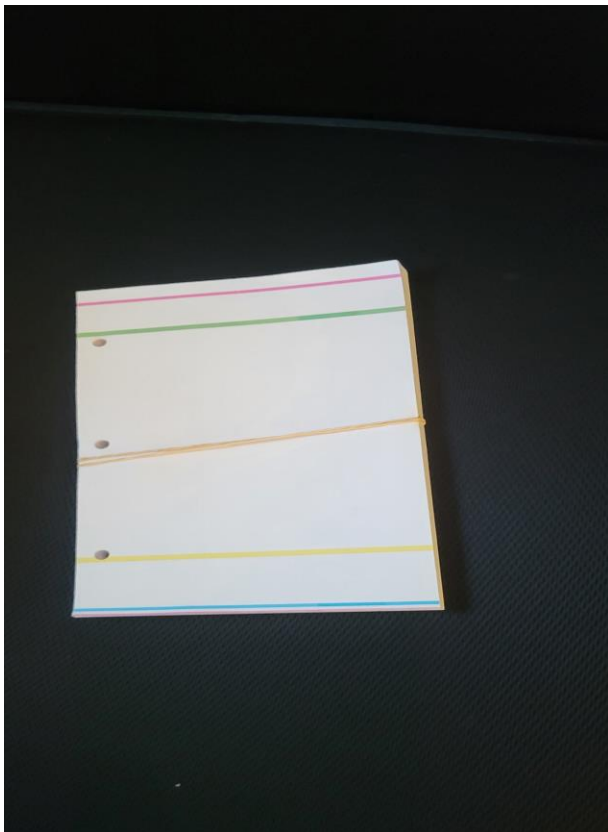
The inspection revealed that the MOR located at the Shady Grove Terminal was not updated properly to reflect the changes in policy, procedures, and regulations. WMSC Inspector notes the updated policy inserts were located within the MOR, but all inserts were still bound and unopened.

Photo 6. MOR inserts bound and unopened from the terminal.
