## **Improper Door Operation**

**Vienna/Fairfax-GMU, Fort Totten, Downtown Largo and King Street-Old Town stations**

**October 6, 2024, October 10, 2024, October 29, 2024, and November 25, 2024**

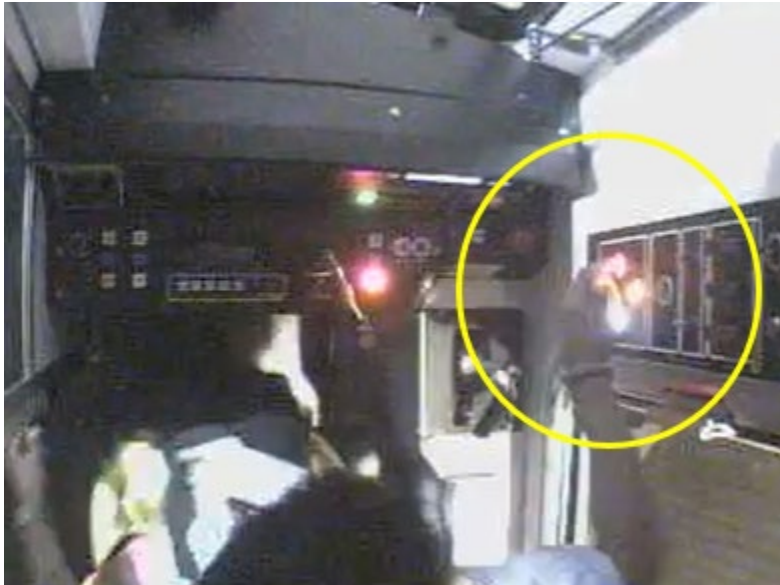
Closed Circuit Television (CCTV) from car 7676 reveals RVO #2 keyed up the train and depressed the right-side door open button on the off-platform side without placing their head out of the operator's cab window. RVO #2 then opened the train doors on the platform side while the off-platform side door remained open. RVO #2 closed and opened the train door on the platform side several times to extinguish the illuminated door signal light.

*Figure 1 – Rail Car 7676 Console video depicts RVO #2 depressing the Door Open Button on non-platform side.*

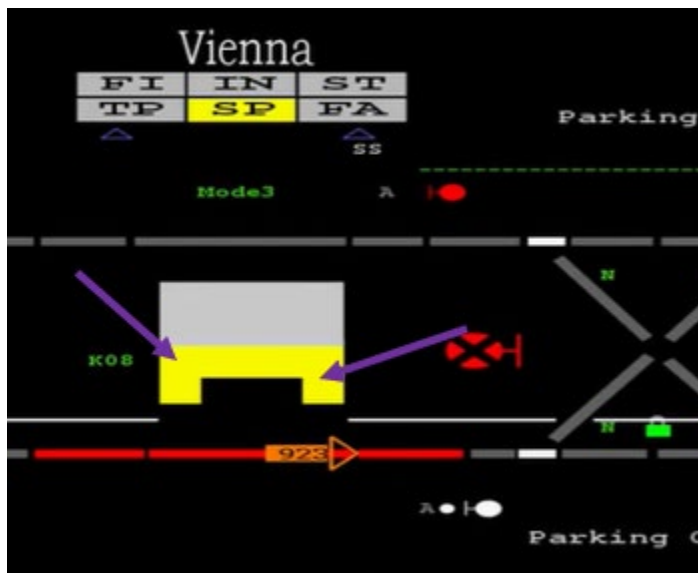
Figure 4 – (Purple arrows) A yellow square and a black rectangle indicate that the train doors opened on the off-platform side at 21:14.

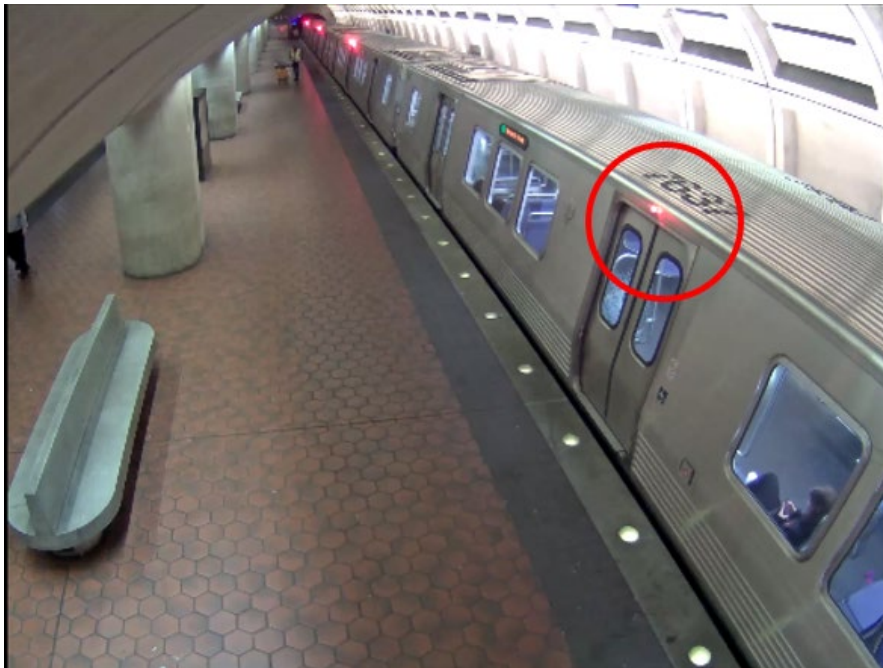
20:07:42 hours - the door lights were illuminated but the platform side doors were not open.  
One of Train ID 504 car number is 7637.

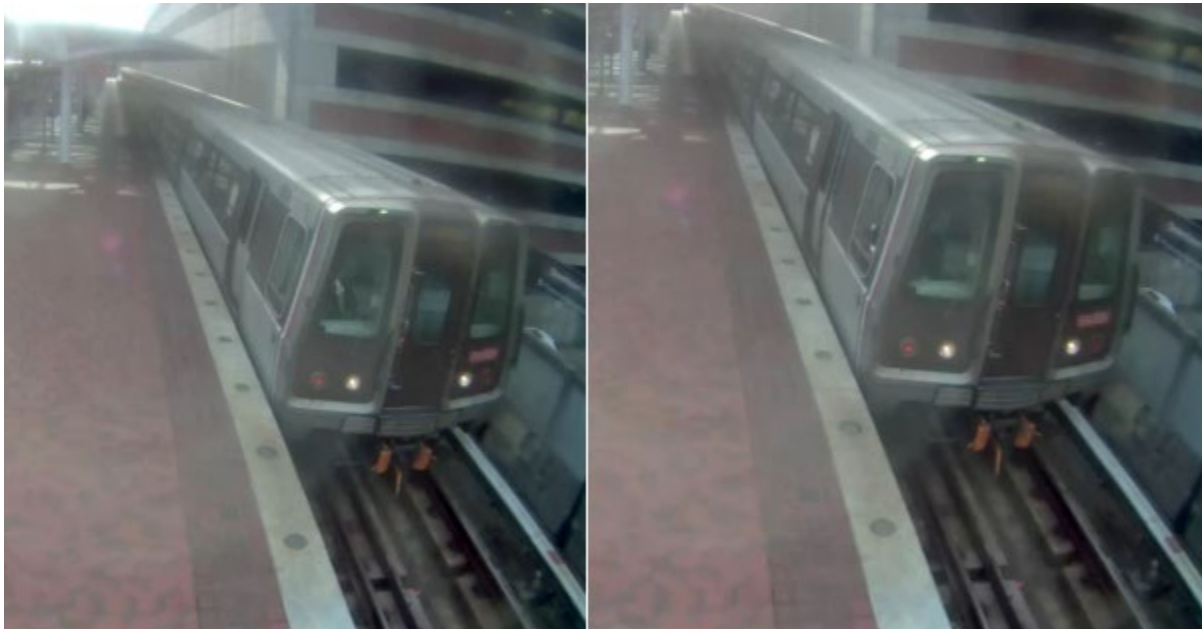
Closed-Circuit Television (CCTV) revealed that Train ID 443 arrived at Downtown Largo Station on track 2, stopped on the platform 20 feet from the 8-car marker, and the RVO manually opened the train doors on the platform side with their head placed outside the operator cab window.

*Figure 1 (left) - Train ID 443 stopped 20 feet before the 8-car marker. (right) – RVO manually opened the train door with their head placed outside the operator's cab window.*

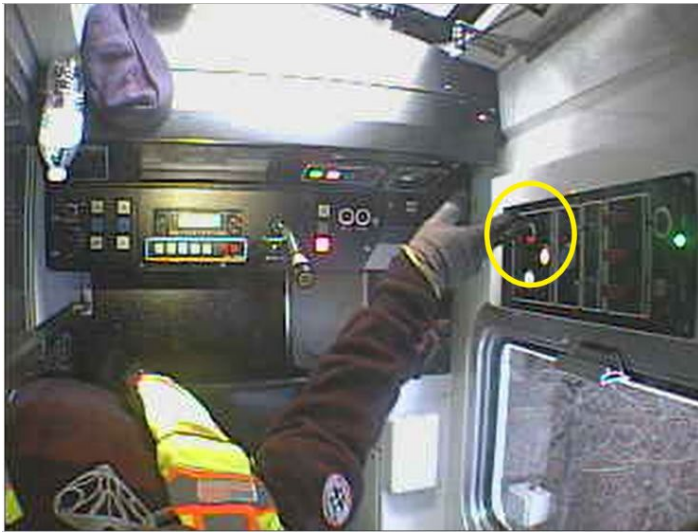
Figure 4 - Depicts RVO #1 pressing the Right Door Open pushbutton.

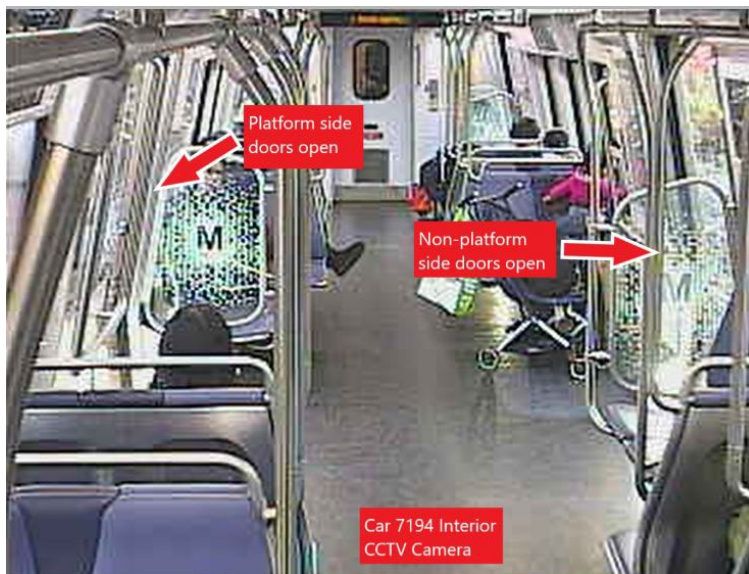
Figure 5 - Depicts the platform and non-platform side doors open on Train ID 332.

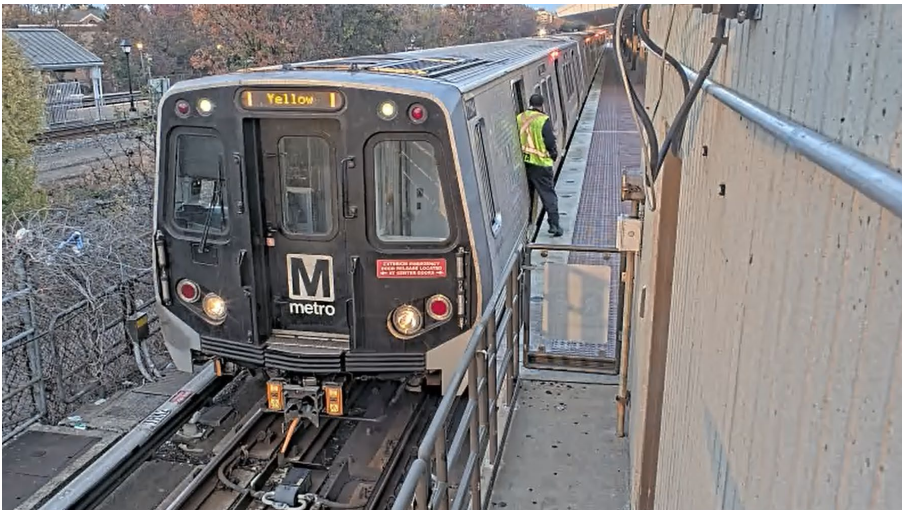
Figure 7 - Depicts RVO #1 exiting the operator's cab without keying down the train.

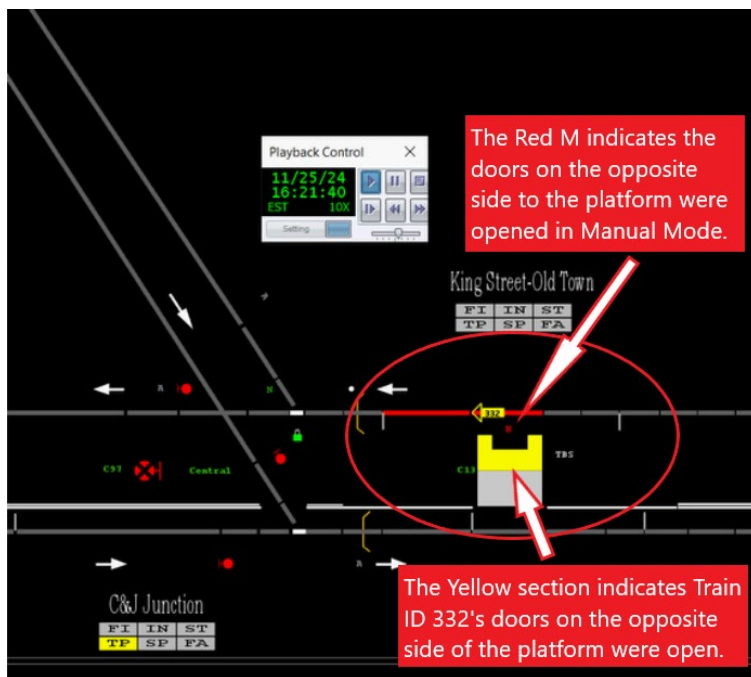
Figure 10 - Indicates Train ID 332 at King Street Station, track 2 with the non-platform side doors open.
