**W-0388 Improper Roadway Worker Protection at Shady Grove Station – October 10, 2024****Document Purpose**

FINAL REPORT OF INVESTIGATION A&I E24814

Shady Grove Station – Improper Roadway Worker Protection

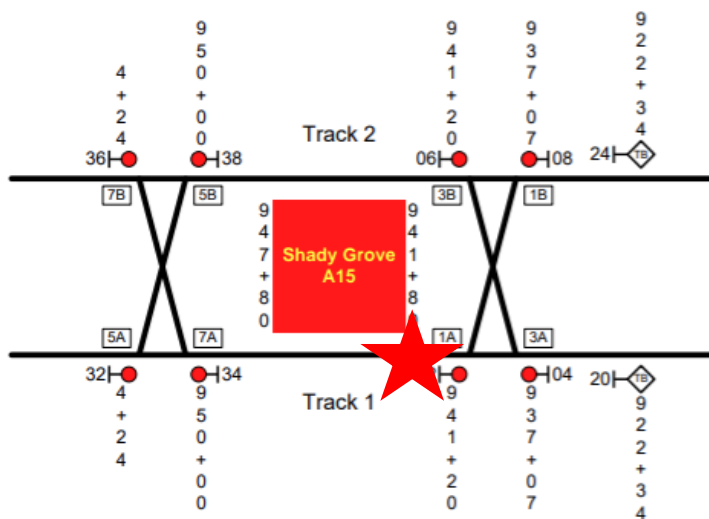
Field Sketch/Schematics

Shady Grove Station is an outdoor terminus station with ballasted tracks. There is an interlocking on the inbound and outbound ends of the station.

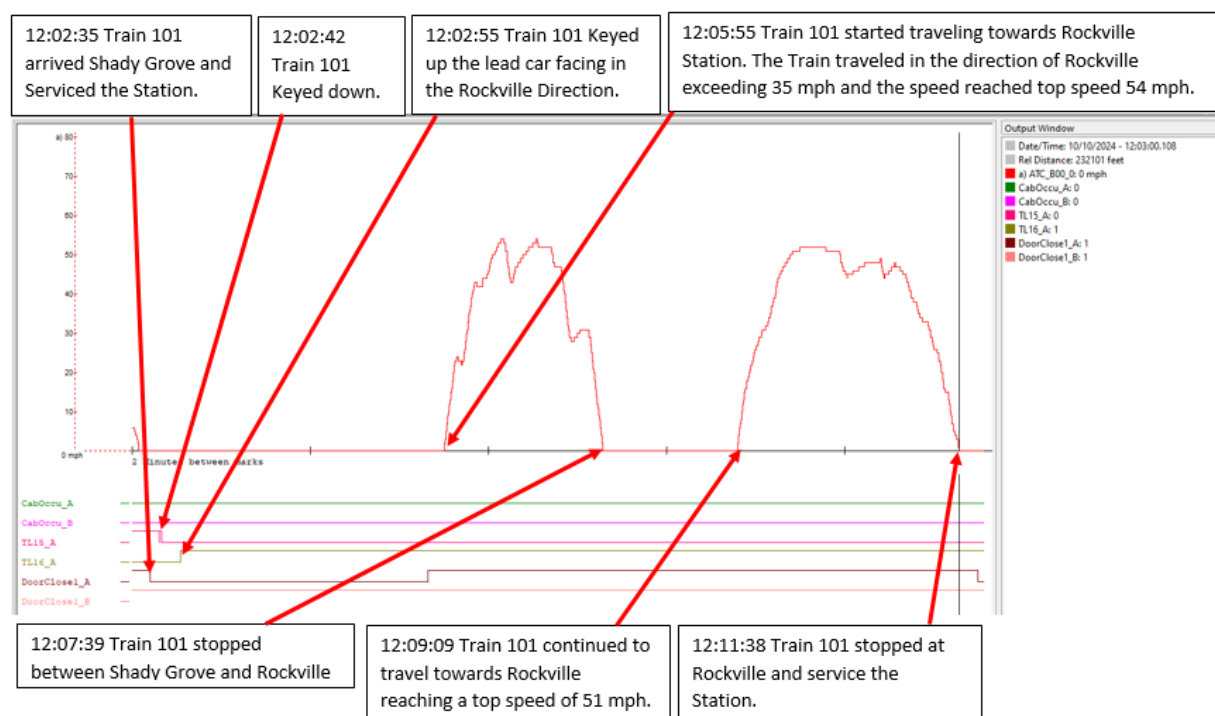
Graph. 1. Data Analysis.

Based on the data, Train ID 101 traveled from Shady Grove Station to Rockville, exceeding the RWP speed restriction. Train ID 101 speed topped at 54 mph while traveling to Rockville. The train stopped after traveling 5899 feet in the direction of Rockville and resumed operation a few moments later. No specifics about the AMF or the crew can be provided since these cars are not equipped with CCTV.

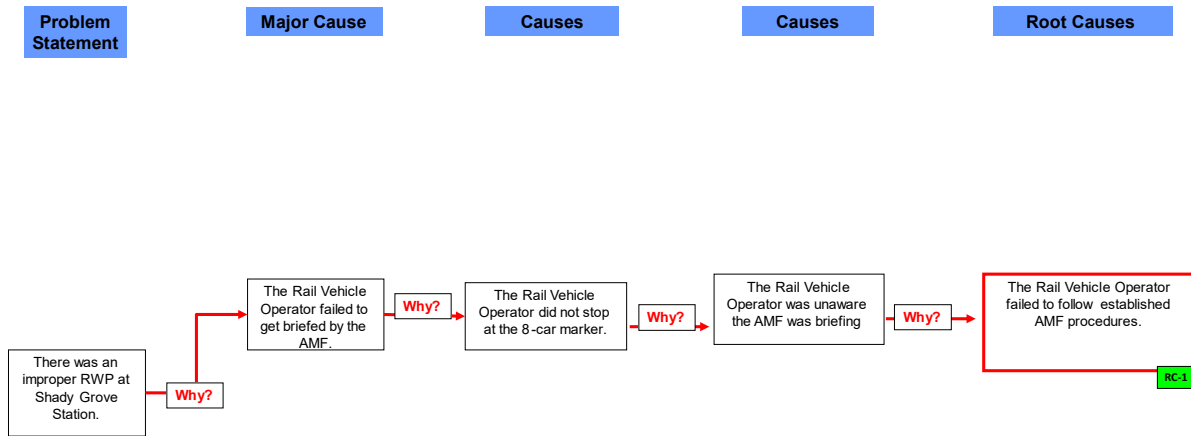
Appendix C – Why Tree

The probable cause of the Improper Roadway Worker Protection (RWP) event at Shady Grove Station on October 10, 2024, was a lack of situational awareness and communication. RVO did not observe the Advanced Flagger and did not receive a briefing before departing the station.
