W-0389 Automatic Train Protection Safety Event at Addison Road Station – November 14, 2024

FINAL REPORT OF INVESTIGATION A&I E24931

Addison Road Station – Noteworthy ATP Cut Out

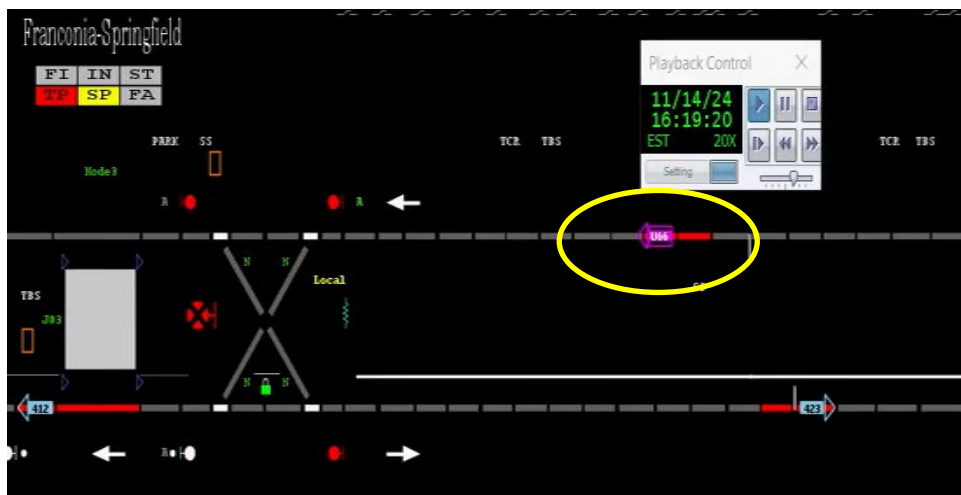
Train ID 427 (727) departed from Alexandria Yard, with RVO #1 operating, in non-revenue service to Franconia Springfield Station with ATP cut out. AIMS display showed that ATP was cut out by showing car numbers in white.

Figure 1 – Train ID 427 departing Alexandria yard with ATP cut-out (unknown Train ID white) at 16:15 hours.

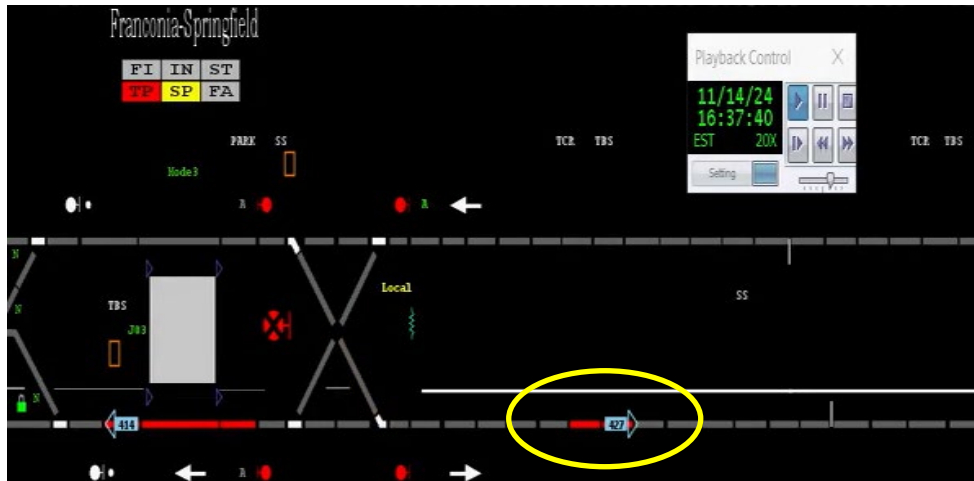
Once the consist arrived at Franconia Springfield Station on track 2 at 16:31 hours, the Train ID was changed to ID 427. The train was keyed up in cat 3063 and departed at 16:37 hours, with Downtown Largo Station as the destination ATP was cut in car 3063.

Figure 2 -Train ID 427 departing Franconia Springfield at 16:37 hours.

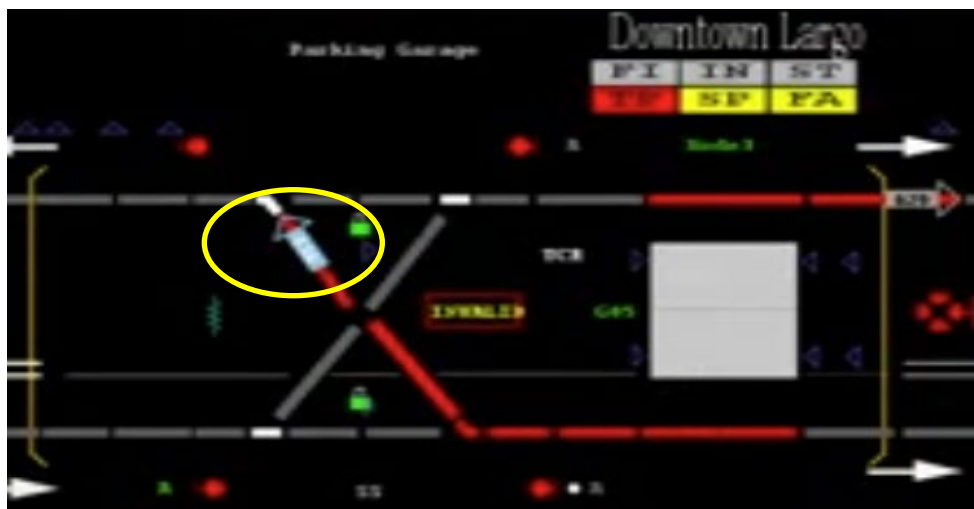
Once Train ID 427 arrived at Downtown Largo Station, RVO #1 keyed down the train and RVO #2 keyed up in Car 3057, changed the Train ID to 444, and departed at 17:54 hours from Downtown Largo Station with ATP cut out.

Figure 1 – Train ID 444 departing Downtown Largo Station at 17:54 hours.

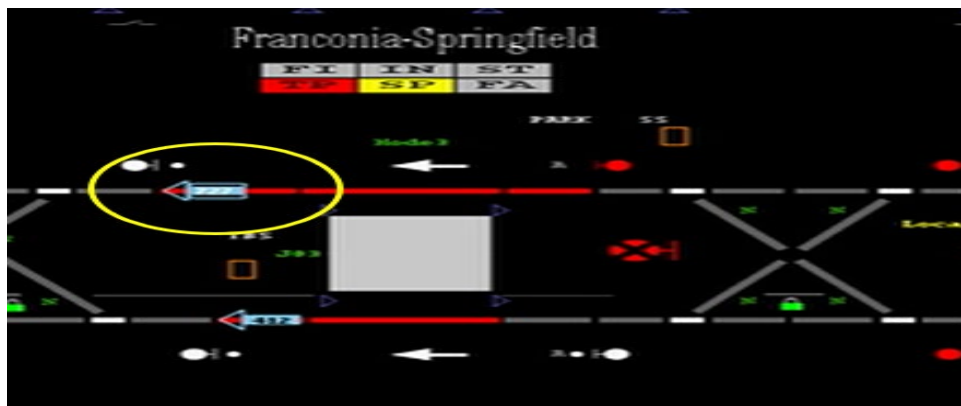
Figure 2 - Train ID 727 on the platform at Franconia-Springfield Station with ATP cut-out at 16:23 hours.

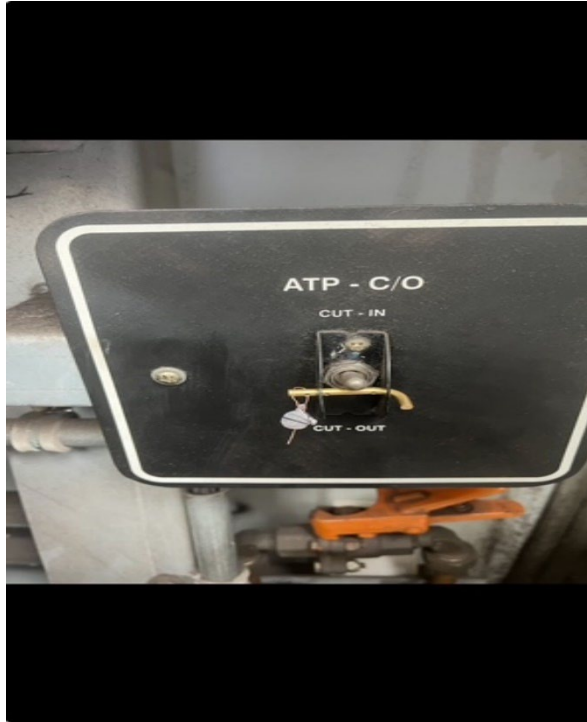
Figure 6 - Depicts ATP Cut in.

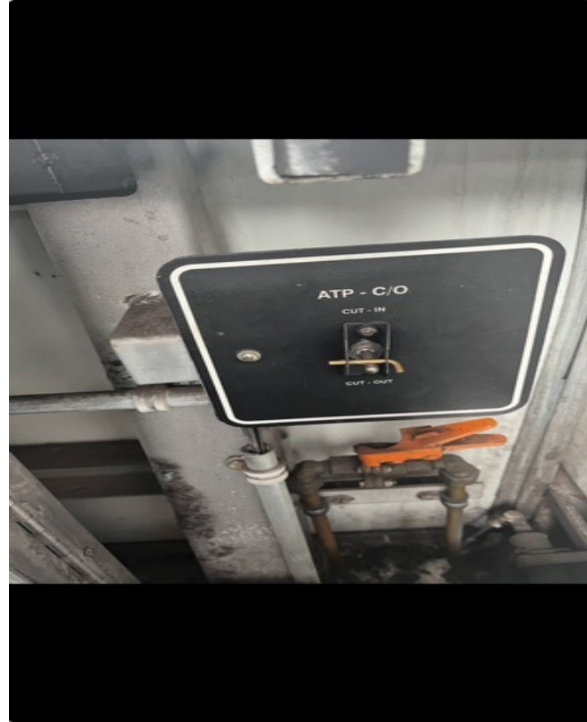
Figure 7 – Depicts ATP Cut out.

Closer examination of the train revealed the Automatic Train Protection (ATP) cut out switch had been sealed in the CUT-OUT position. In this configuration, the train has no overspeed protection, no ability to maintain safe distance from the train ahead of it, and no ability to detect broken rails. This is an extremely dangerous condition that could have led to a collision or derailment, putting our colleagues and customers at serious risk of injury or death.

The CMNT Road Mechanic boarded Train ID 444 and observed ATP was in the cut out position, then cut in the ATP, and re-sealed the ATP toggle switch at Addison Road Station on track 2.

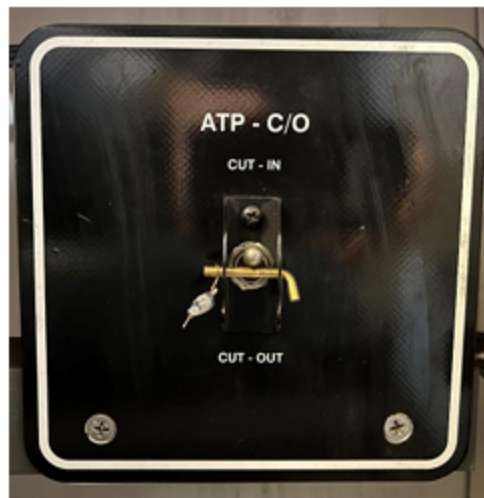
After repairs had been completed, the technician performing Daily Inspection (DI) installed a new switch bar and seal after properly identifying the missing seal. Unfortunately, the switch bar was installed in a way that caused the ATP cutout switch to remain in the CUT-OUT position. After installing the new switch bar, the technician did not key up or take any other steps that would have verified the switch bar had been installed correctly.

An example of a properly installed ATP cutout switch bar (pin) and seal is provided below.
