## WMSC Inspection Report 20250806

Title: Track and Rough Ride Inspection, Ballston-MU (K04) to West Falls Church (K06)

Location: Ballston-MU Station (K04) to West Falls Church Station (K06) Track 1 and 2

Date of Inspection: 8/6/2025

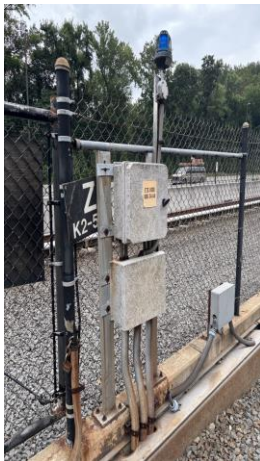
WMSC Inspectors noted that four emergency trip station (ETS) box blue lights were not illuminated between K&N Junction (K98) and West Falls Church Station (K06). ETS boxes on track 2 were functioning correctly; however, WMSC inspectors could not verify whether the ETS boxes on track 1 were functioning correctly as the track walk portion of the inspection was confined to track 2. ETS K100 K06-34,44.

**Hazard Rating: 1E**

Photo 1. ETS K100 K06-34,44.

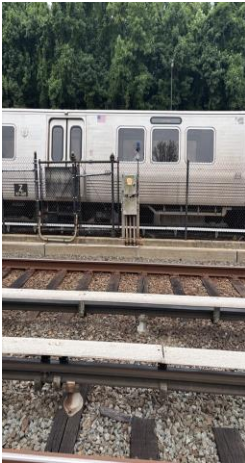
ETS blue lights are out for ETS K99 K06-33,44.

**Hazard Rating: 1E**

Photo 2. ETS K99 K06-33,43.

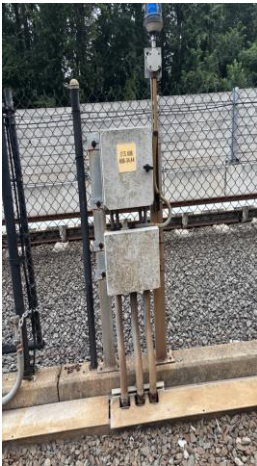
ETS blue lights are out for ETS K98 K06-34,44.

**Hazard Rating: 1E**

Photo 3. ETS K98 K06-34,44.

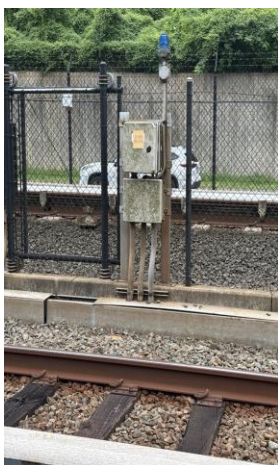
ETS blue lights are out for ETS K97 K06-33,43.

**Hazard Rating: 1E**

Photo 4. ETS K97 K06-33,43.

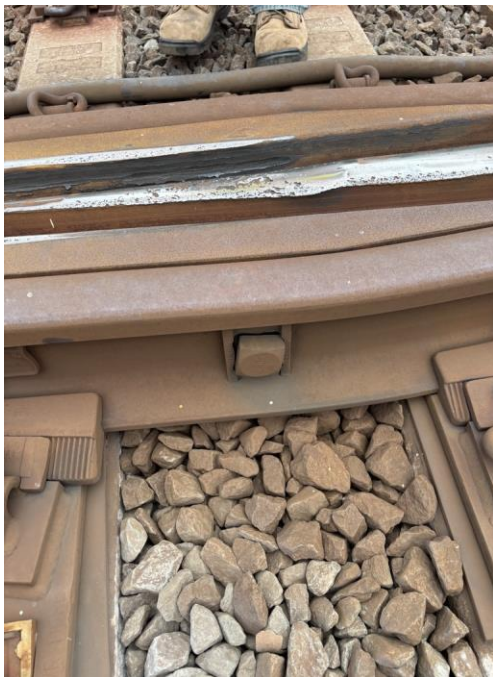
WMSC Inspectors noted a defective frog<sup>2</sup> bolt and frog at K&N Junction (K98), 7 switch.

**Hazard Rating: 2B**

Photo 5. The loose middle frog bolt contributes to wear on the frog and causes banging. Because the frog is at the convergence of two lines, replacement and tamping are recommended due to the wear stated in the TRST-1000 section 108.6 (F).

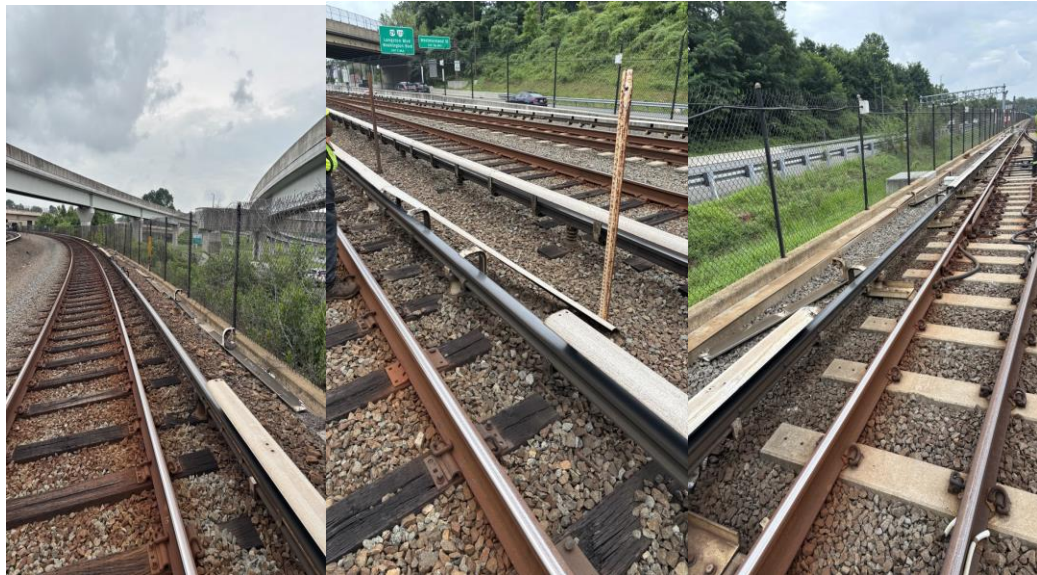
WMSC inspectors noted several cover boards that were missing or damaged between East Falls Church (K05) and West Falls Church (K06). (See photos 6 through 8.) Metrorail track inspectors confirmed that the cover boards have been previously reported.

**Hazard Rating: 3C**

Photo 6 (left). Missing cover boards.

Photo 7 (middle). Damaged cover board.

Photo 8 (right). Additional missing cover boards.
