WMSC Inspection Report 20250716

Title: Negative Return Cable Structure Configuration and Integrity

Location: Braddock Road (C12)

Date of Inspection: July 16, 2025

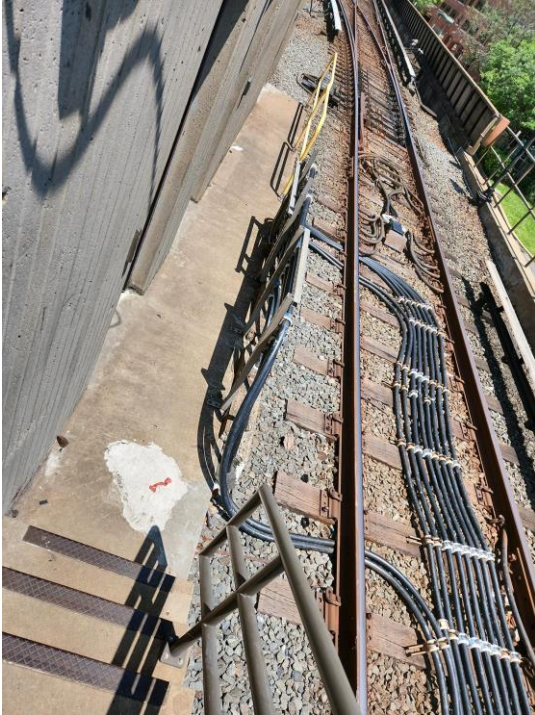
The cable structure at Braddock Road Station creates a handrail gap that exceeds six feet. Metrorail personnel advised the WMSC that the cable structure is not a handrail.

There is a handrail gap that exceeds six feet. Through a combination of on-site inspection and communication with Metrorail, WMSC Inspectors learned that the cable structure is ineligible as a safety handrail. And considering the potential for electrical current passing through the cables, the cables and the cable structure should likewise not serve as an intended handrail.

Hazard Rating: 3B

Photo 1. The gap between the handrails exceeds six feet.

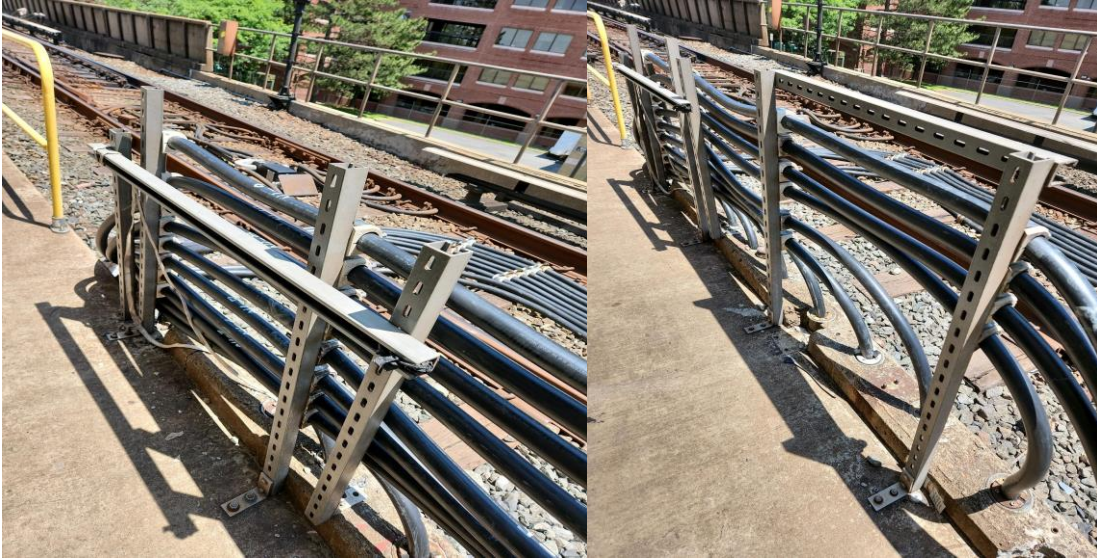
The cable structure was observed as missing cross braces that assist in providing structural support and rigidity to the vertical cable tray framing. The structure also presents as temporary in that the brace is not attached to the cable structure, and the horizontal member of this detached structure is held together with discarded polyester webbed pull tape providing insufficient stability support.

WMSC inspectors identified that the support structure was unstable, shaking, and detached from the cable tray frame. The cross brace is attached by pieces of cloth and is not uniform across the vertical post, causing the entire structure to sway.

Hazard Rating: 3B

Photo 2 (Left). Structure being held together with discarded polyester webbed pull tape.

Photo 3 (Right). Structure missing braces for rigidity.
