## **Improper Door Operations**

### **Bethesda, Rockville, Franconia-Springfield, and Pentagon Stations**

**November 1, 2024, December 13, 2024, December 21, 2024, and December 29, 2024**

## Bethesda Station – Improper Door Operation

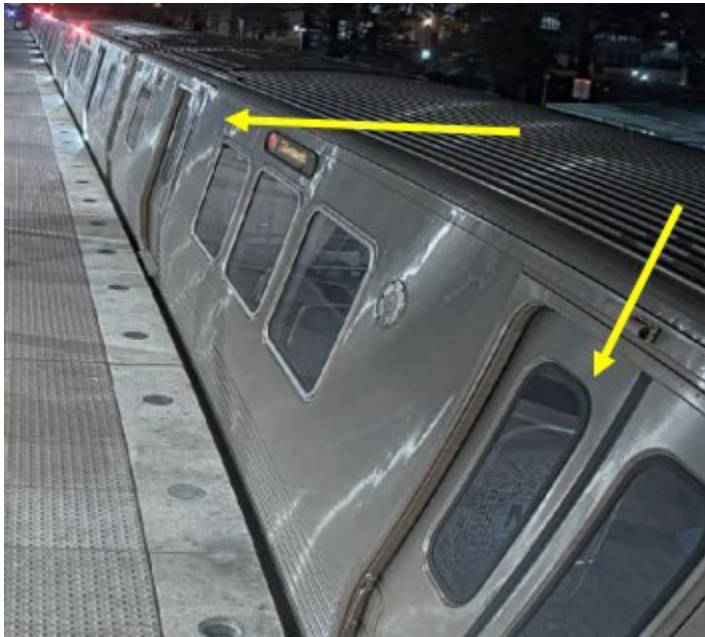
*Figure 1 - (Yellow Arrows) depict the closed train doors on (isolated) railcar 7098.*

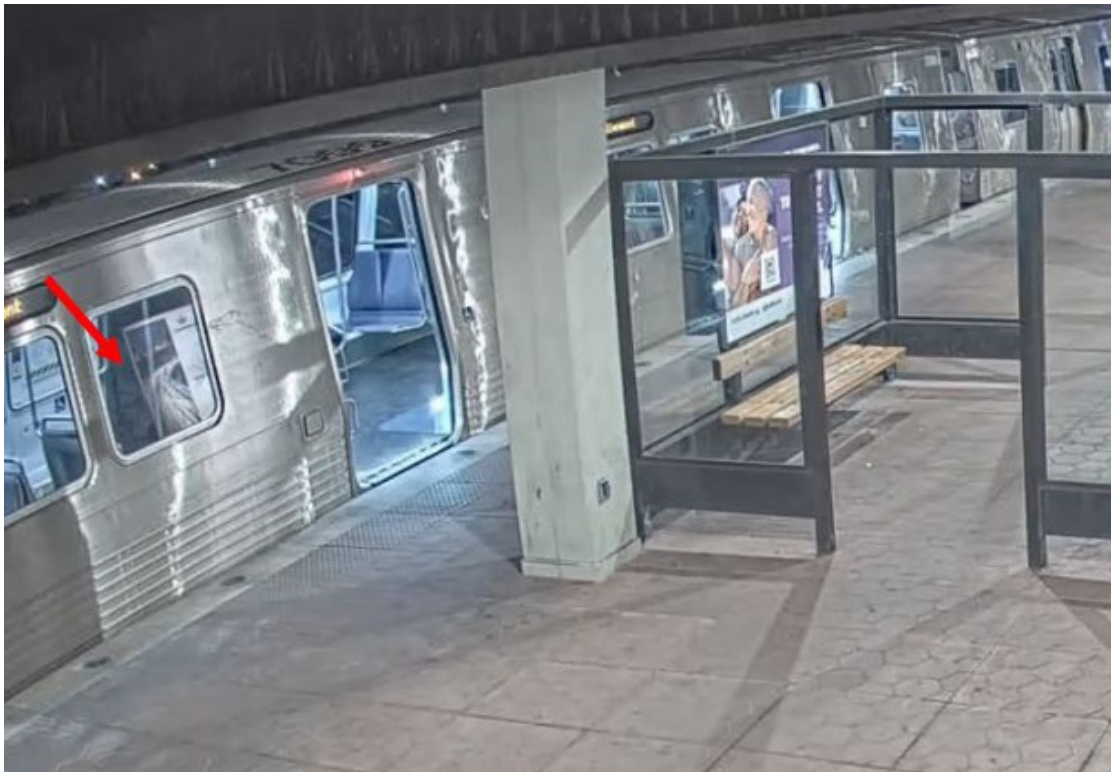
*Figure 2 - (Red Arrow) depicts the doors open on the off-platform through the window of railcar 7099.*

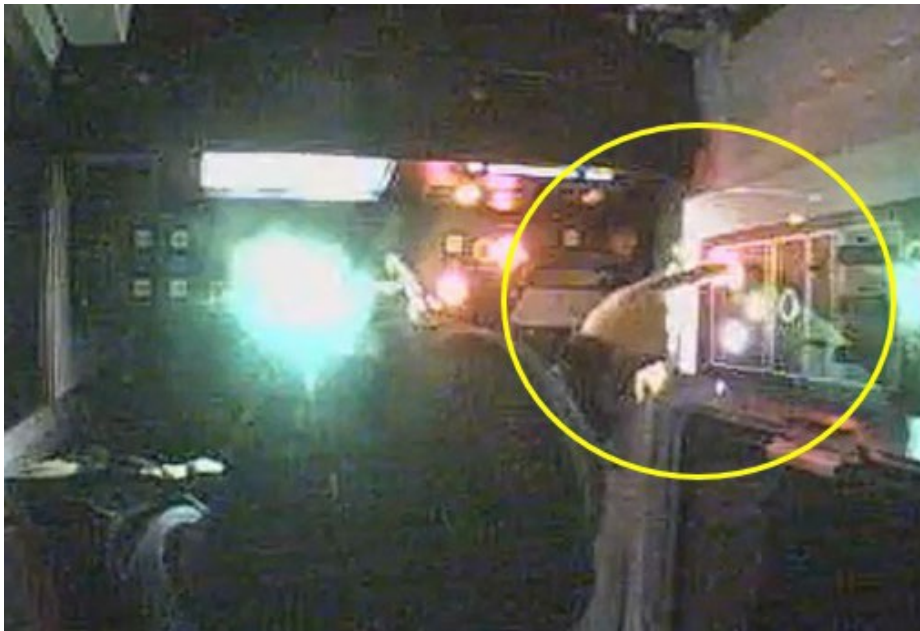
*Figure 3 (Yellow Circle) depicts the RVO depressing the door open button on the off-platform side of the train.*

During a formal interview, the RVO revealed that upon picking up the train at Shady Grove platform, they observed that one railcar was isolated and made note of it. Upon arrival at Rockville Station, the train was properly berthed, and the doors opened automatically on the platform side. The RVO reported that an alarm appeared on the Train Control Display (TCD), which confused them. In response, they inadvertently depressed the door open button on the non-platform side of the train.

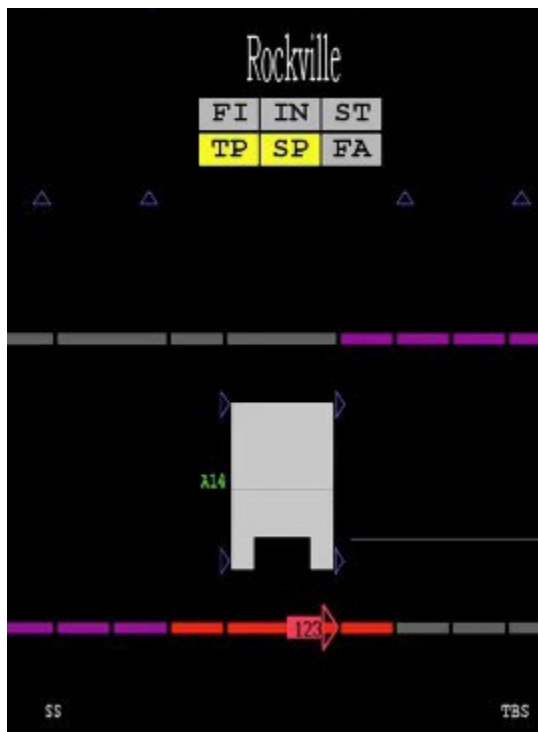
*Figure 4 - AIMS depict Train ID 123 doors opened at Rockville Station 20:16 hours.*

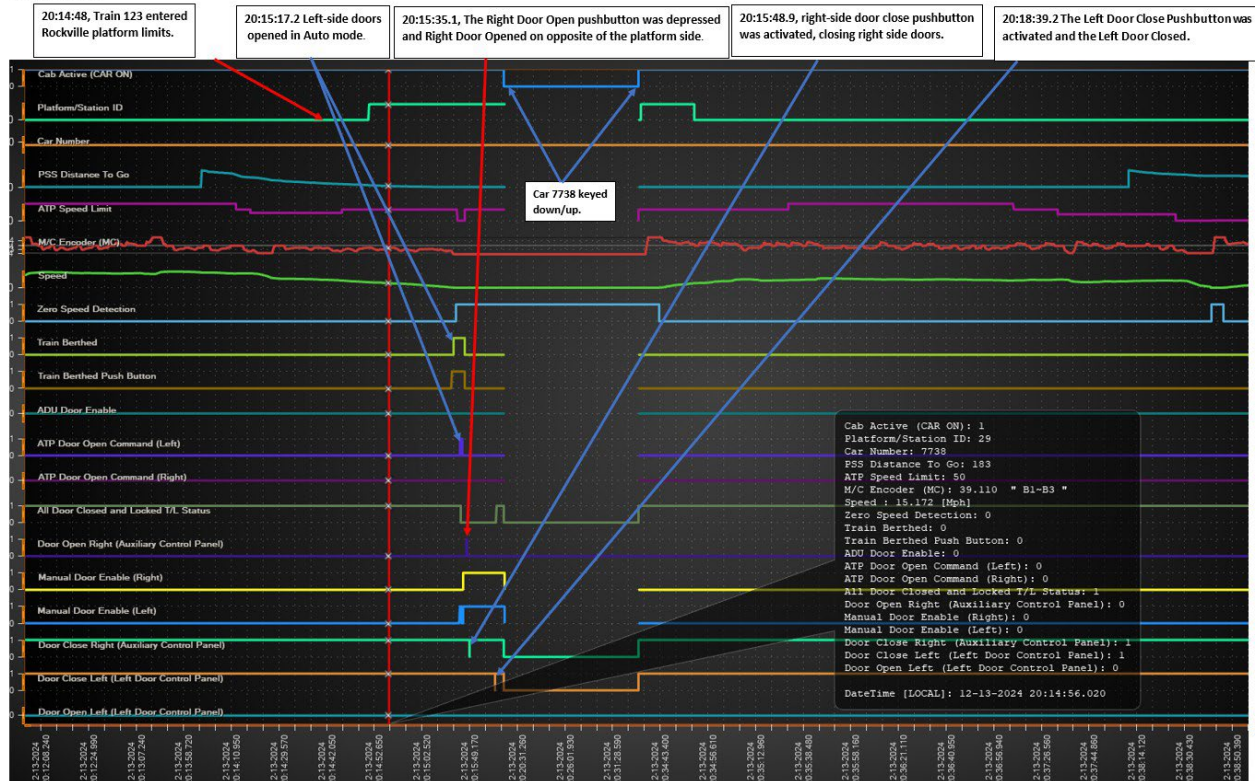
Based on train data, the door opened on the opposite side of the platform as a result of being commanded manually. There was no fault observed with the pushbuttons, The door pushbuttons were exercised multiple times with no indication of sticking or binding.

Figure 5 - Event Recorded Data from railcar 7738.

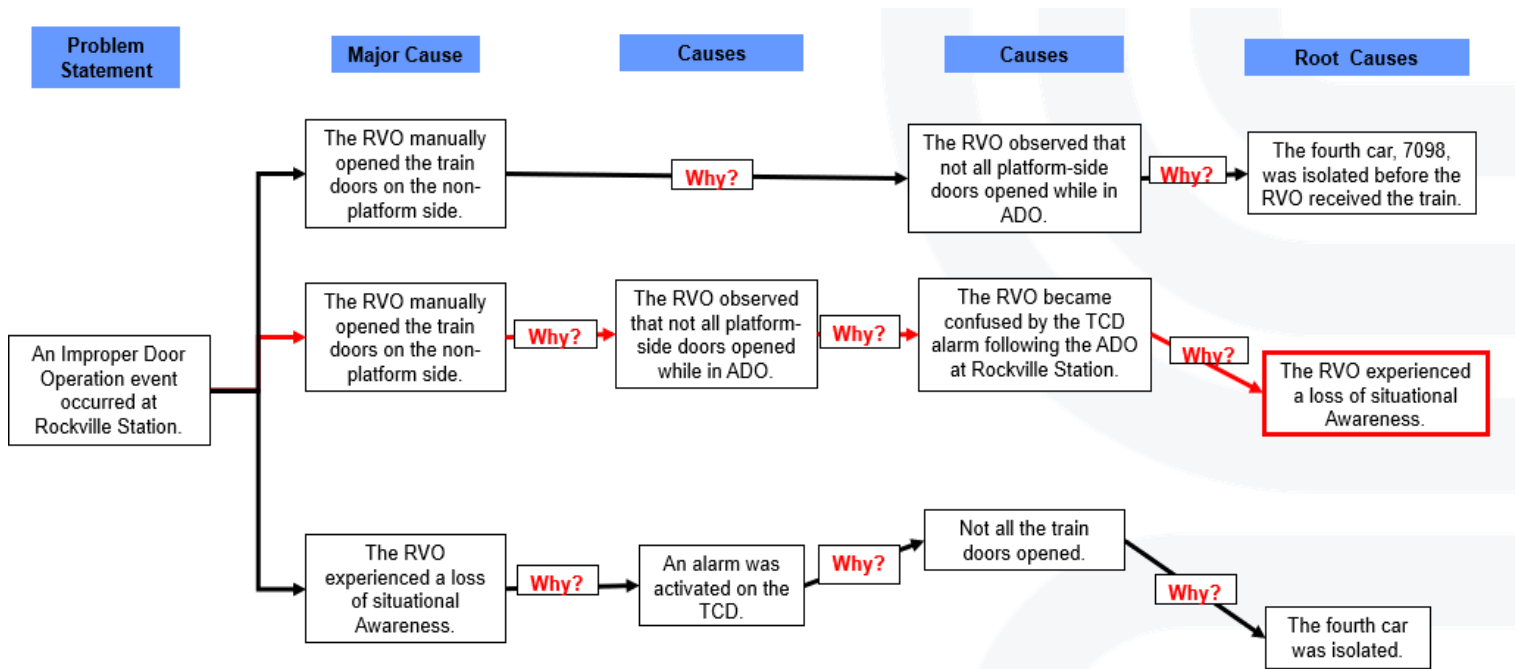
## Appendix C – Why-Tree Analysis

The probable cause of the improper door operation event on December 13, 2024, was the RVO's failure of situational awareness. Specifically, the RVO observed that not all of the train doors in the consist opened automatically on the platform side and inadvertently manually opened the doors on the off-platform side.

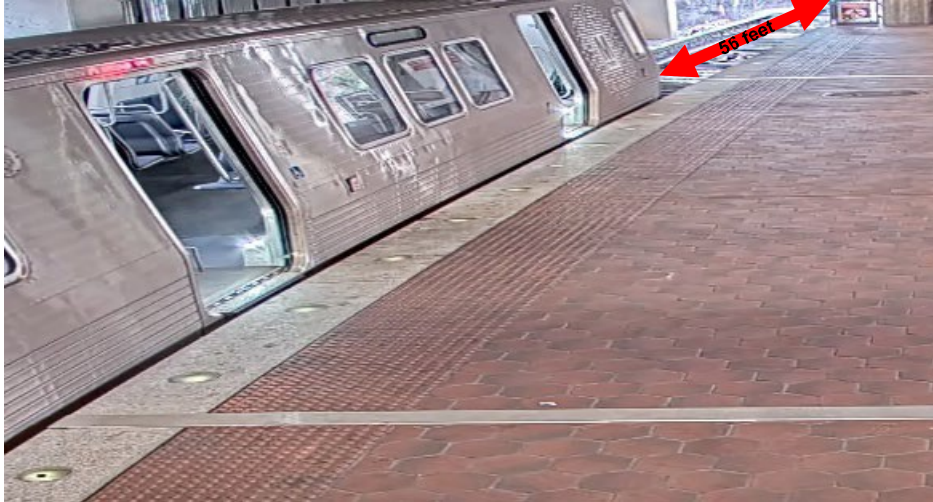
*Figure 1: Train ID 404 stopped 56 feet short of the eight-car marker and serviced the station.*

The train was not properly berthed at the eight-car marker when the RVO serviced the station. After servicing the station, the RVO keyed down the train and exited the Operator's cab. The RVO was completing their last trip when this event happened. The RVO that was operating Train ID 404 never reported the last two doors being opened outside the platform limits. At 13:20 hours, the Division Superintendent informed the MICC AOM to removed the RVO from service.

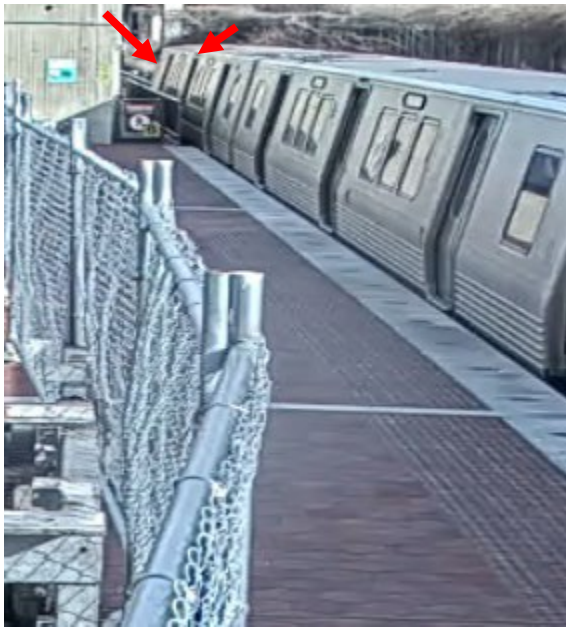
*Figure 2: The last two doors were outside the platform limits.*

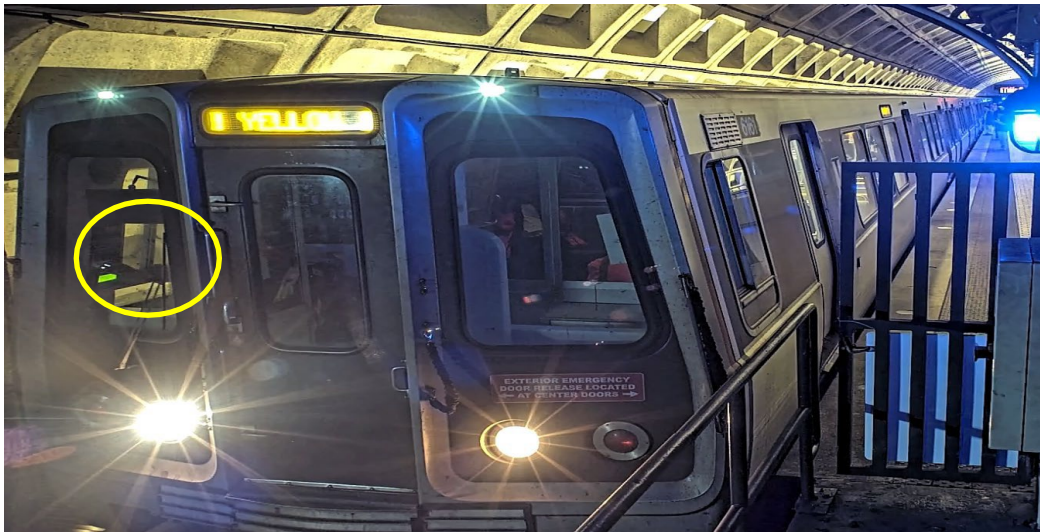
At 11:57 hours, the RVO of Train ID 321 properly berthed the train at Pentagon Station track 1, eight-car maker, remained in the operator's seat, and then pressed the Right Door Open pushbutton, opening the non-platform side doors of the train.

*Image 2 – Depicts the RVO of Train ID 321 pressing the Right Door Open pushbutton at 11:57 hours.*

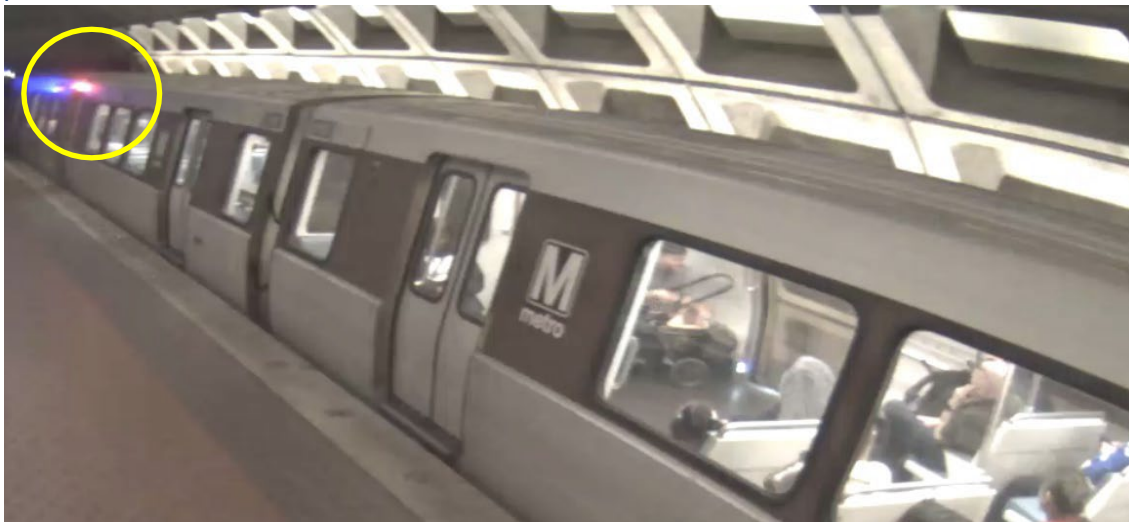
*Image 3 – Depicts Door Signal Lights illuminated platform doors remained closed indicating the train doors were opened on the non-platform side.*

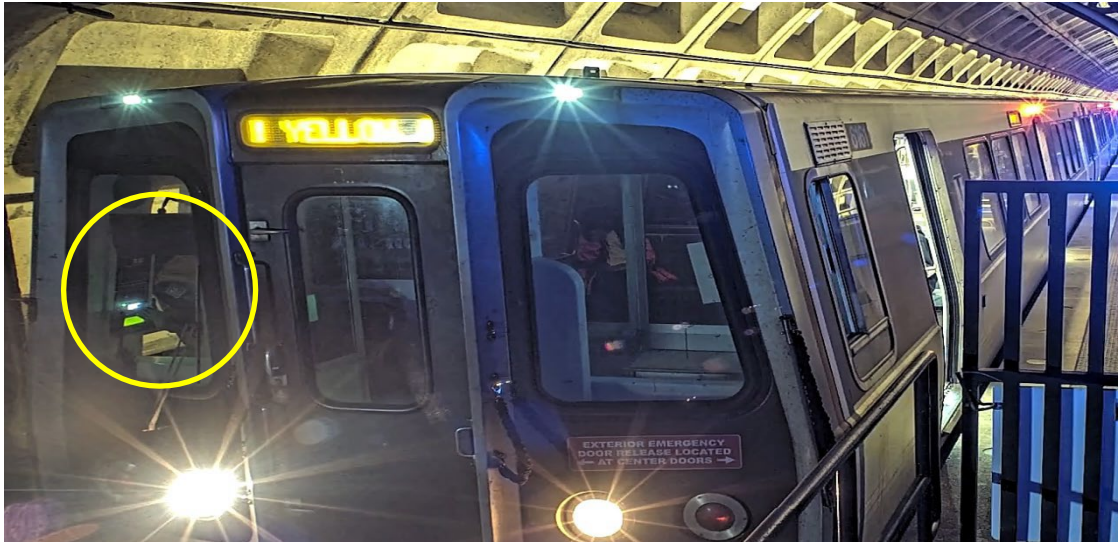
*Image 4- Depicts the RVO closing the train doors on the non-platform side.*
