**W-0396 – Derailment – near Ronald Reagan National Airport Station – April 16, 2024****Document Purpose:**

Washington Metropolitan Area Transit Authority  
Department of Safety (SAFE)  
Office of Safety Investigations (OSI)  
**FINAL REPORT OF INVESTIGATION A&I E24301**

# National Airport – Derailment

April 16, 2024

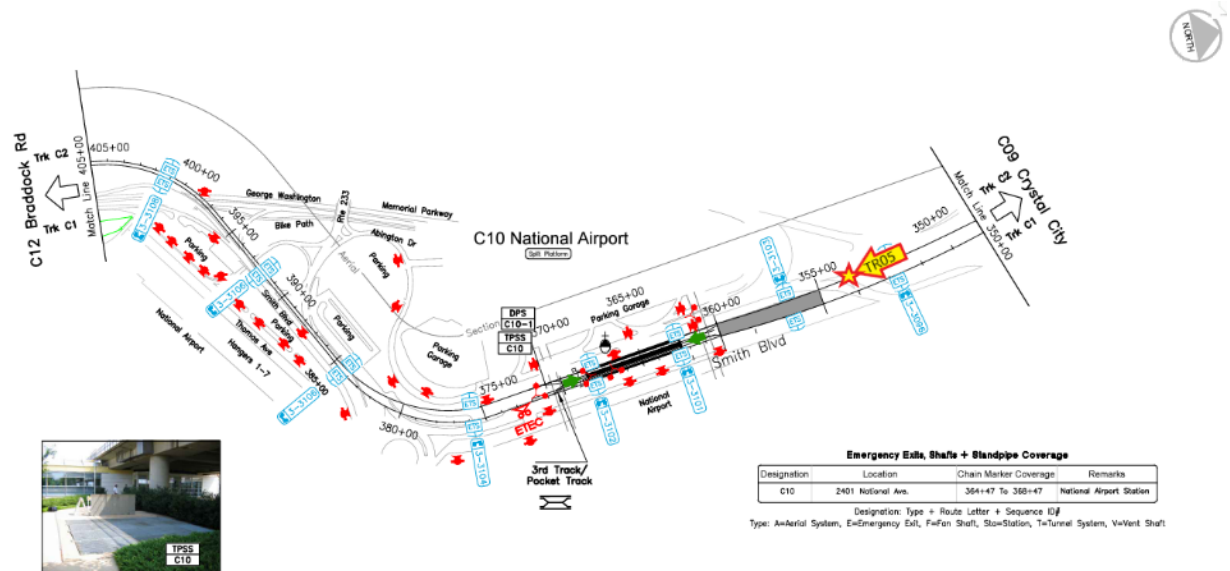
Figure 3 - Field sketch of the location where TR-05 derailed in approach to National Airport Track 2 platform limits.

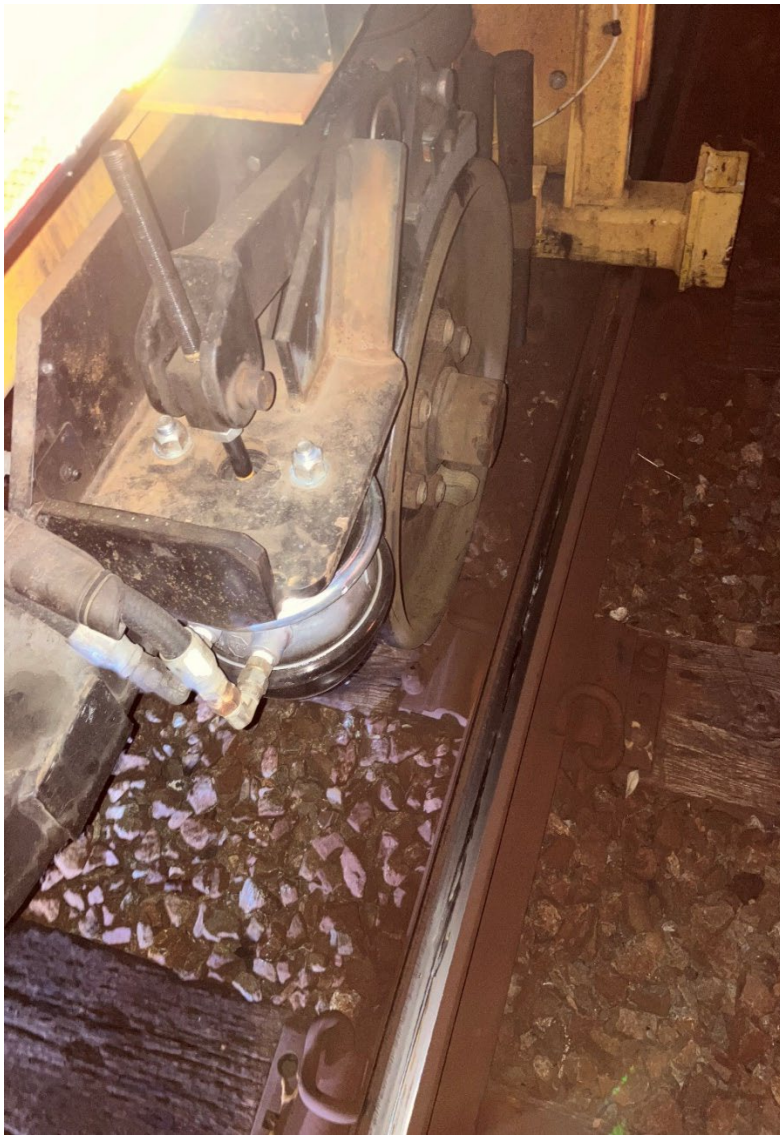
*Figure 8 - Depicts the location where TR-05 is at the point of final rest with the front wheel off of the running rail.*

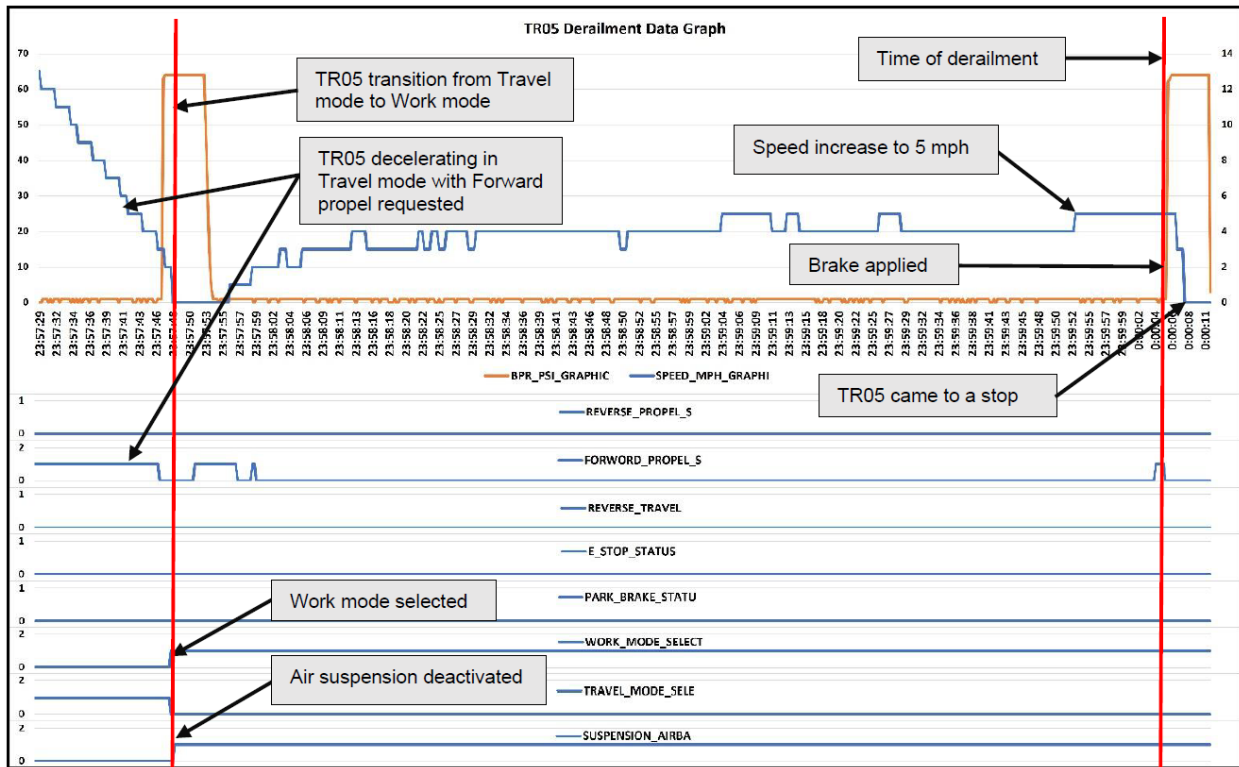
Leading up to this incident, TR-05 was unable to negotiate the incline coming out of the Crystal City station in Travel mode. The 4% incline combined with an 800-foot radius required more tractive effort than was available. Although the operator was requesting full power to the wheels, TR-05 decelerated. Switching to Work mode allowed TR-05 to continue up the incline. The difference between Travel mode and Work mode is limited to the suspension, with propulsion remaining unaffected. Vehicle Program Services, Rail Fleet, has not, at this point, been able to define track conditions, either singularly or sum-total, that will result in a derailment or the reason why additional tractive effort is available in Work mode.

Figure 13 - TR-05 Event Recorder log of the derailment at National Airport

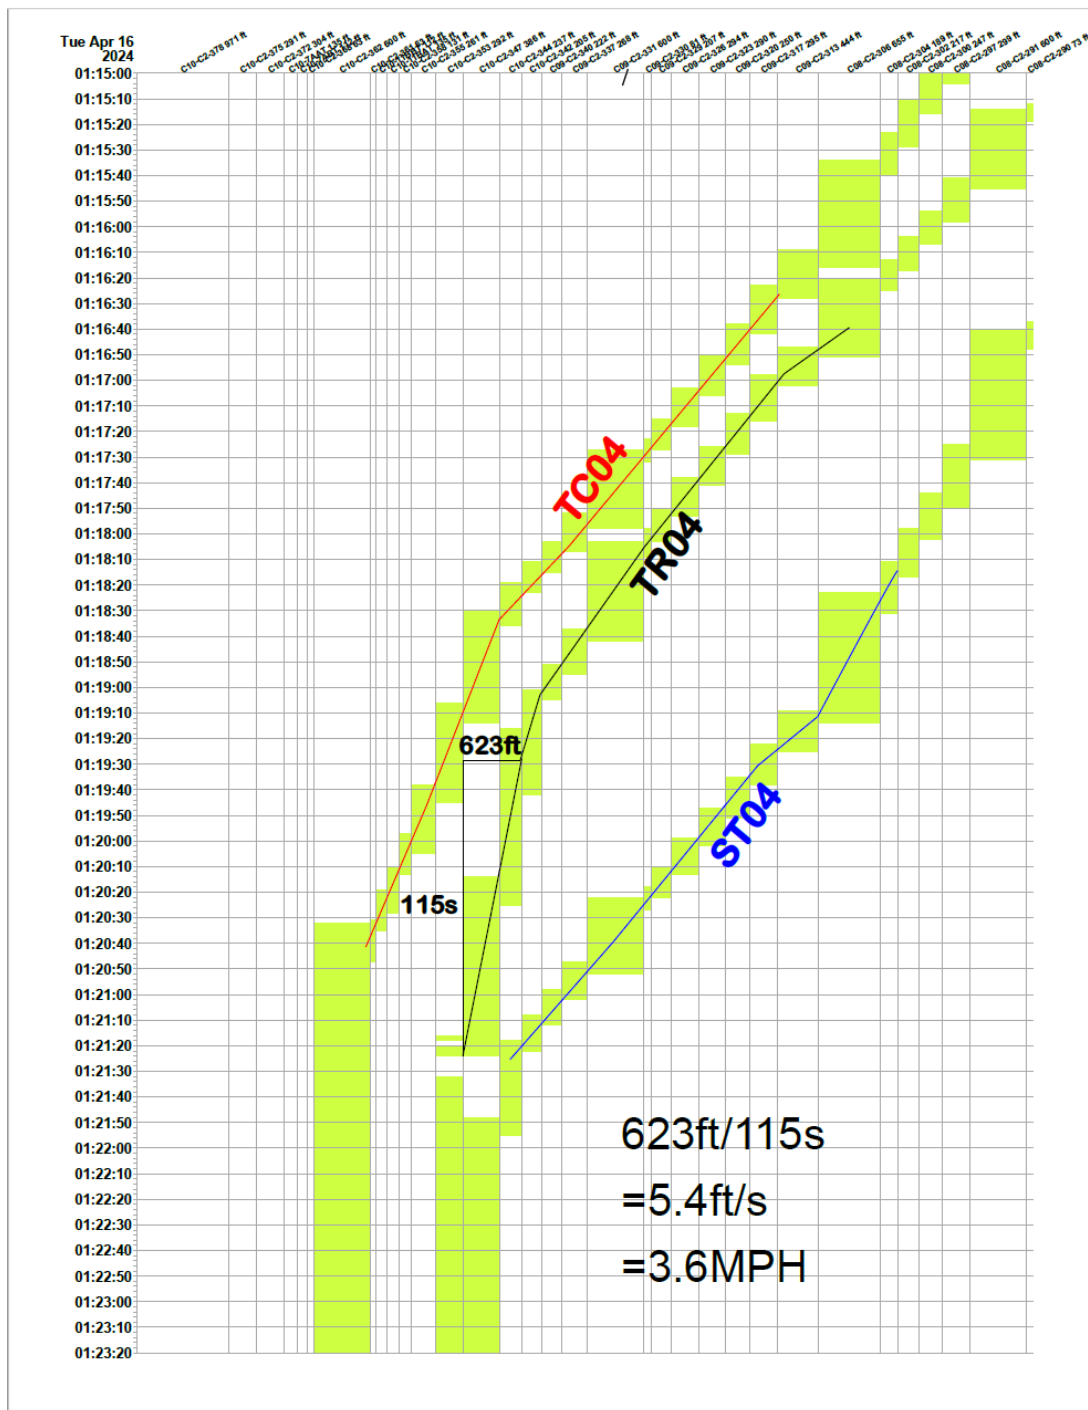
Based on the AIMS playback and Track circuit occupancy data, ITSS identified three (3) vehicles on track 2 at National Airport. This information, in addition to the ARS playback, we were able to deduce TR-05 (identified as TR-04 in AIMS) was the middle vehicle of the convoy. The estimated speed of the vehicle before the Point of Derailment (POD) was 3.6 MPH.

Figure 14 The graph above represents the track circuit occupancy on track 2 near National Airport. The green cells represent rail vehicle occupancy. The top of the graph shows the distance between CMs, and the left side shows the time in 10-second intervals. This data is used to calculate the estimated speed of the RMM at the time of the event.

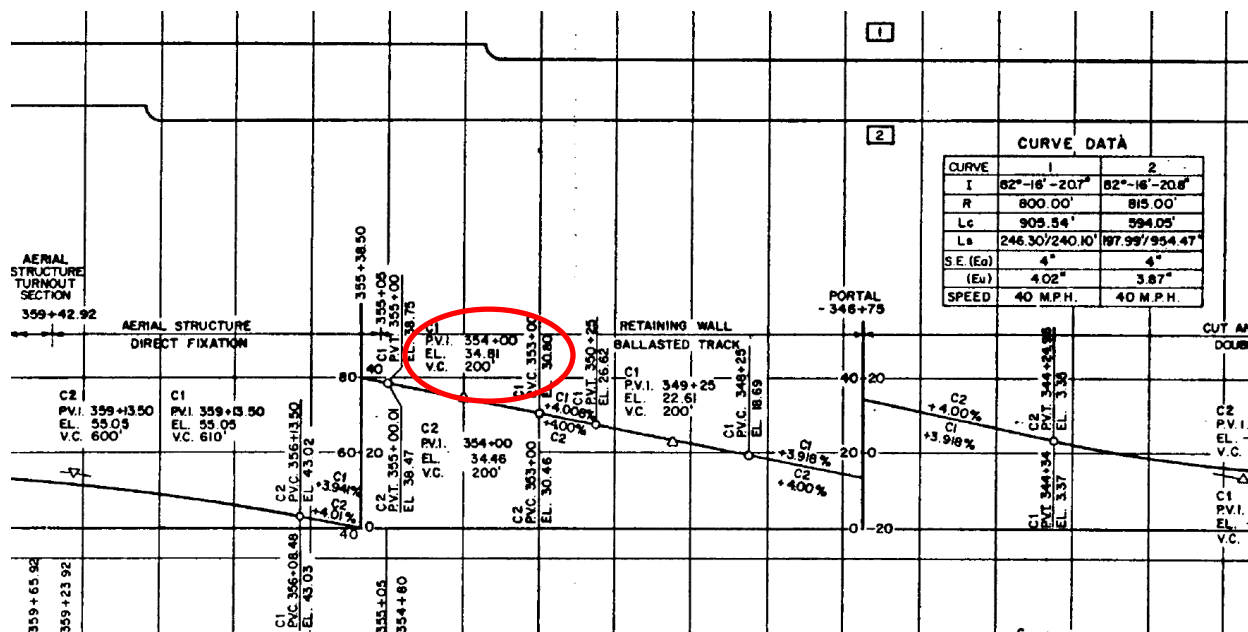
MOWE provided information after the derailment to determine whether track conditions contributed to the derailment. The curve on track 2 leaving Crystal City Station is from CM 338+85 to 352+86, with a right-side super elevation of 4 inches. The body of the curve is from 341+31 to 350+37. The curve ends at 352+97. The POD occurred at 354+00.

Figure 15 – depicts the Track Map between Crystal City Station and National Airport Station, showing POD circled in red..

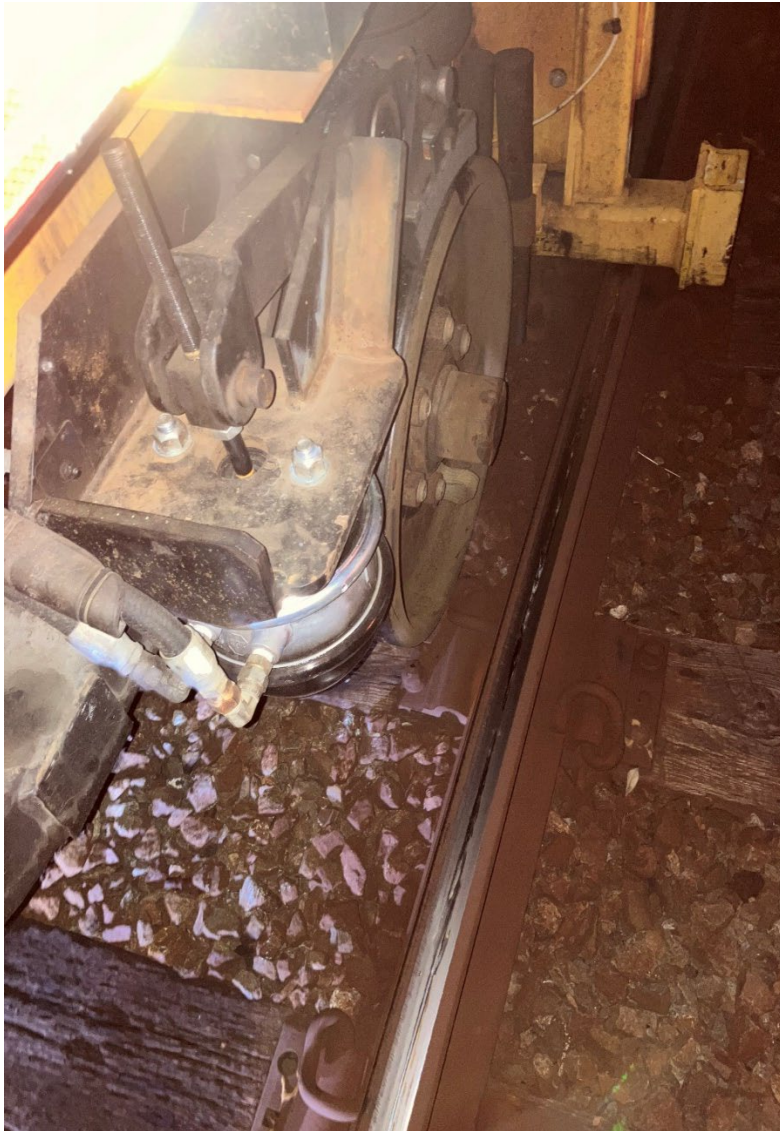
*Figure 17 - Depicts the location where TR-05 derailed and scrapes on the running rail*

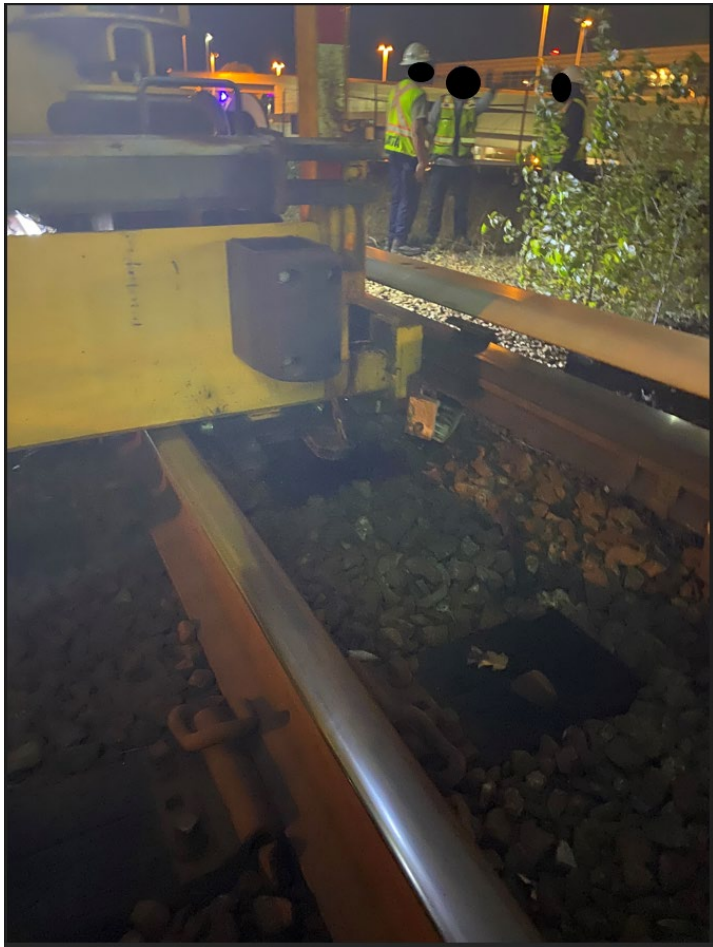
At 01:26 hours, the Equipment Operator of TR-05 confirmed that their unit derailed outside the platform limits near Chain Marker (CM) C2 354+00. The left front wheel made contact with a third rail insulator and coverboard.

*Figure 18 - Photo of TR-05 left front wheel derailed*

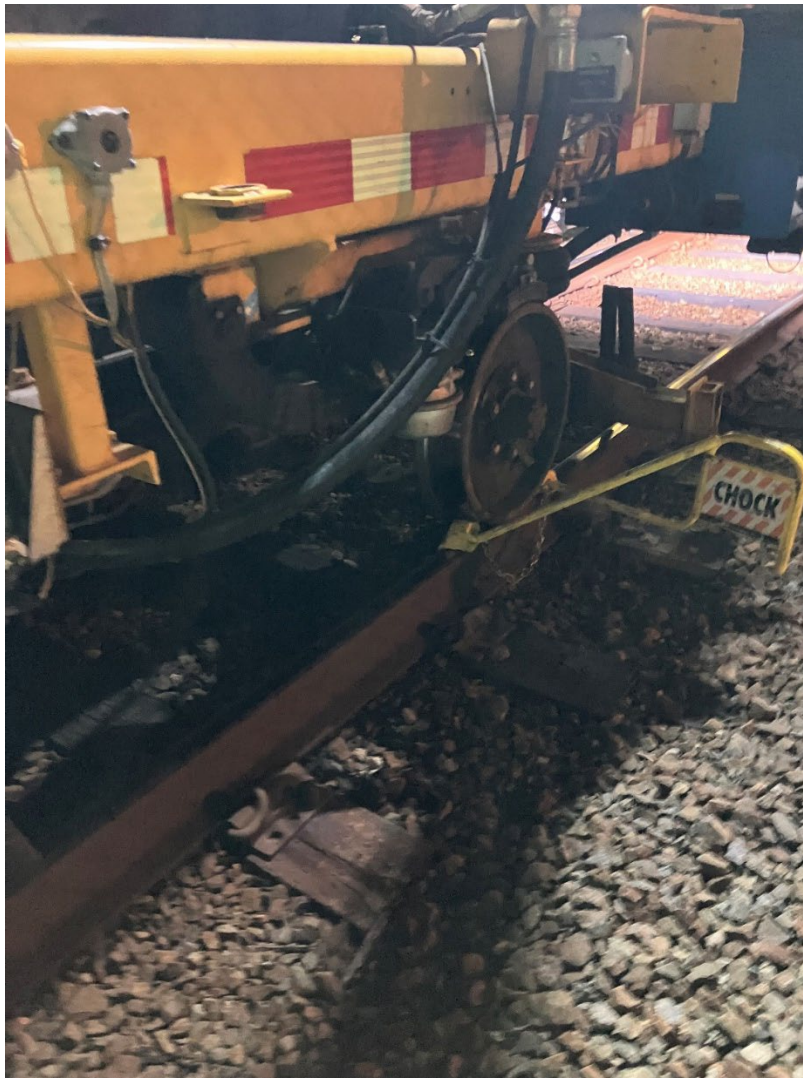
*Figure 19 - depicts the rear wheel of TR-05 that remained on the running rail*

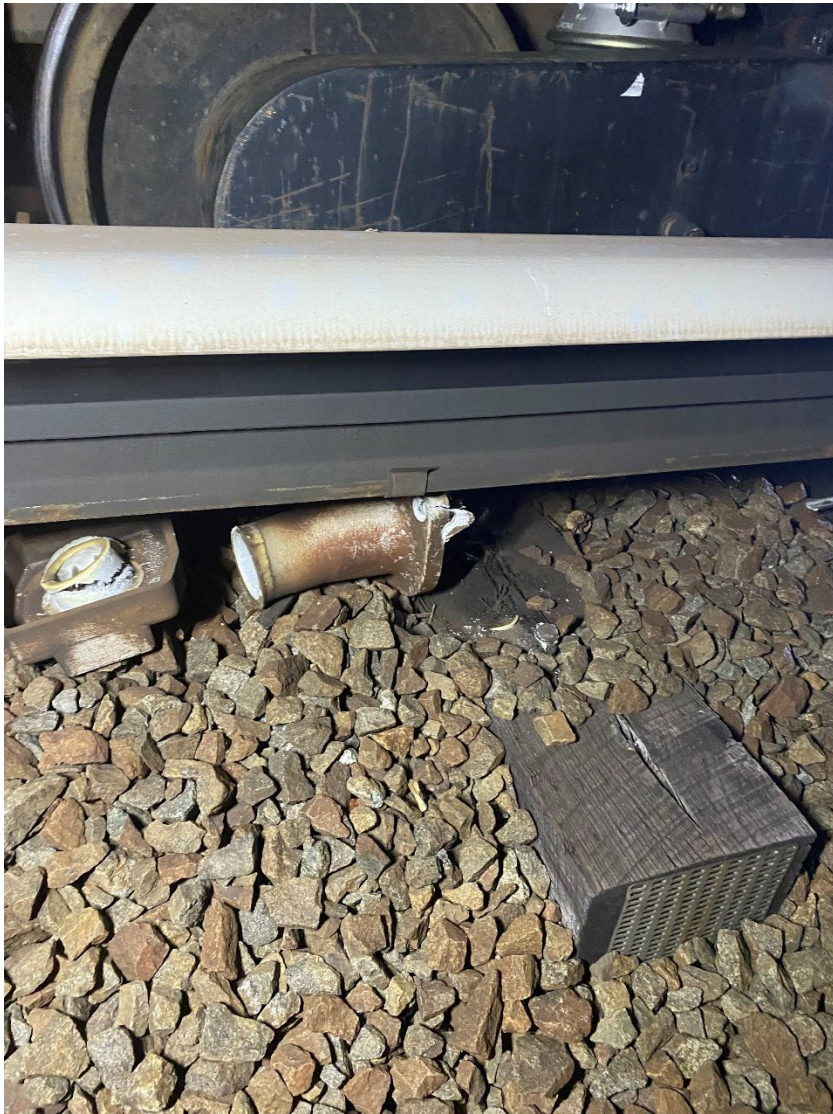
*Figure 21 - Depicts damages to the Third Rail insulator.*

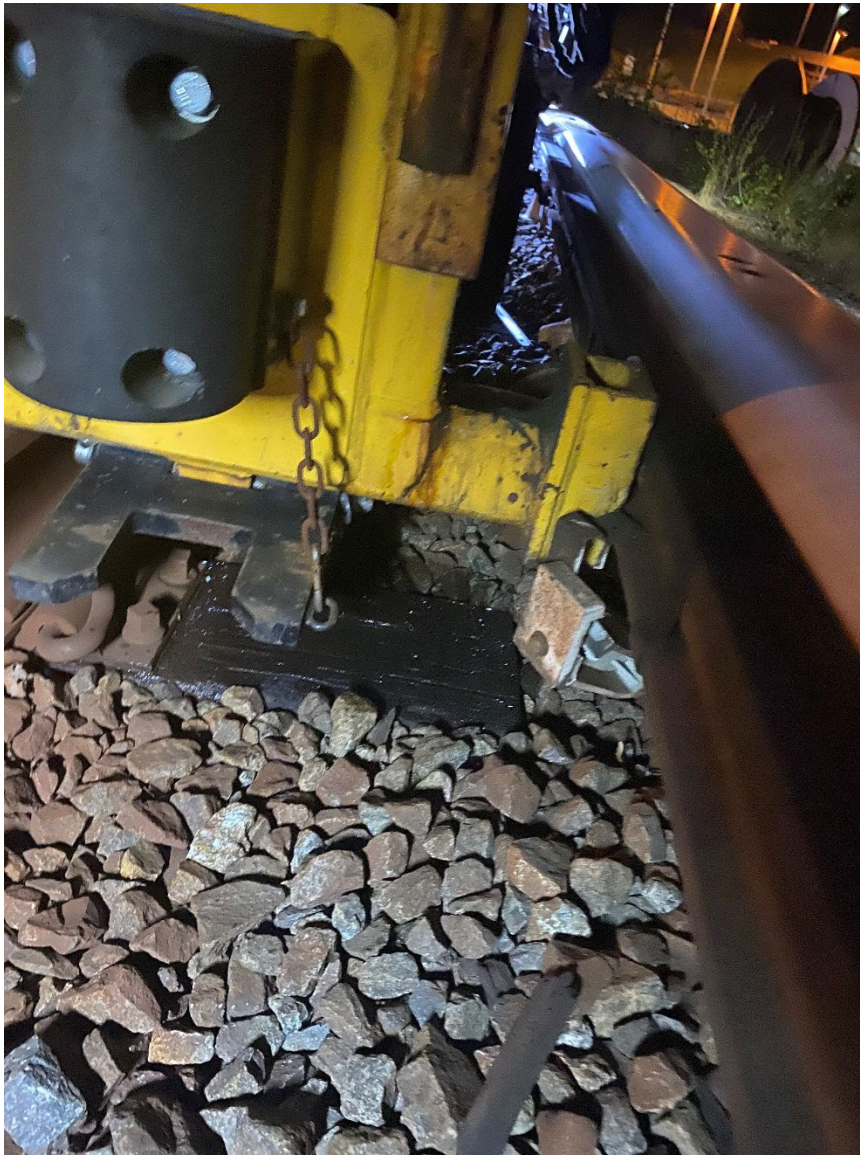
*Figure 22 - TR-05 contact with the third rail and broken Insulator*

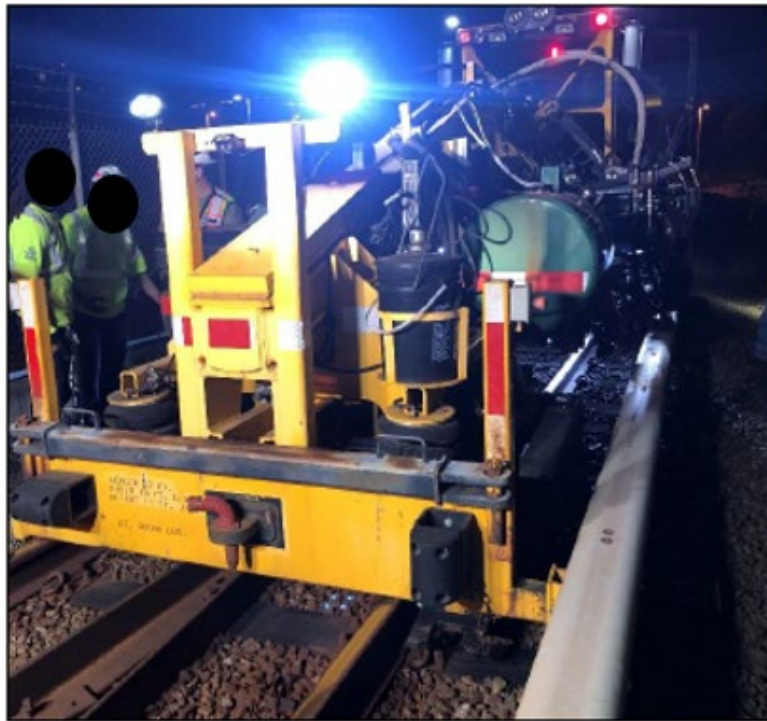
At approximately 0121 hours on the morning of April 16, 2024, TR05 was traveling, in the forward direction, outbound on Track 2, toward National Airport (C10). Near chain marker C2 354+00, the front axle derailed to the left side (Figure 3). Third rail power was down at the time of the incident. Damage to the third rail was reported without arcing. Coincidental damage to TR05 was not noted.

Figure 3. TR05 Derailed Front View

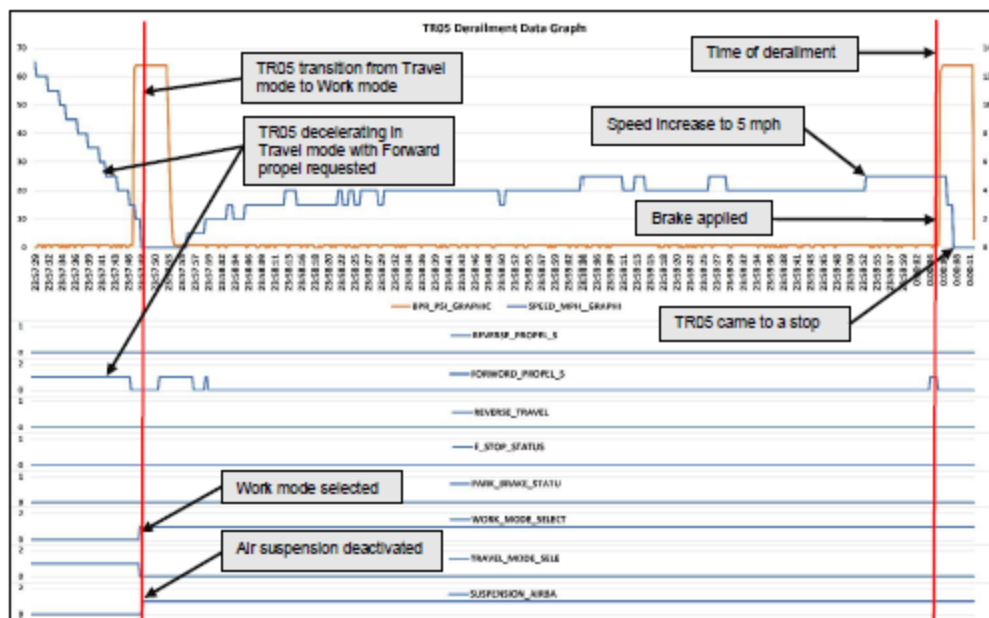
Analysis from the data recorder reveals that TR05 encountered difficulty ascending an incline in Travel mode approximately two minutes prior to the derailment. After failing to maintain speed, TR05 was placed in Work mode. Forward travel resumed in Work mode for approximately 725 feet before derailling.

Figure 4. TR05 Derailment Incident Data Graph

Leading up to this incident, TR05 was unable to negotiate the incline coming out of the Crystal City station in Travel mode. The 4% incline combined with an 800 foot radius required more tractive effort than was available. Although the operator was requesting full power to the wheels, TR05 decelerated. Switching to Work mode allowed TR05 to continue travelling up the incline. The difference between Travel mode and Work mode is limited to the suspension, with propulsion remaining unaffected. Vehicle Program Services, Rail Fleet has not, at this point, been able to define track conditions, either singularly or sum-total, that will result in a derailment nor the reason why additional tractive effort is available in Work mode.
