Collisions

At or Near Minnesota Ave Station,

March 19, 2024, and March 22, 2024

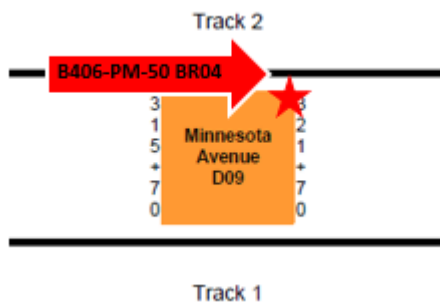
Field Sketch/Schematics

Damage to ETS Box D-92 and Post, Cables, Staircase Railing, and Fence were identified. TRST determined that there was no damage to the track.

The probable cause of the Collision event that occurred on March 19, 2024, at Minnesota Avenue Station was due to the ETS Box and Post which was previously damaged and encroaching on the roadway.

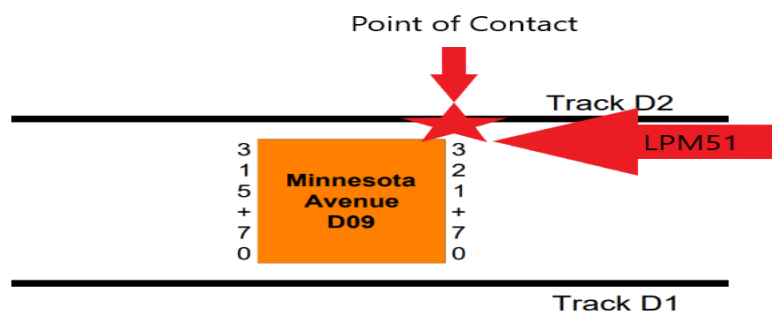
Field Sketch/Schematics

Damage to the staircase railing and the step bracket on F617 were identified. TRST determined that there was no damage to the track.

The probable cause of the Collision event that occurred on March 22, 2024, at Minnesota Avenue Station was due to the improper measurement of the replacement wooden staircase railing which was too wide and encroached on the roadway.

Facilities Maintenance personnel removed the wooden staircase railing and replaced it with a temporary fence netting.

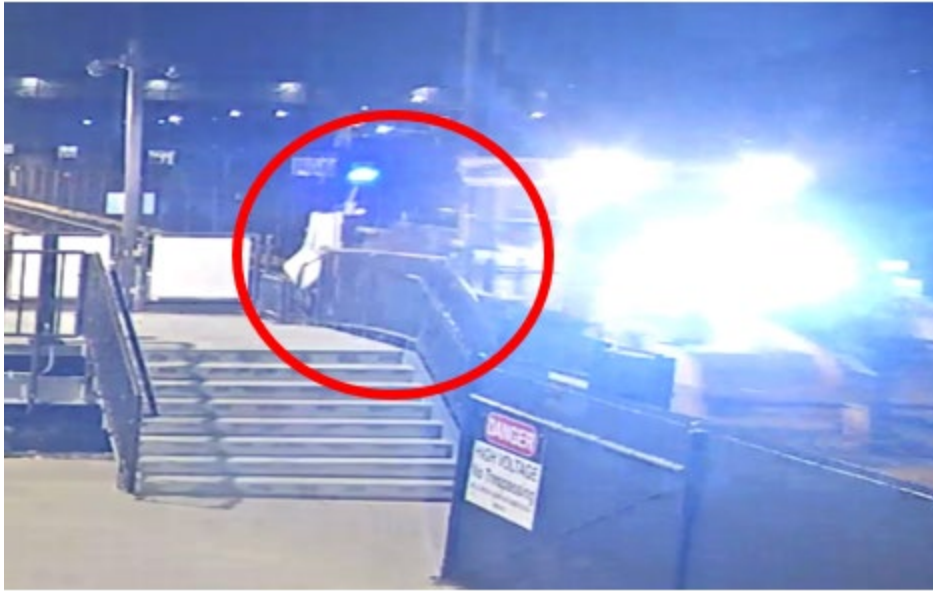
At 01:31 hours, the convoy was traveling outbound on track 2, when BR-04 struck a ETS Box structure at Minnesota Avenue Station causing the pole to lean towards the roadway. The Equipment Operator of BR-04 was unaware of the collision and did not report it to the MICC.

Image 1 – Image of BR-04 colliding with the ETS Box and Post at Minnesota Avenue Station.

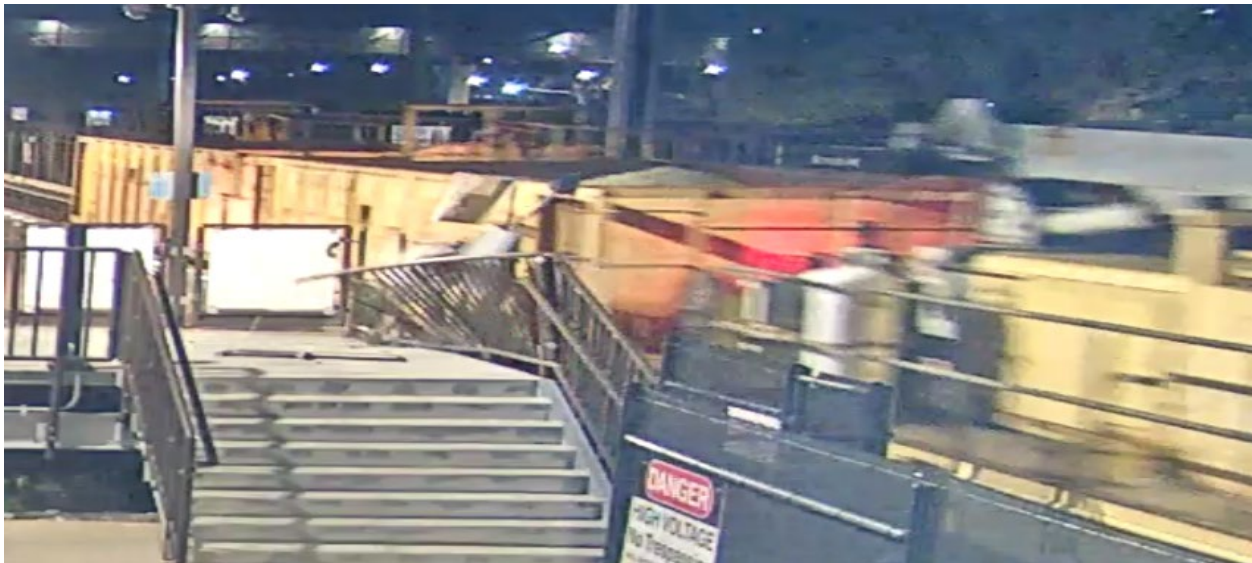
At 01:36 hours, PM-50 with B406 attached traversed the same area and caused additional damage when B406 collided with the ETS Box and pole, dislodging the equipment and causing damage to the fence and handrail at the end of the platform.

Image 2 – Image of B406 colliding with the ETS Box at Minnesota Avenue Station.

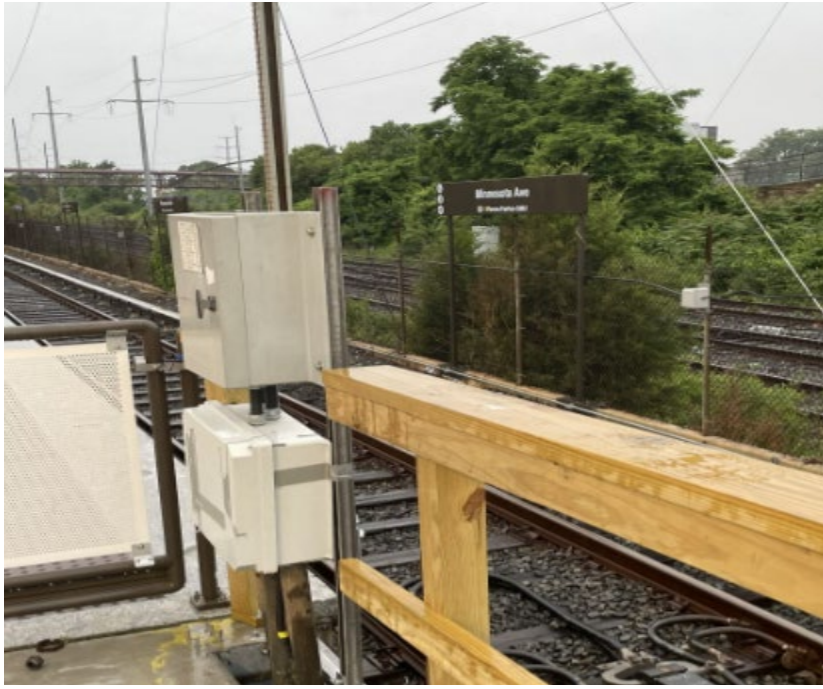
Image 3 – Image 1 of the new ETS Box and temporary wooden railing.

Power personnel performed an assessment and assisted with making repairs. TRST personnel performed a track gauge measurement and removed debris from the wayside. Facilities Maintenance personnel replaced the staircase railing with a wooden handrail. COMM IT began to repair and replace the ETS Box and Post.

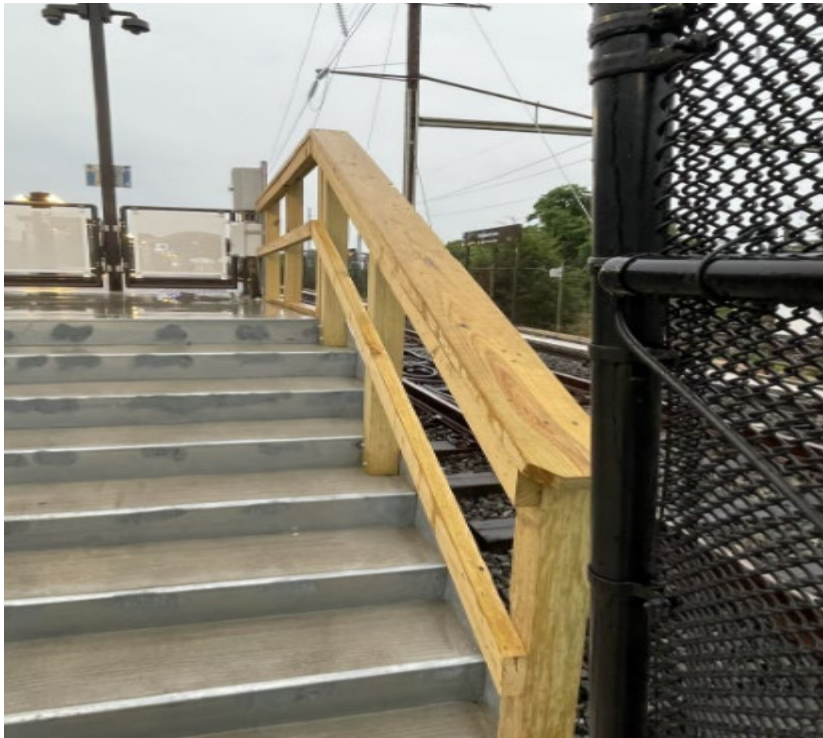
Image 4 - Image 2 of the new ETS Box and temporary wooden railing.

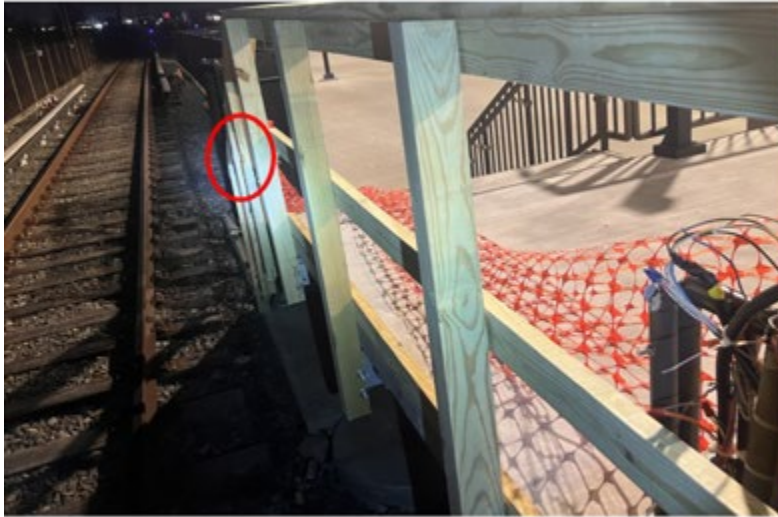
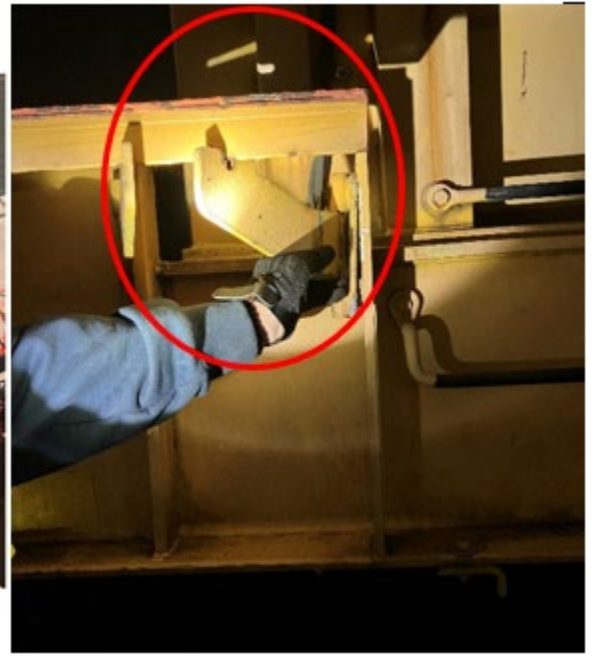
Image 5 – Images of damage to the wooden staircase railing and step bracket on F617.

Damage to the staircase railing and the step bracket on F617 were identified. ERT determined that there was no damage to the track.

Facilities Maintenance personnel removed the wooden staircase and replaced it with a temporary fence netting.

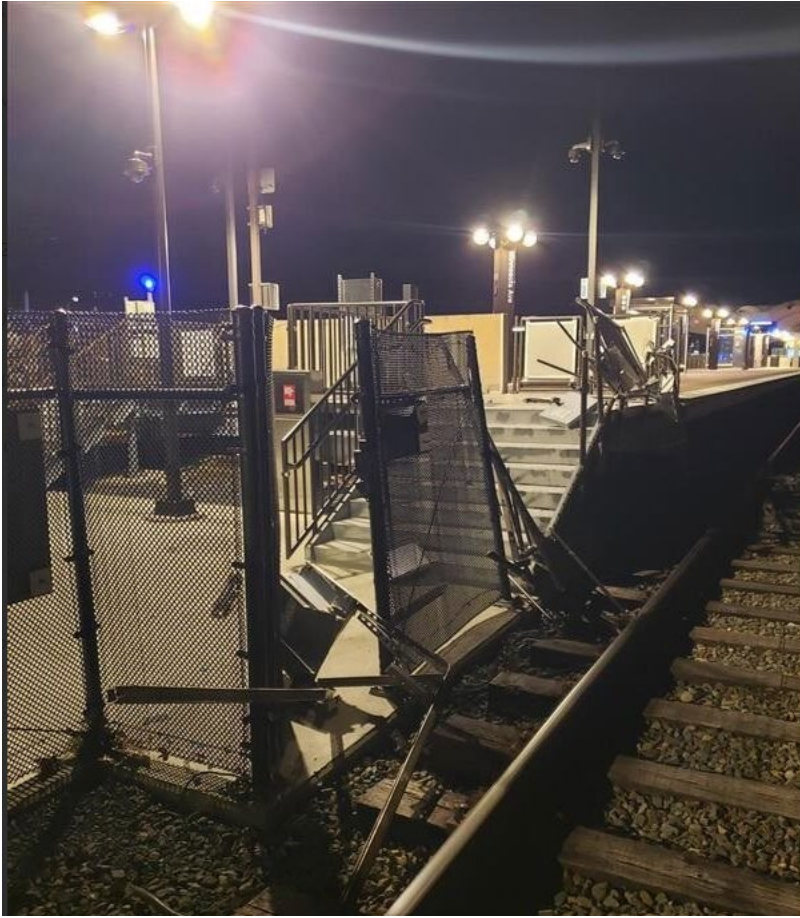
Image 6: Shows damage to the ETS Box and handrail.

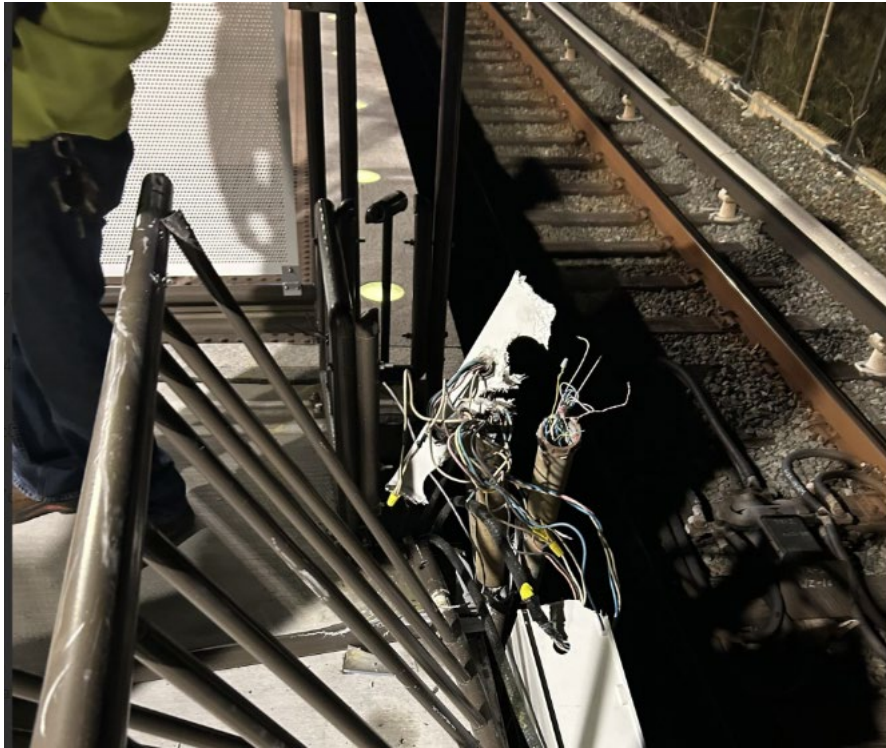
Image 7: Depicts the location of the ETS Box and shows damage to the handrail.

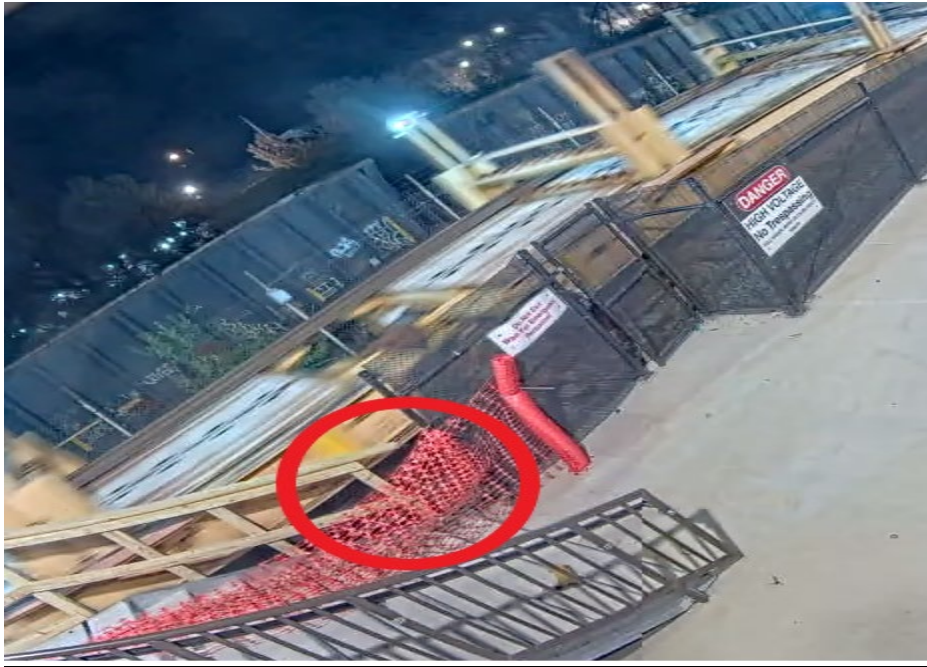
Image 8: Shows the point of impact.

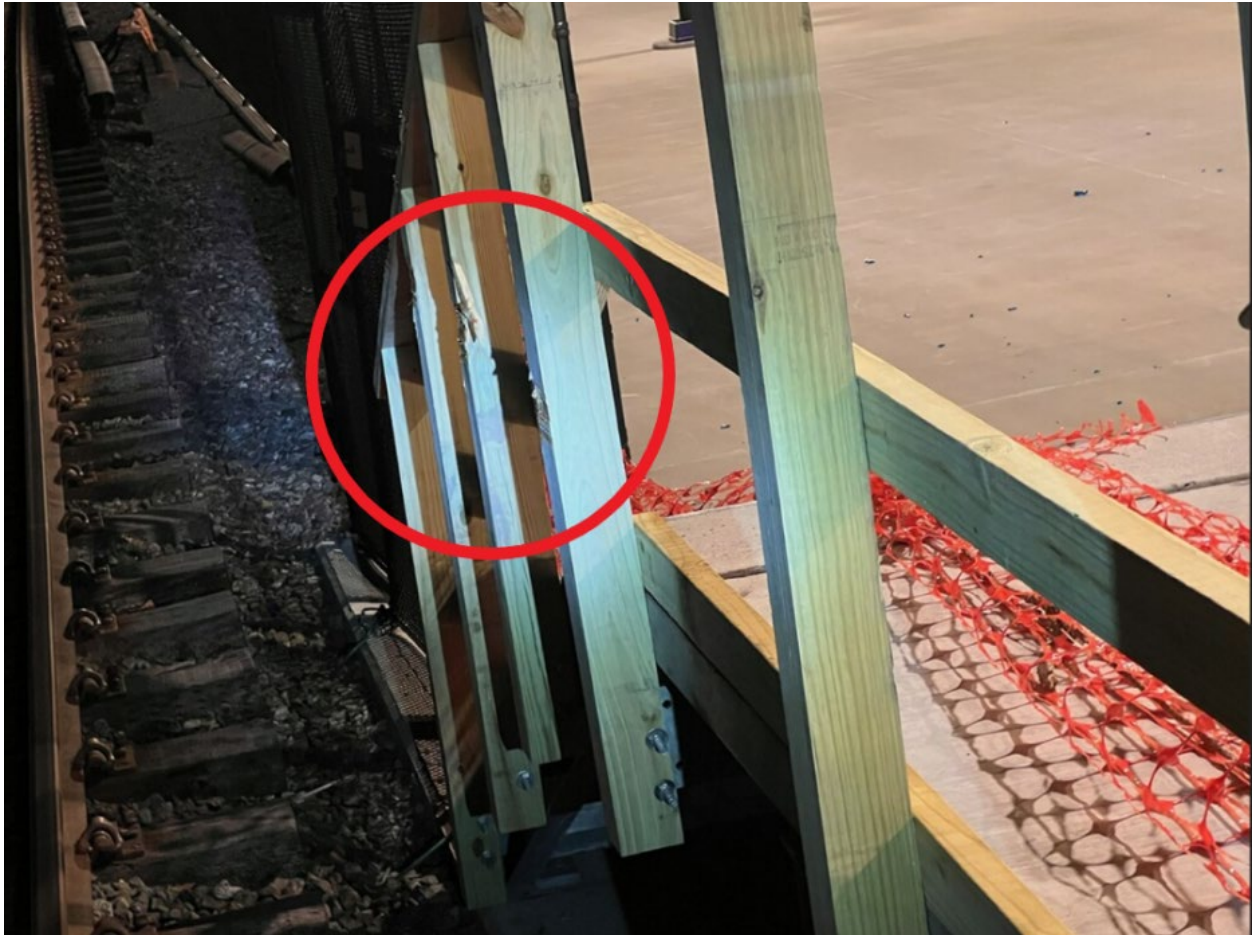
Image 9: Depicts the point of contact.

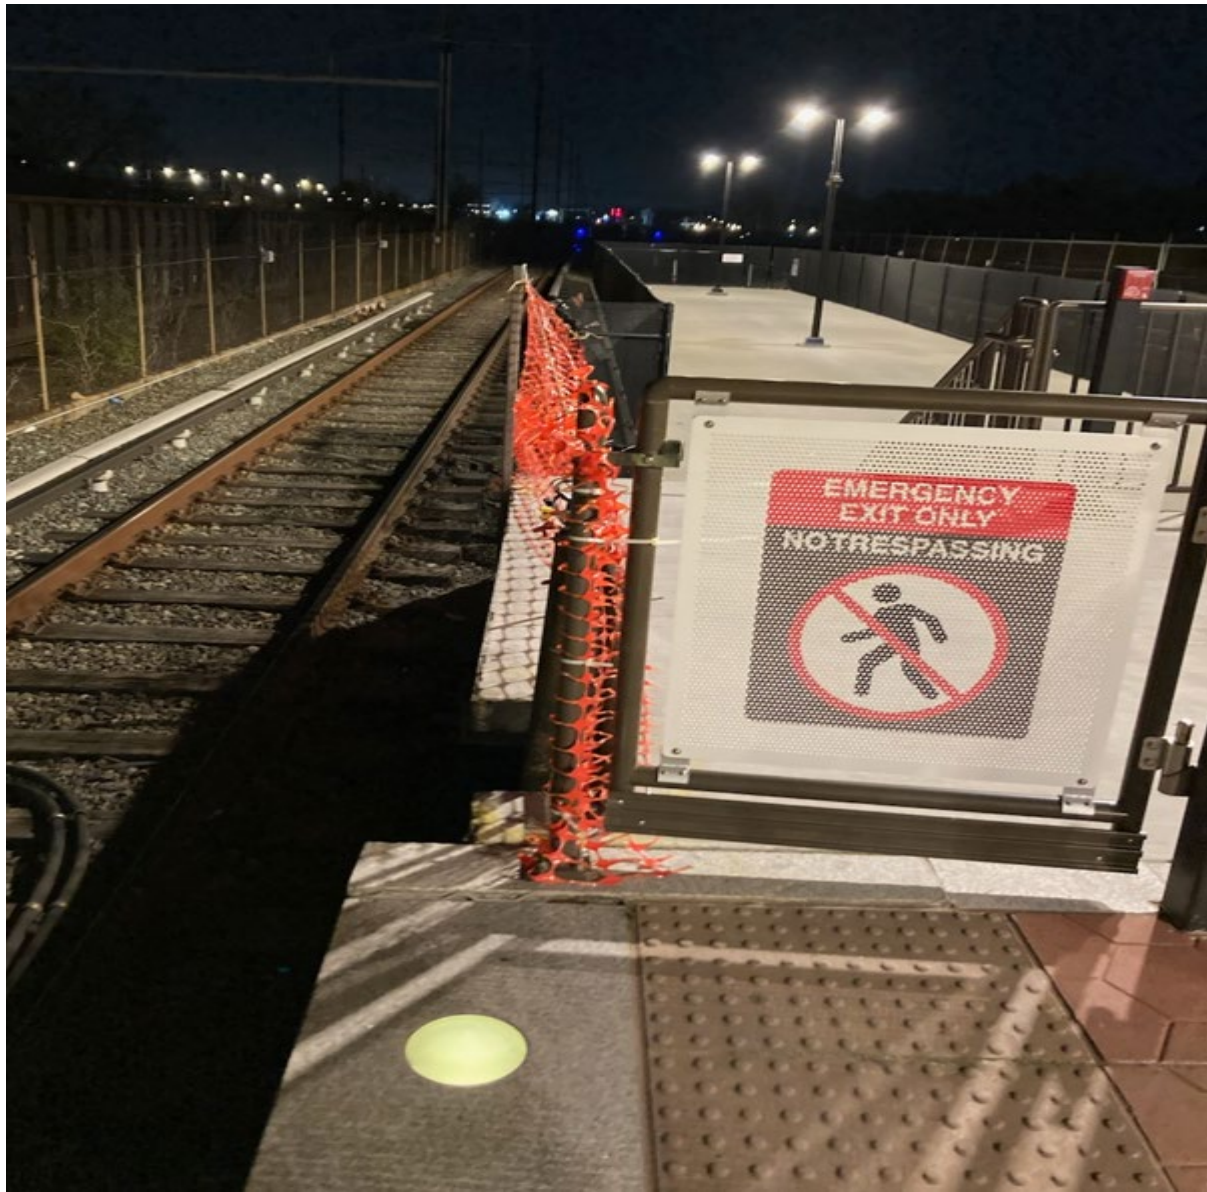
Image 10: Shows the orange temporary fencing.

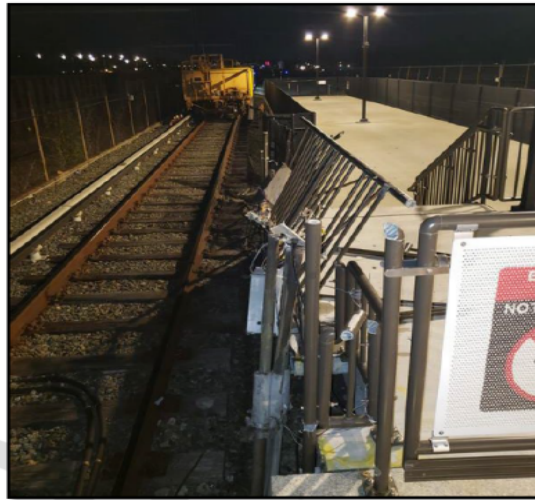
At approximately 0130 hours on the morning of March 19, 2024, ballast regulator, BR04 contacted the pole supporting the ETS box at the east end of the Minnesota Avenue Station (D09) Track 2 platform while traveling outbound to New Carrollton Rail Yard (D99). The contact caused the box to lean into the dynamic envelope. Five minutes later, ballast car, B406, being pulled by PM50 struck the ETS box causing additional damage to the hand railing and protective fencing in the Area of Safe Dispersal (ASD) (Figure 1). No injury to personnel was reported. Superficial damage was noted to both BR04 and B409.

Figure 1. Station Damage

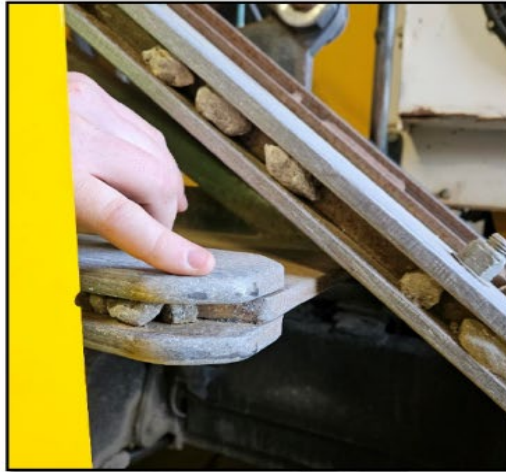
Figure 2. BR04 Contact area

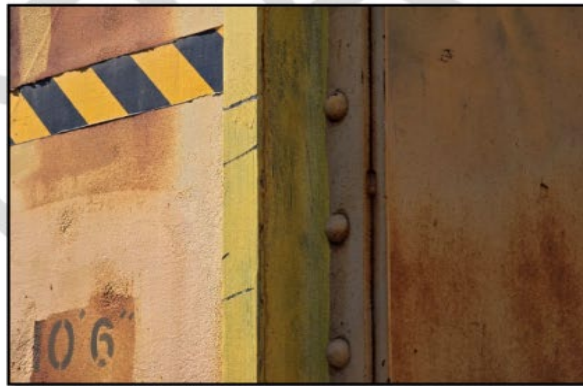
B406 was inspected and found to have recent strike marks consistent with contacting wayside equipment (Figure 3).

Figure 3. B406 Contact area

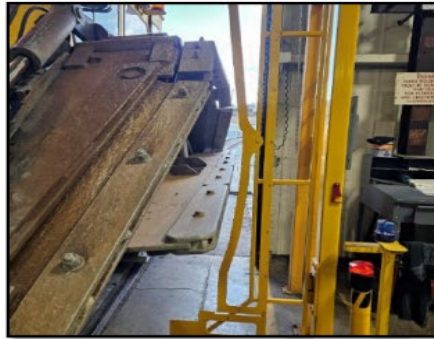
After visual inspection, BR04 successfully cleared the dynamic envelope template at the New Carrollton Yard with right and left wing stowed and locked (Figure 4). B406 passed a clearance test December 15, 2021.

Figure 4. Left Side Clearance

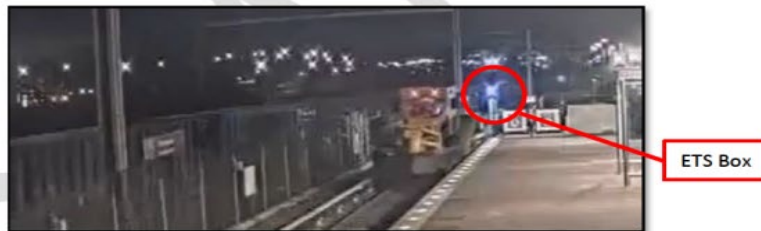
Review of video recording from the Minnesota Avenue platform (MINA 03-19-2024 0131-0137 hrs_C-D09-PN-062_Tuesday March 19 202465351 9aa1a51) shows BR04 contacting the ETS support. After coming to rest, the ETS box is leaning further into the revenue envelope (Figure 5 and Figure 6).

Figure 5. Pre-contact

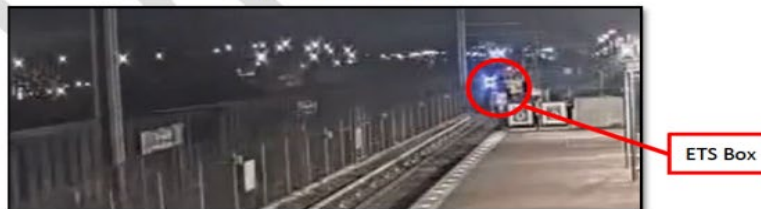
Figure 6. Post-contact

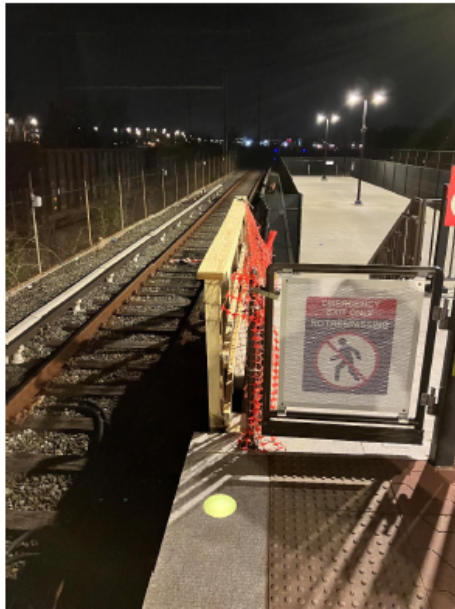
Picture 1: Picture taken on 3/20/2024

Due to the urgency of the situation, a supervisor from the Carpenters Office was dispatched to the site to assess the damage and provide a temporary mitigation plan. The supervisor recommended reinstalling the handrail using the existing mounting brackets. To ensure it remained outside the dynamic envelope, the platform's granite edge was used as a visual reference point. As shown in Picture 1, the repaired handrail was installed approximately three inches inside the granite edge to allow clearance for the top rail. The supervisor who overseen the initial repair is no longer with the authority.

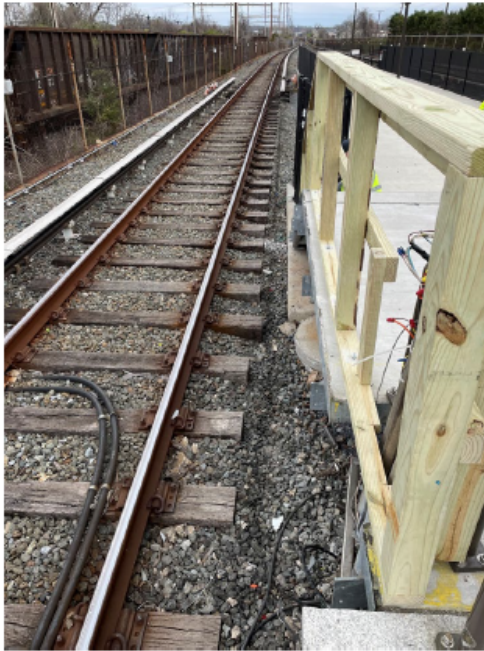
Picture 2: Picture taken on 3/22/2024

However, on March 22, 2024, another Roadway Maintenance Machine made contact with the replaced handrail. A superintendent was then sent to reassess the site. This time, the handrail was relocated further back—from outside the step tread to inside the step tread—to ensure sufficient clearance from the dynamic envelope (Picture 2).
