WMSC Inspection Report 20251017B

Title: Roadway Worker Protection Overnight Inspection

Location: Suitland Ave (F10)

Date of Inspection: 10/16/2025

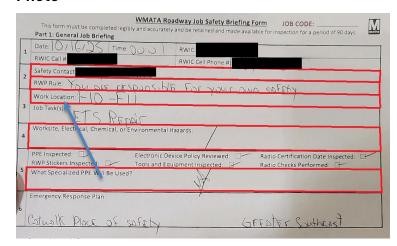
The information technology work crew's job safety briefing should have included chain markers for the applicable work zone.

Photo 5: no chain markers are noted in work location.

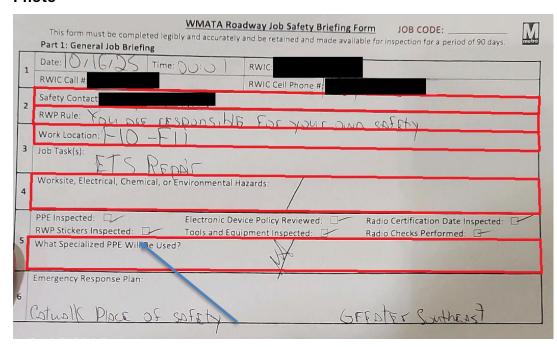
For the information technology briefing, WMSC noted several missing hazards from the briefing. Two examples, working during the nighttime hours and the third rail being present.

Photo 6: No worksite hazards were listed on the briefing.

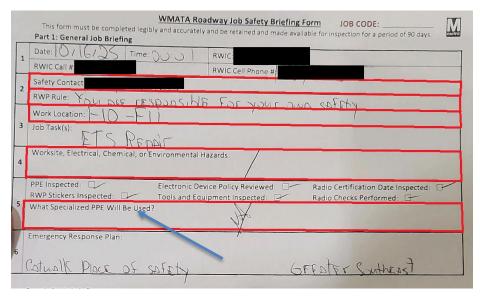
The information technology work crew required the use of hot sticks as well as warning strobe and alarm devices (WSADs) in this work zone and should have been noted in the briefing.

Hazard: 1B

Photo 7: blank field reserved for specialized personal protective equipment (PPE).

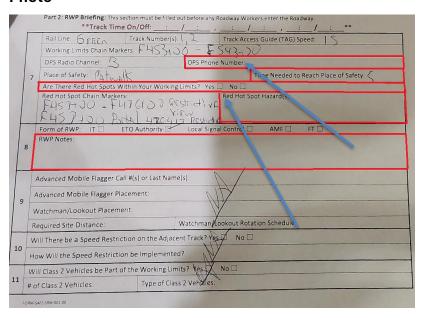
Section 7 of the information technology work crew's job safety briefing is missing an OPS phone number. Time to reach a place of safety is missing a unit of time. Red hot spots were present but missing an indication on the form despite being identified in the next box. The individual hazards of each hot spot are not present in the appropriate box.

Photo 8: Missing, wrong, or blank items on section 7 of the job safety briefing.

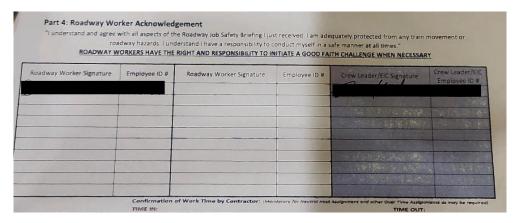
The RWIC of the information technology work crew informed WMSC Inspectors that he had two other workers setting up the work zone with one being at Branch Ave (F11) and the other being on site with the RWIC at Suitland (F10). It was at this point in the briefing that WMSC and Metrorail inspectors noted that the workers currently on the roadway setting up the work zone had not signed the briefing before fouling the track. They were immediately instructed to clear the area.

Hazard Rating: 1B

Photo 12: missing signatures from the job safety briefing.

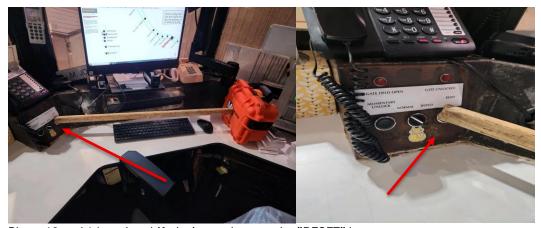
During the observation inspectors noticed that the station manager was using a make-shift device to depress the "RESET" button on the emergency swing gate's control while away from the kiosk which disabled the crash bar release and rendered the gate unable to release workers or patrons in the event of an emergency. Once this issue was raised to the Metrorail safety inspector on site the defect was immediately mitigated.

Hazard: 1B

Photo 13 and 14: make-shift device to depress the "RESET" button
