## WMSC Inspection Report 20251016A

Title: Roadway Worker Protection Overnight Inspection

Location: Brentwood Yard (B99)

Date of Inspection: 10/16/2025

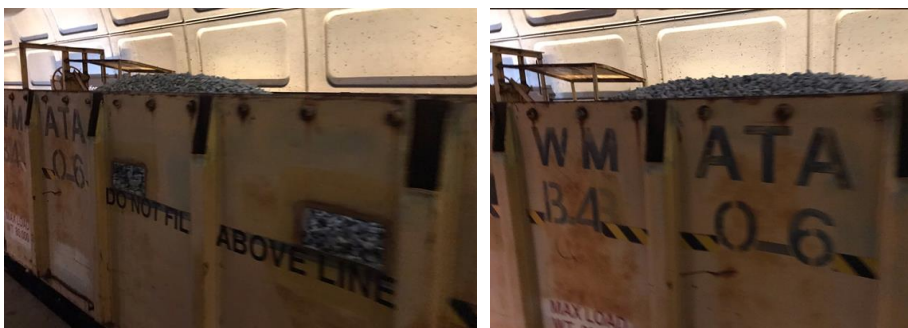
The ballast carrying vehicle was filled with ballast beyond the limit indicated on the vehicle as the maximum level the car should be filled with ballast posing a movement hazard as well as falling ballast during transport causing injury to roadway workers.

### Hazard Rating: 1B

Photo 1 and 2: Overfull ballast car.

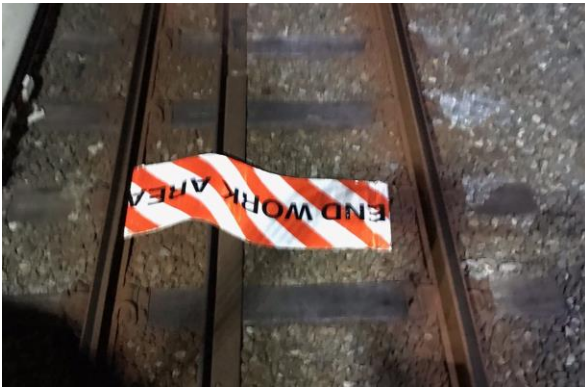
Inbound on track 2 near Union Station (B03) the second piggybacking work crew did not install all safety equipment in the work zone. Specifically, lights and shunts were not set in the correct location. Additionally, members of the work crew were not wearing safety glasses which are required as personal protective equipment per MOR 18.7.1 Table 13.

Metrorail Operating Rulebook 17.21.9

Joint Occupancy/Piggyback Work Area workers and equipment must not proceed beyond the "END OF WORK AREA" reflective mats without permission from the RWIC, nor shall an Employee-In-Charge extend their work area without the consent of the RWIC.

### **Hazard: 1B**

Photo 3: End work area mats installed in joint occupancy without lights.

This was mitigated onsite.

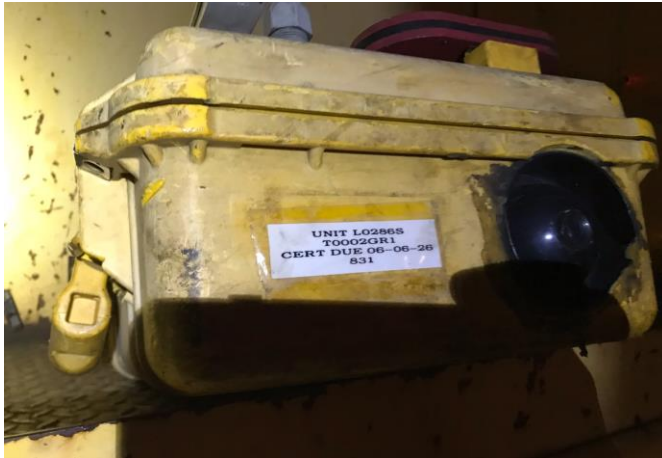
WMSC Inspectors observed a work crew between Union Station (B03) and NoMa-Gallaudet U (B35) that did not install the Warning Strobe and Alarm Device (WSAD).

Metrorail Operating Rulebook 19.4 (General Third Rail Power Outage Requirements)  
19.4.8

A Warning Strobe and Alarm Device (WSAD) must be installed on the sections of de-energized third rail within audible and visual range of personnel within those specific sections of third rail when work requiring a power outage is being performed.

### **Hazard Rating: 1B**

Photo 4: Uninstalled WSAD located on the associated prime mover.

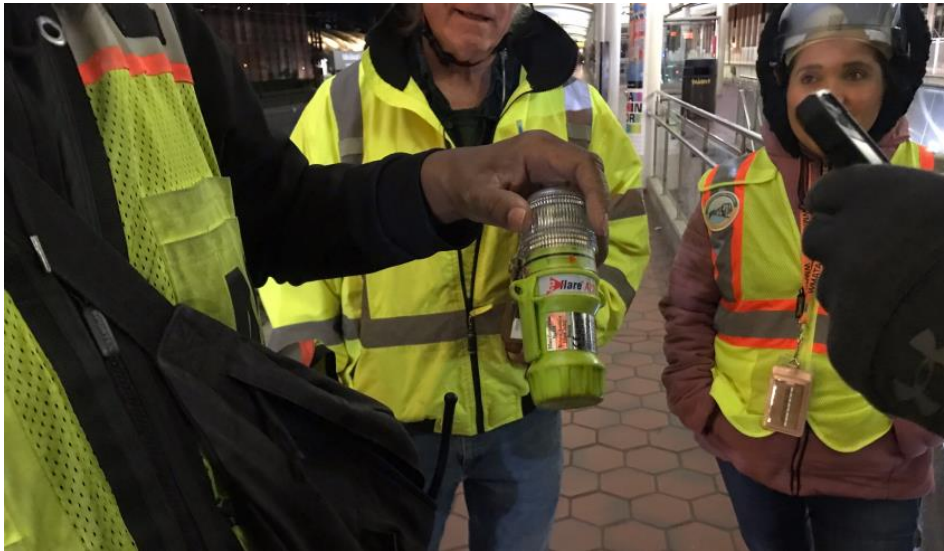
Moreover, the RWIC, working as the Watchman lookout, was not carrying an air horn, which is required PPE for all Watchman lookouts. This is outlined as a requirement in Metrorail's Quick Access Guide in the table on page 3. As a result, of these roadway worker protection

violations Metrorail's Safety Department, representatives of which were onsite with the WMSC Inspectors, issued a Safety Notification O-23: Improper RWP-NoMa-Gallaudet U at 3:55am October 16, 2025 (incident number: 2205759374924561). The RWIC and the Track Walker were taken out of service for post-incident testing.

### **Hazard Rating: 1B**

Photo 5: AMF Equipment Check

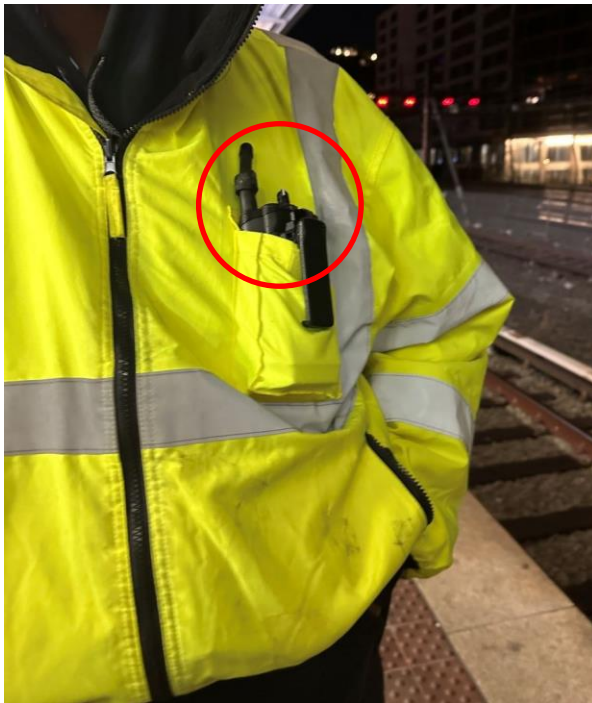
Improper radio antenna on WMATA radio. A radio is required equipment when on the roadway. The radio was installed with an aftermarket radio antenna, which is not permitted (see safety bulletin SB 25-06-F issued 5/30/2025). The senior safety specialist was not certain of a violation. WMSC emailed the Safety Bulletin the same afternoon.

Photo 6: Incompatible radio antennae.
