**W-0399 Collision at Benning Road Station – December 10, 2024****Document Purpose**

**FINAL REPORT OF INVESTIGATION A&I E24983**

# Benning Road Station – Collision

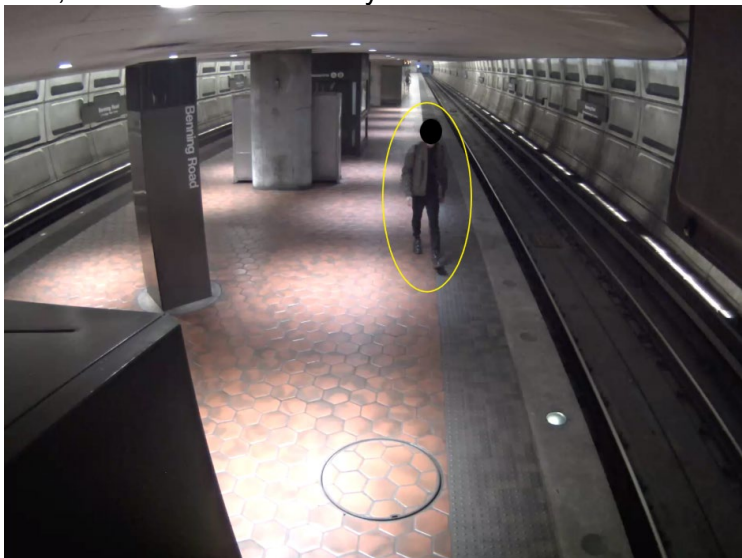
At 16:29 hours, the patron walked past the eastbound Track 2 end gate and walked down to the safety walk. The patron entered the roadway, crossed over the running rails, bent over, and reached towards the energized third rail. The patron then stood up, crossed back over the running rails, and stood on the safety Walk.

*Figure 1 - Depicts the patron walking towards the station end gate.*

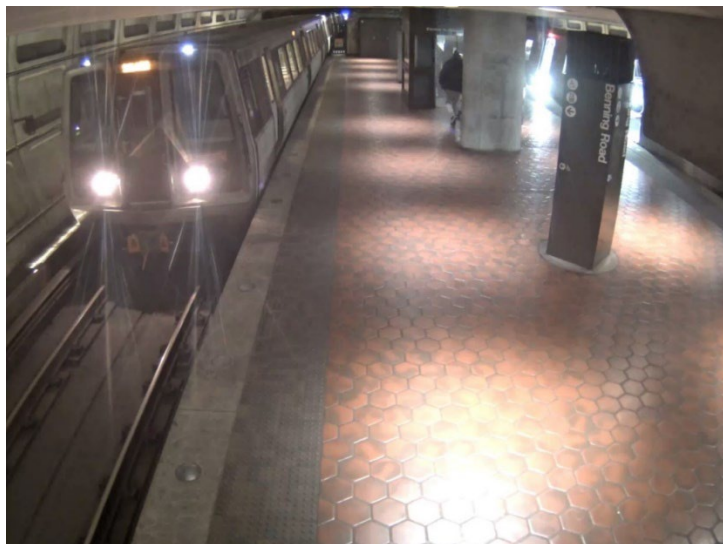
The train's vehicle monitoring system (VMS) data showed that the RVO cycled the Master Controller from a "B4-B5" Braking mode to "Emer" Braking Mode, initiating emergency braking and dumping the brake pipe. The train made contact with the patron and came to a complete stop approximately 80 feet from the point of impact, with one (1) complete car on the platform.

*Figure 2 - Depicts Train ID 732 at the point of final rest.*

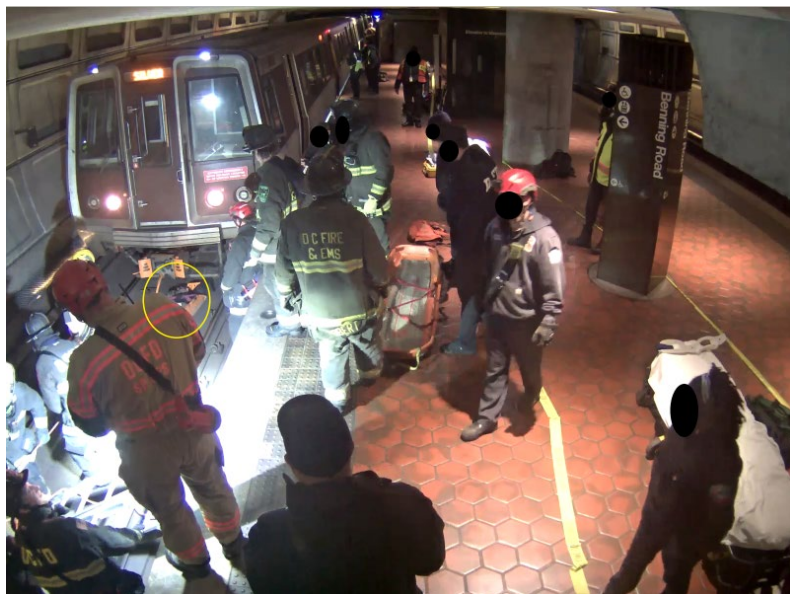
Figure 3 - Depicts the patron being extricated from beneath Train ID 632 (note ID was changed to 732 after the incident).

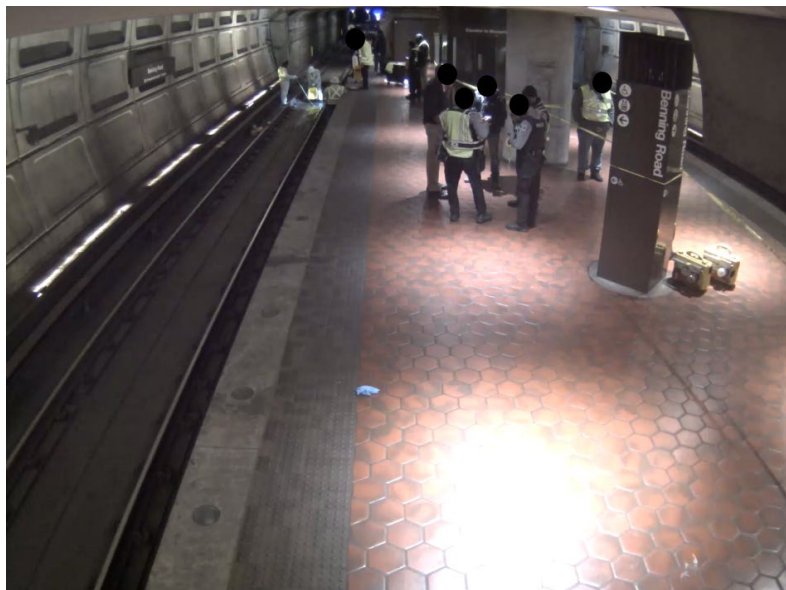
Figure 4 - Depicts ERT cleaning bodily fluid from the Benning Road Station, track 2 roadway.

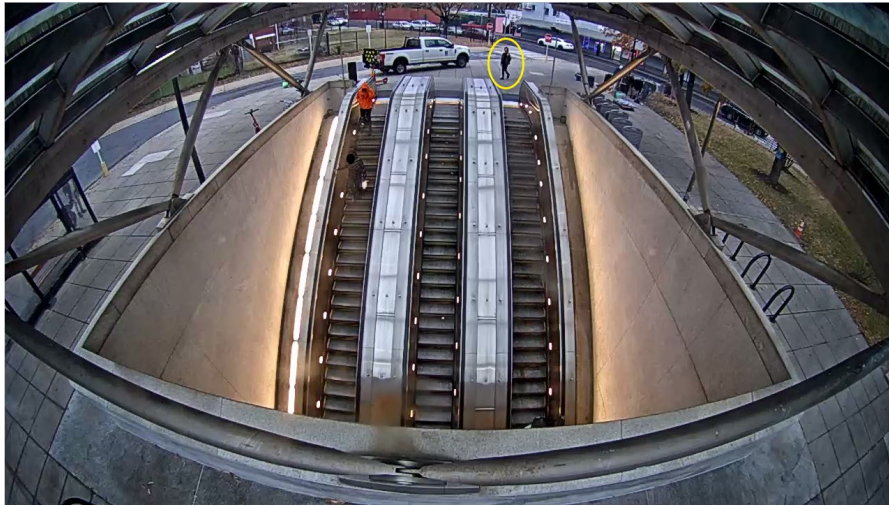
Figure 5 - Depicts the patron's arrival at Benning Road Station.

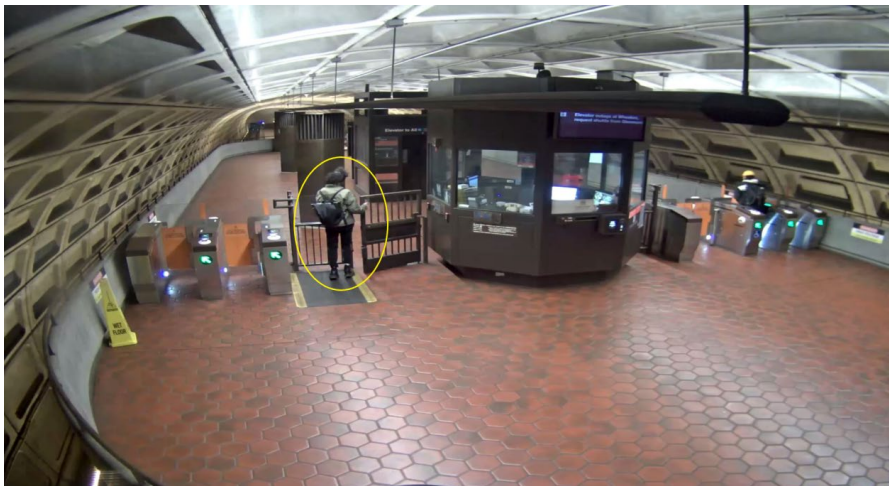
Figure 6 - Depicts the patron entering Benning Road Station through an unsecured Emergency Exit gate.

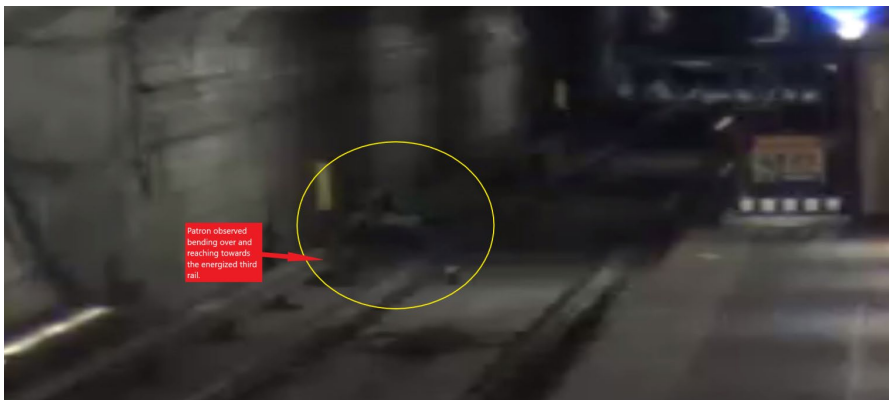
Figure 7 - Depicts the patron touching or attempting to touch the third rail.

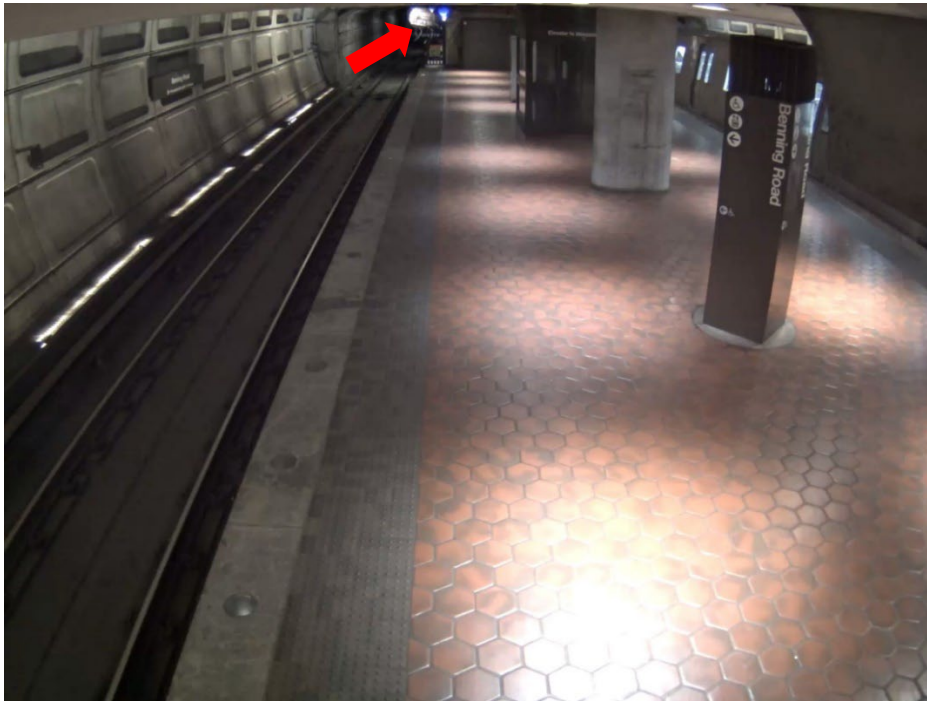
Figure 8 - Depicts Train ID 632 entering Benning Road Station, Track 2, traversing a curved section of rail.

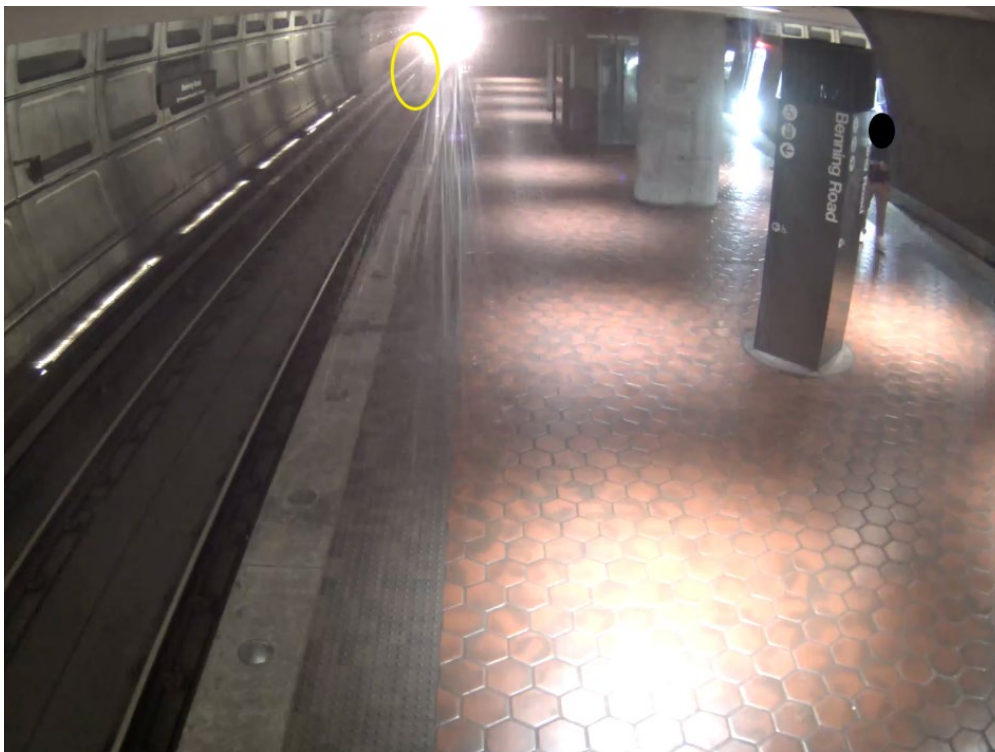
Figure 9 - Depicts the patron entered the roadway and intentionally stood in front of Train ID 632 as it entered Benning Road Station, Track 2.

The probable cause of the Collision event that occurred on December 10, 2024, at Benning Road Station, was the intentional action of the patron to trespass onto the rail right-of-way and was subsequently struck by Train ID 632.

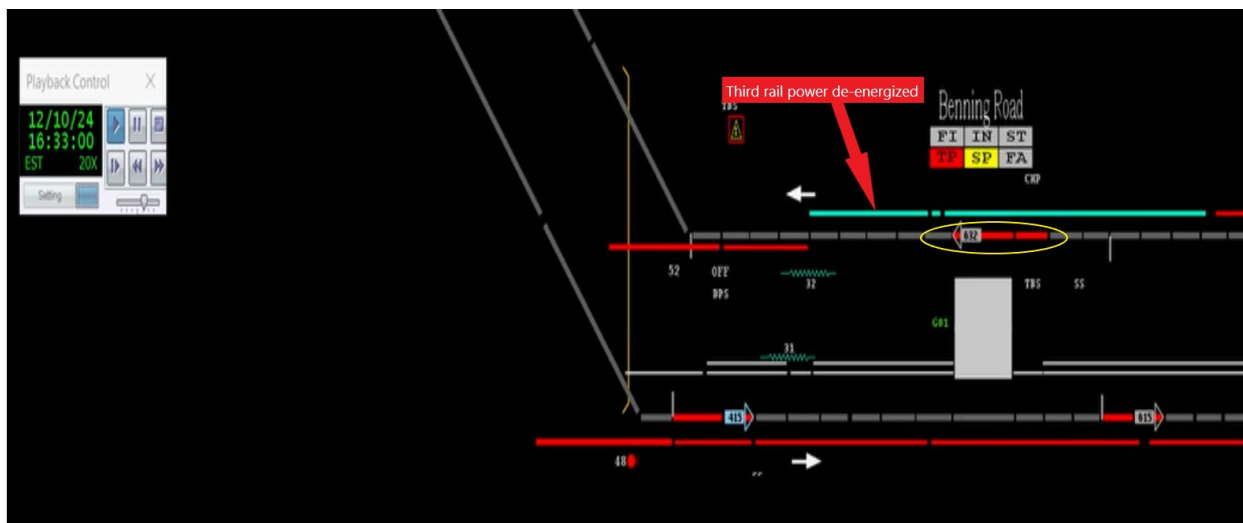
Figure 10 - Depicts Train ID 632 at Benning Road Station, Track 2, after the incident was reported and third rail power was de-energized.

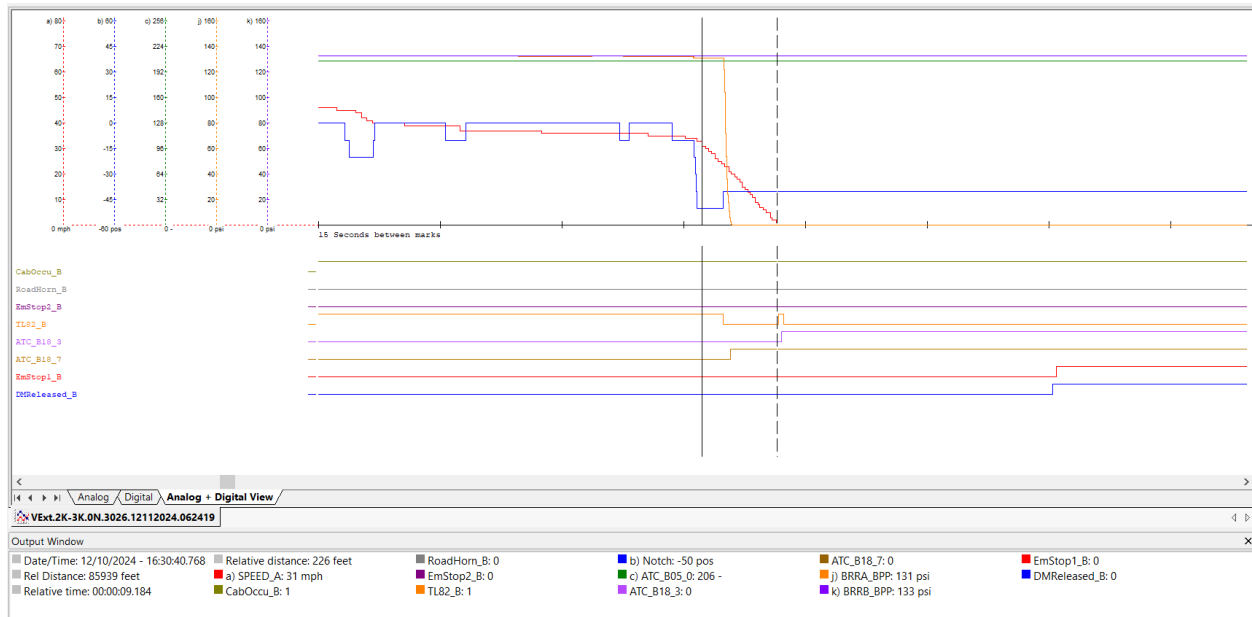
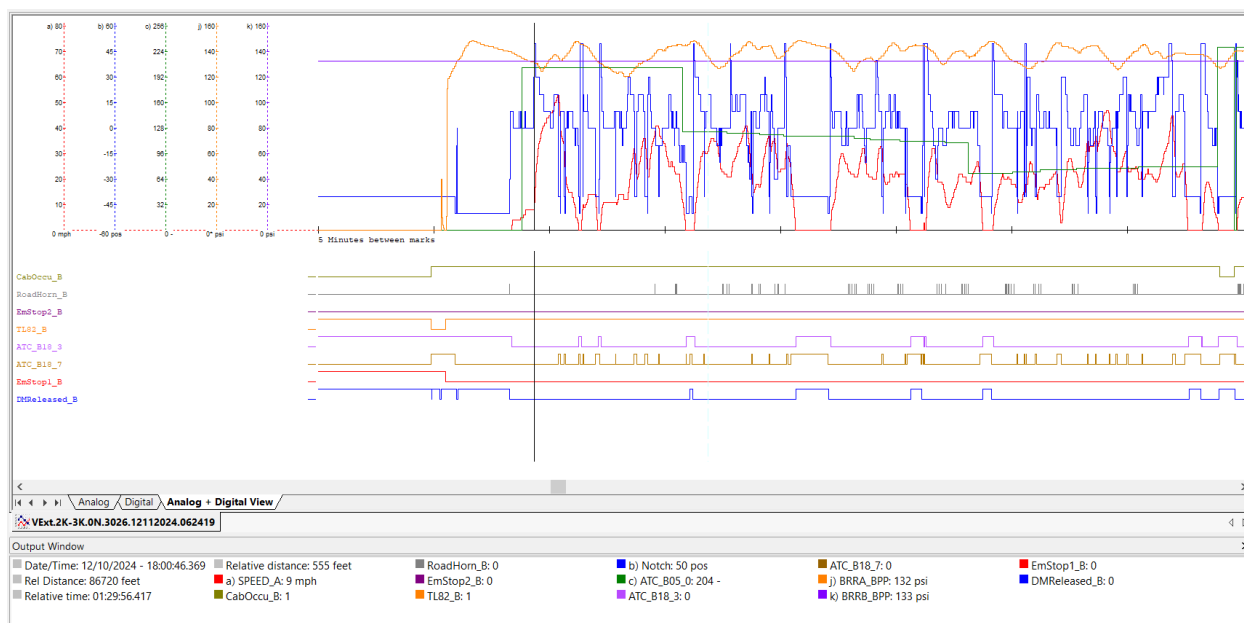
The calculated deceleration rate of the train is within the specifications. The train brake system responded appropriately.
