W-0400 Collision at Gallery Place Station - December 14, 2024

FINAL REPORT OF INVESTIGATION A&I 24995

Gallery Place Station – Collision

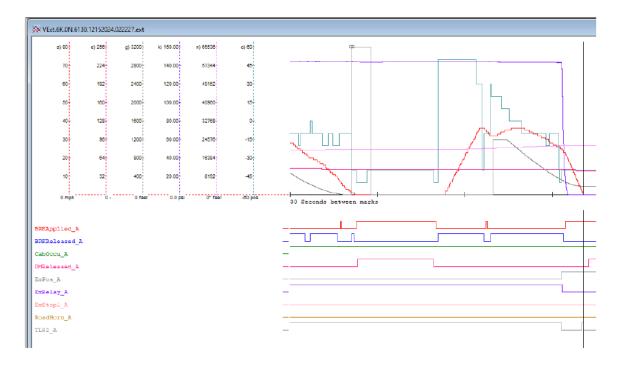
CENV has completed a review of the VMS data for the incident consist ID 140 Lead Car 6130 with the following results.

20:44:30 – Train 140 enters Gallery Place Station on Track 2 at 27mph with the Master Controller in B1 Brake position.

20:44:31 – Master Controller transitions to B4 Brake position at 25 mph. The train travels 75 feet when the Console Emergency Stop is activated. Brake Pipe Dumps, Emergency Relay denergizes, and TL 82 drops. Road Horn is not activated.

20:44:38 - Train reaches zero speed after traveling 127 feet.

The Train responded as designed.

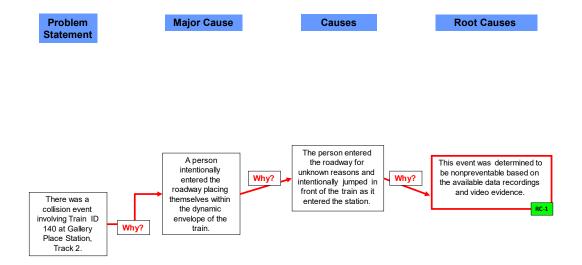
Appendix D - Why-Tree Analysis

The probable cause of the Collision event that occurred on December 14, 2024, at Gallery Place Station, was the intentional action of the person to trespass onto the rail right-of-way and was subsequently struck by Train ID 140.
