# WMSC Inspection Report 20250709

Title: Metro Operating Rulebook (MOR) Inspection

Location: Shady Grove Yard (A99)

Date of Inspection: 7/9/2025

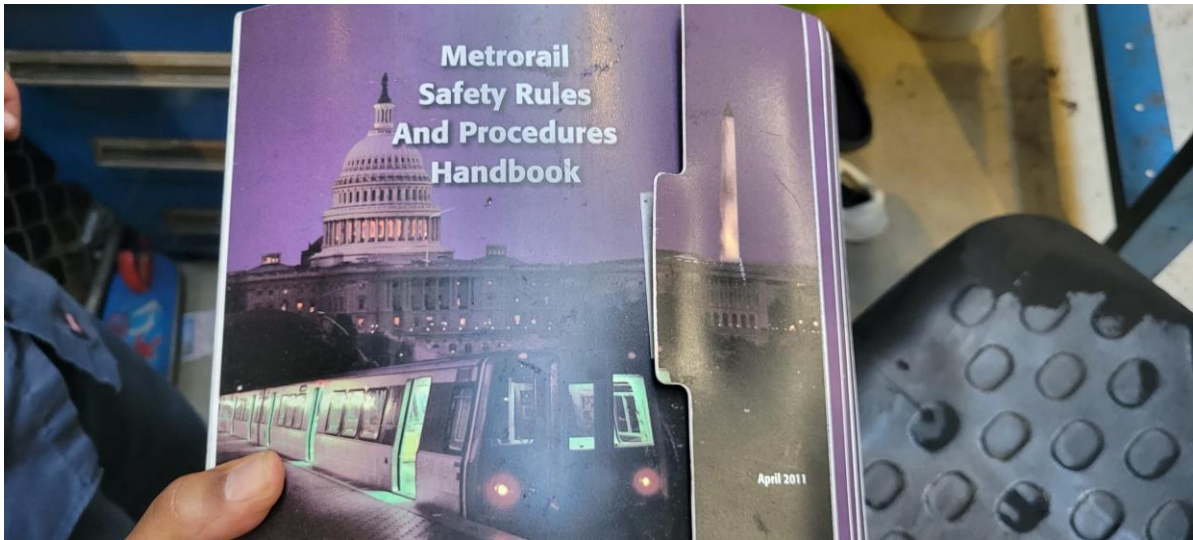
The inspector found a copy of an outdated Metrorail Safety Rules and Procedures Handbook (MSRPH) (dated April 2011) in the Shady Grove Service and Inspection (S&I) building. According to the current Metrorail Operating Rulebook (MOR) which states "This Metrorail Operation Rulebook supersedes and replaces all previous versions of the Metrorail Safety Rules and Procedures Handbook...", the MSRPH was to be removed from all work areas. This was remediated onsite by a member of the Department of Safety.

Photo 2. 2011 MSRPH.

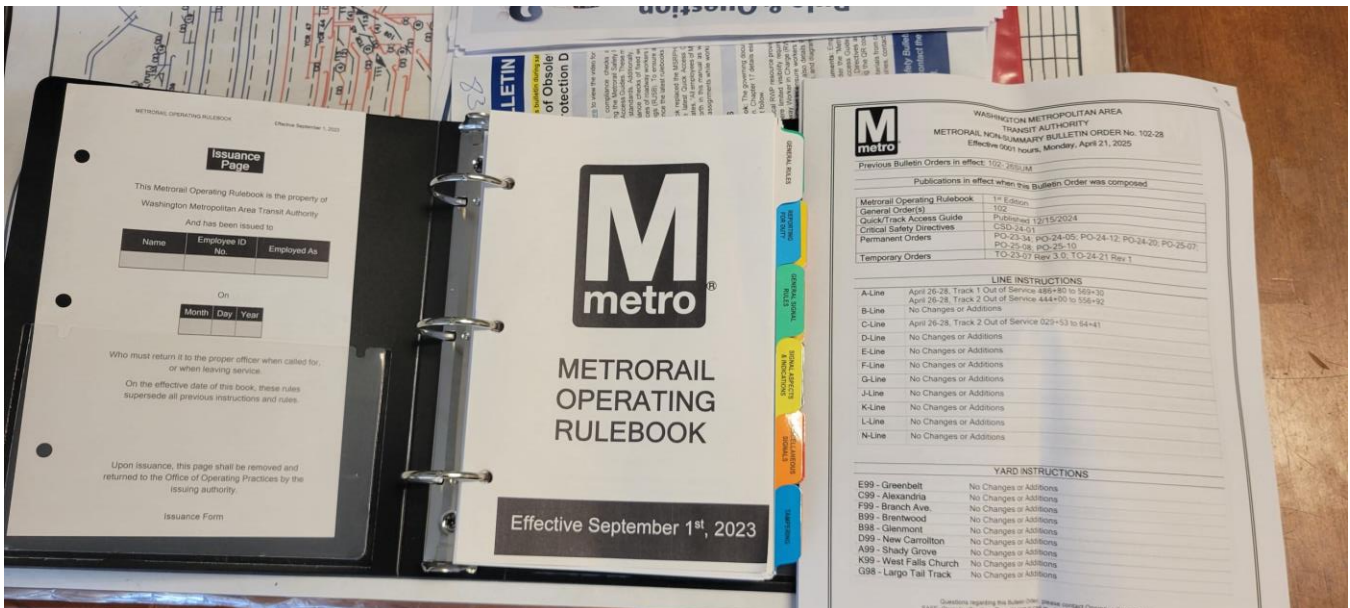
The WMSC Inspector identified that copies of the MORs were not fully up to date in the specified locations. That is, none of the MORs inspected at the three locations at Shady Grove Rail Yard (the tower, station terminal, and breakroom) were equipped with the latest bulletin and safety orders.

Photo 3. Outdated MOR from the tower.

After concluding the inspection, the WMSC Inspector conducted a debrief with onsite Metrorail Department of Safety personnel, in accordance with Program Standard Section 6.F.1. As a result of the debrief, the Department of Safety stated the Shady Grove Division management would be notified, and the Metrorail Operating Rulebooks at these locations would be updated with the bulletin and safety orders immediately.
