## WMSC Inspection Report 20251023A

Title: Roadway Worker Protection Overnight Inspection

Location: Wheaton Station (B10)

Date of Inspection: 10/23/2025

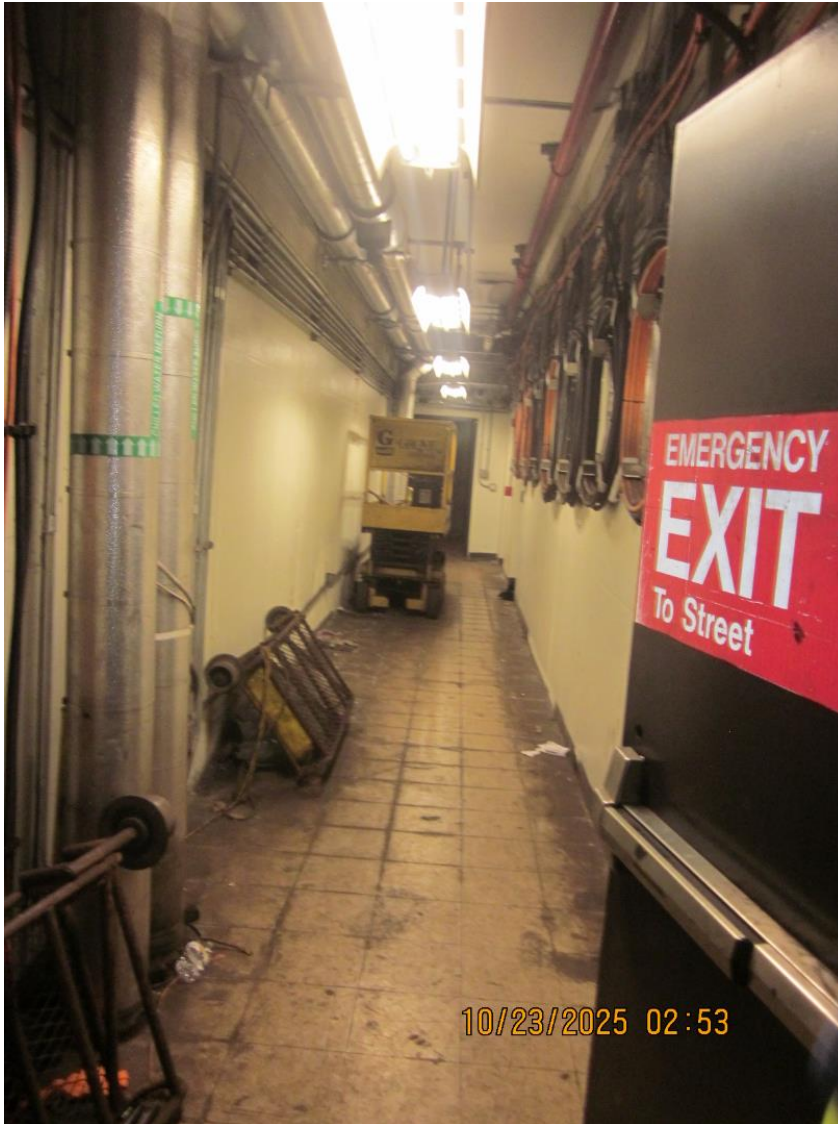
While inspecting communications room 108 and train control room 110, WMSC Inspectors passed through room 104, which is a hallway to the Mechanical, Comm, and ATC rooms. This hallway is partially blocked by equipment and some of the floor tiles are not secured and move. Room 104 (the hallway) is part of the emergency egress for the station platform and is not clear of obstacles in case of emergency.

**Hazard Rating: 1B**

Photo 1: Emergency egress room 104 (hallway) blocked by equipment broken fire exit door.

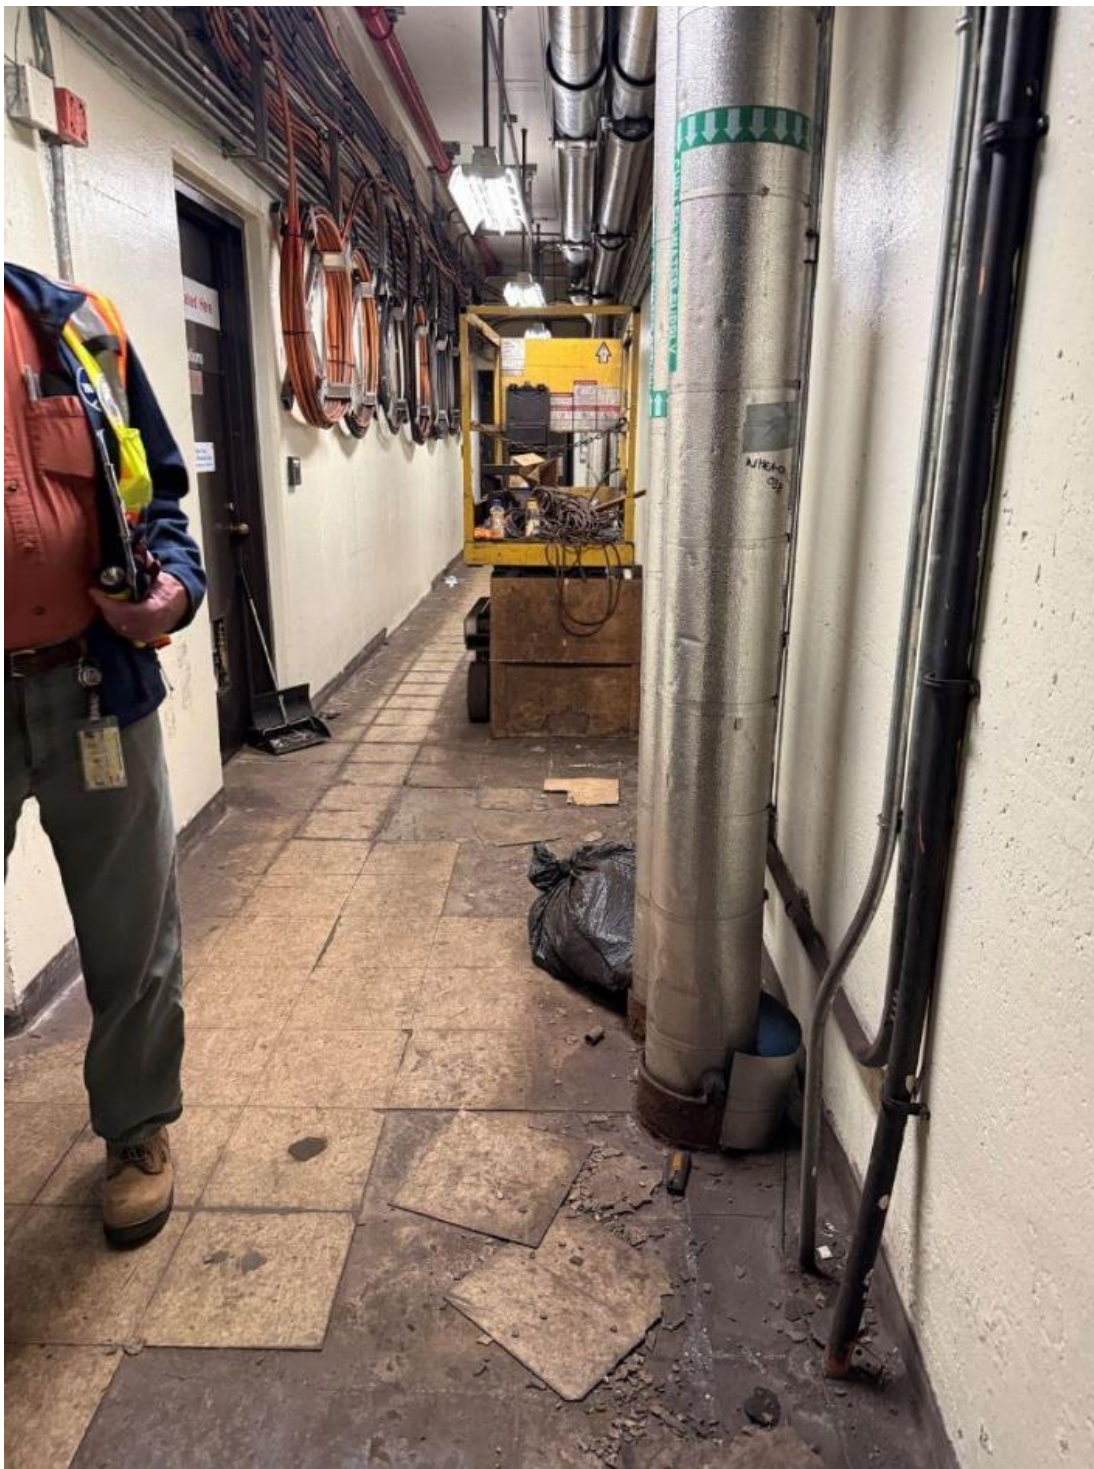
Photo 2: reverse angle of room 104.

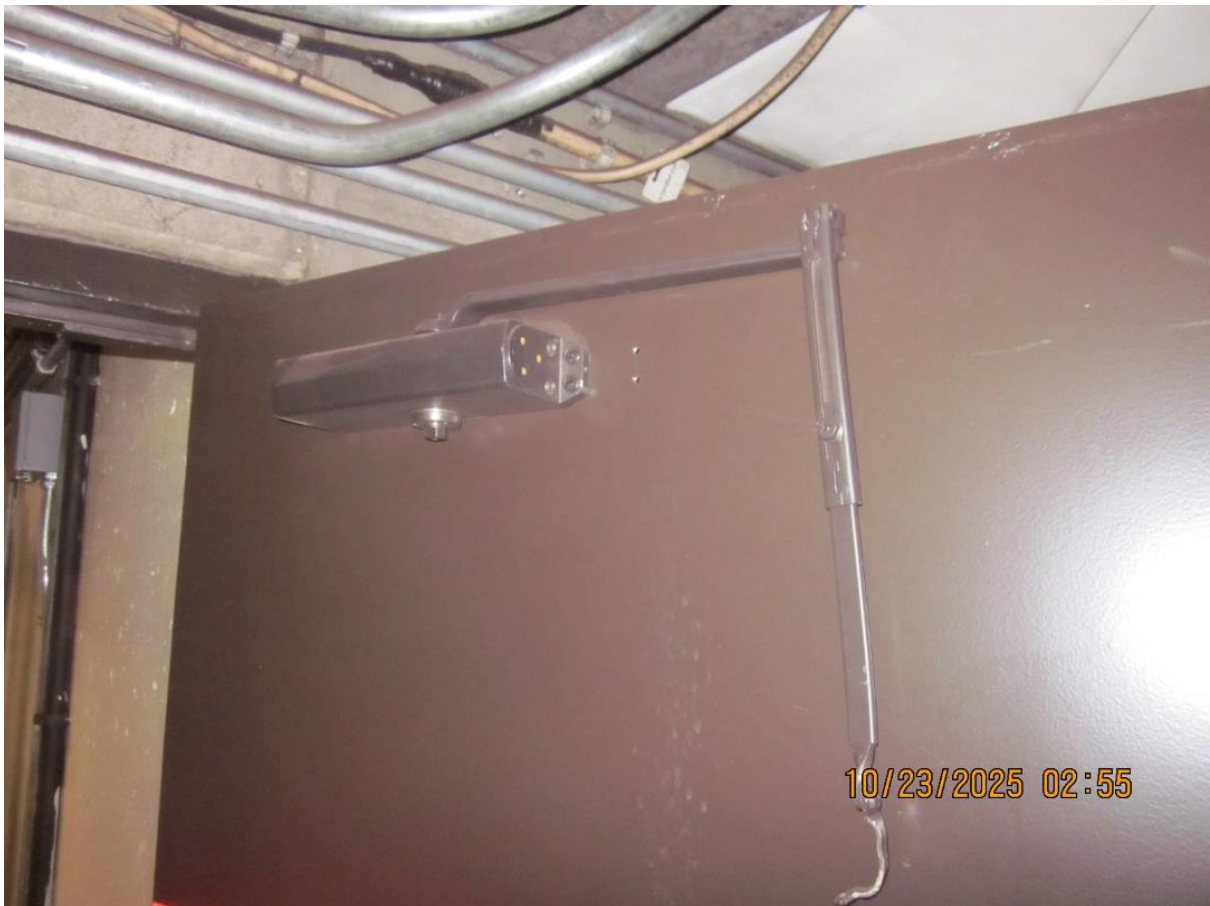
Also in room 104, WMSC Inspectors noted the west end fire door of the hallway was broken. The door would not shut in a closed position.

### **Hazard: 1B**

Photo 3: Broken fire door.
