# WMSC Inspection Report 20251023B

Title: Roadway Worker Protection Overnight Inspection

Location: Pentagon City Station (C08) to Crystal City Station (C09)

Date of Inspection: October 23, 2025

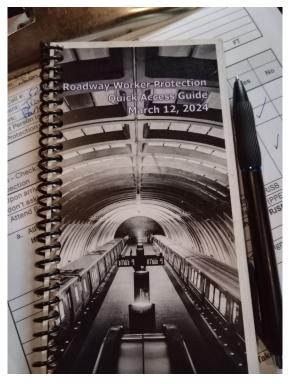
A Track and Structures crew conducting fastener renewal, between Pentagon City Station (C08) and Crystal City Station (C09) were relying on an expired RWP Quick Access Guide (see photo 1). The guide was dated March 12, 2024, when the current guide is dated December 15, 2024.

This guide provides safety information such as a listing of hot spot locations and no clearance locations throughout the Metrorail system. Using accurate information such as hot spots and no clearance zones is critical to conducting a job safety briefing prior to the commencement of roadway work, safely, by all roadway workers, and for ensuring their safety throughout the work.

# **Hazard Rating: 1E**

Photo 1: Outdated Quick Access Guide in use.

The SAFE Inspector removed the out-of-date quick access guide and provided the roadway worker in charge with the current version.

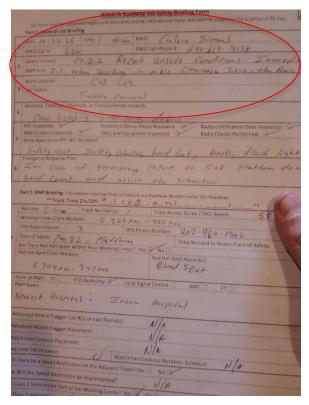
A roadway worker in charge that was in charge of a crew conducting fastener renewal work, between Pentagon City Station (C08) and Crystal City Station (C09), relied on a no-longer-in-effect-rule for the "Rule of the Day" during the roadway job safety briefing. Section 17.2.2 was cited for the Safety Contact and "2.1" is listed for the "RWP Rule,", however, neither match up with the current Metrorail Operating Rulebook.

This defect demonstrates the importance of the open corrective action plan (C-0193) based on finding 13 from the 2022 Audit of Rail Operations which states, "With frequent modifications due to temporary and permanent orders, and outdated versions of Metrorail's rulebook being distributed to personnel when hard copies are available, the latest Metrorail rules are not easily accessible to train operators. This creates document control issues and makes a rule requiring personnel to carry the latest version of the Metrorail Safety Rules and Procedures Handbook (MSRPH) unrealistic." Therefore, "Metrorail must ensure that only current copies of the rulebook are available and in use. Metrorail must provide operational

**Hazard Rating: 3C**

Photos 2: Roadway Job Safety Briefing Form referencing incorrect rules.

The SAFE Inspector advised the roadway worker in charge that the rule was outdated and not included as written in the current Metrorail Operating Rulebook (MOR) and that he must utilize the current rules moving forward.

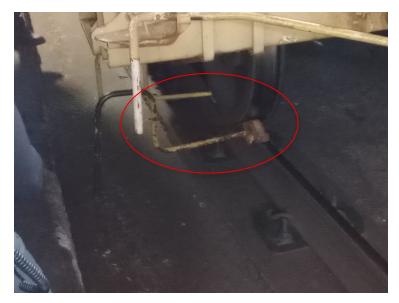
The Track and Structures crew did not secure a prime mover with wheel chocks when stopped for long periods of time as required by the Metrorail Operating Rulebook (MOR) section 11.12.1 that states "Operators shall secure Roadway Maintenance Machines while they are stopped within the work area."

**Hazard Rating: 3C**

Photo 3: Wheel chock mitigation placement, front of vehicle.

Photo 4: Wheel chock mitigation placement, rear of vehicle.

The SAFE Inspector advised the roadway worker in charge of the rule listed above and the requirements to secure the prime mover with wheel chocks. Crew members chocked the wheels at that time.

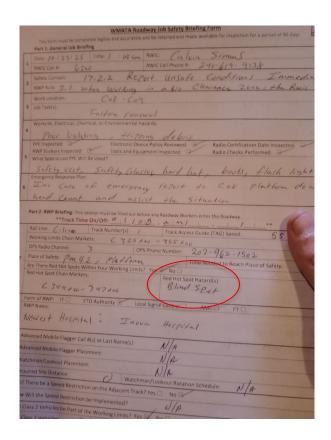
A roadway worker in charge that was in charge of a crew conducting fastener renewal work, between Pentagon City Station (C08) and Crystal City Station (C09) cited on their Roadway Job Safety briefing, that there was a "Blind Spot" from chain markers C344+00 – C347+00. However, it should be listed as "Portal" per the current Quick Access Guide.

**Hazard Rating: 1E**
