# WMSC Inspection Report 20251024A

Title: Roadway Worker Protection Overnight Inspection

Location: D&G Junction (D98)

Date of Inspection: October 24, 2025

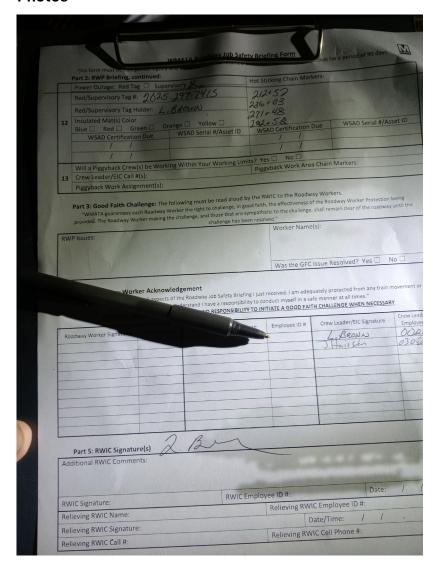
A Track and Structures crew was engaged in emergency repairs near the D&G Junction (D98) between Stadium-Armory Station (D08) and Minnesota Ave Station (D09). The work crew arrived on a prime mover ahead of WMSC and SAFE personnel. Upon arrival, it was noted that Metrorail personnel had entered the roadway before receiving a roadway job safety briefing. After noting the missing roadway job safety briefing, the roadway worker in charge gathered the work crew personnel and conducted the roadway job safety briefing with WMSC Inspectors and SAFE Inspector present. One member of the work crew left the site prior to the briefing and upon arrival back to the site, entered the roadway prior to being briefed. This is a violation of section 17.8.2.3 that requires the briefing to be completed prior to fouling the roadway.

17.8.2.3 Roadway Worker In Charge Responsibilities. "Ensures all Roadway Workers receive the Roadway Job Safety Briefing <u>prior to fouling</u>, or having the potential to foul, any track." (Emphasis added.)

WMSC Inspectors and the SAFE Inspector discussed that the rule states "prior to fouling, or having the potential to foul, any track," the rule is not activated by whether work has begun.

Hazard Rating: 1B

Photo 1: Roadway Job Safety Briefing form unsigned after personnel had entered the roadway.

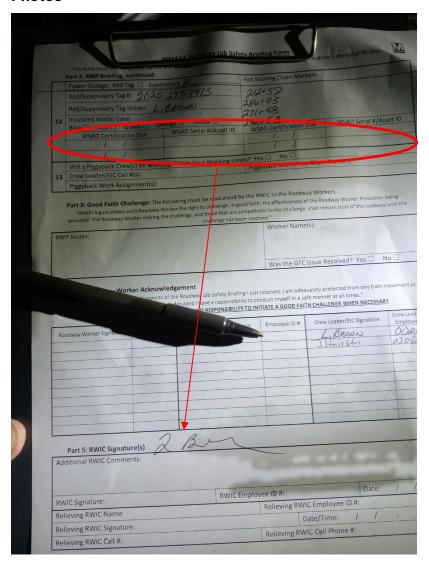
The roadway worker in charge for the Track and Structures crew did not include the warning strobe and alarm device (WSAD) serial number and certification dates on the roadway job safety briefing as required.

Metrorail Operating Rulebook 17.5.4 The following must be considered when participating in a Roadway Job Safety Briefing: Safety Equipment Certification Dates (radios, mats, shunts, gloves, etc.).

WMSC and SAFE personnel reviewed the WSADs and the installation thereof and found no issues with the devices or installation. However, the information should be recorded on the briefing prior to signing.

**Hazard Rating: 1B**

Photo 2: Roadway job safety briefing form signed by RWIC without WSAD certification date or serial number.

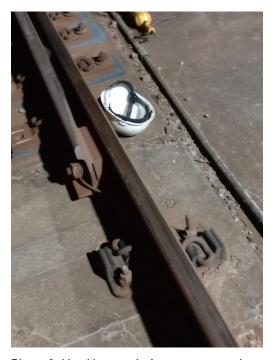
Several personnel from the Track and Structures work crew were observed not wearing the required personal protective equipment (PPE): hard hats and safety glasses. All personnel were in possession of the PPE but were not wearing it while conducting work on the roadway.

## **Hazard Rating: 1E**

Photo 3: Hard hat not being worn as work was underway.

WMSC Inspectors and the SAFE Inspector reminded the roadway worker in charge that all personnel must have and keep on the required personal protective equipment.
