## WMSC Inspection Report 20251029A

ISSUED 10/31/2025

Title: Roadway Worker Protection Overnight Inspection

Location: Landover (D12) to New Carrollton (D13)

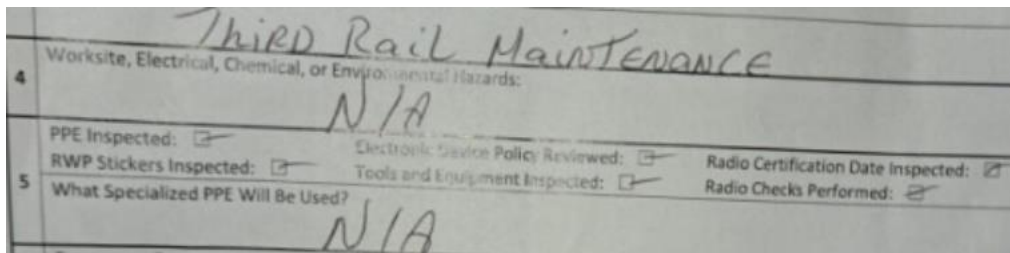
During the roadway job safety briefing, the roadway worker in charge is required to identify and cover worksite electrical, chemical, or environmental hazards. Part 1: General Job Briefing – Section 4 of this RWIC's job safety briefing was populated with an N/A (Not Applicable) indicating there were no hazards within the working limits. However, WMSC Inspectors identified multiple hazards within the working limits between the running rails, including but not limited to, lengths of running rail stored, lengths of guard rails, and WEE-Z Impedance bonds. Working overnight also creates a low light visibility hazard. There was also an electrical hazard requiring the implementation and use of two warning strobe and alarm devices (WSAD).

**Hazard Rating: 1B**

Photo 1: Section 4 of the job safety briefing noting "N/A."

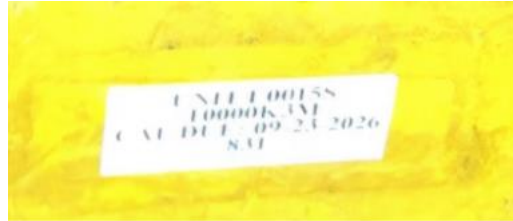
During review of the roadway job safety briefing, WMSC Inspectors determined that the roadway worker in charge did not write the correct corresponding certification and calibration information for the WSAD in use within the work zone. (See photo 2 showing section 12 of the job safety briefing below and photo 3 showing the actual WSAD information.)

**Hazard Rating: 1B**

Photo 3 (right) the actual WSAD information.
