## WMSC Inspection Report 20251030

ISSUED 10/31/2025

Title: Roadway Worker in Charge (Level IV) Requalification

Location: Carmen Turner Facility (CTF)

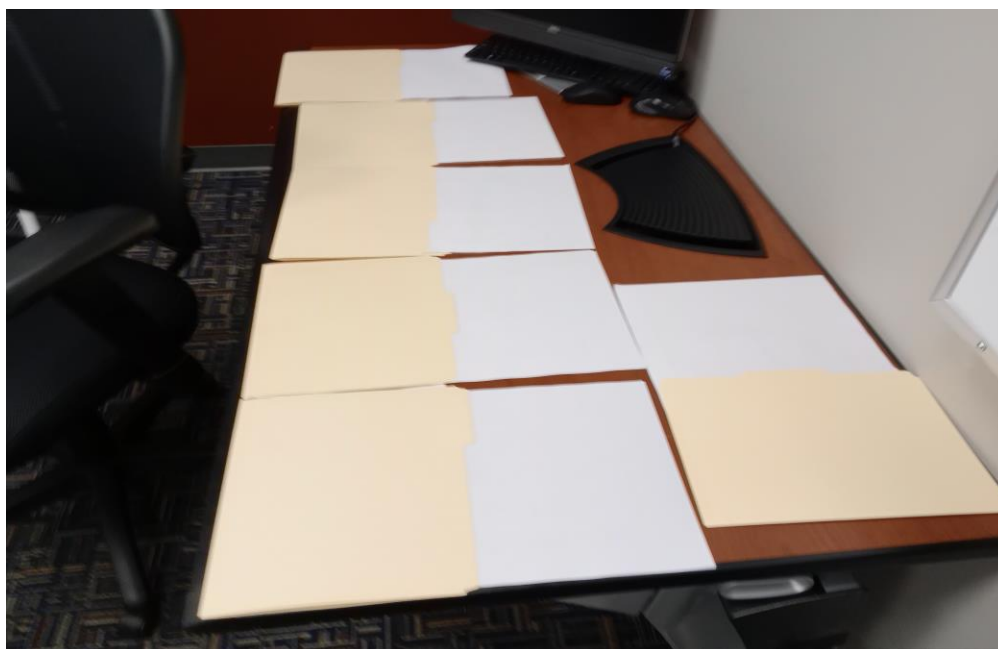
Photo 1: Random practical exam RWP scenarios in folders. Examinees must choose one folder at random.

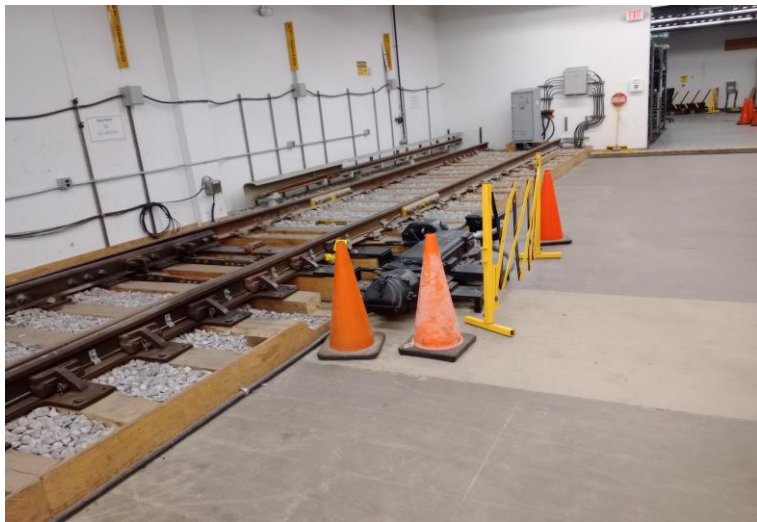
Photo 2: Practical exam setup and testing area in the ATC lab.

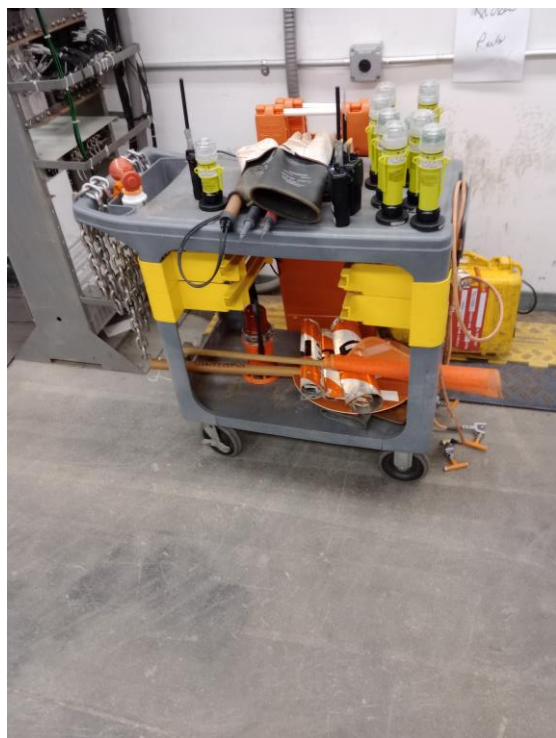
Photo 3: Practical exam equipment used during the practical examination portion of the requalification.
