W-0409 – Evacuation for Life Safety Reasons at Foggy Bottom-GWU Station – October 8, 2024

FINAL REPORT OF INVESTIGATION A&I E24800

Foggy Bottom Station – Evacuation for Life Safety Reasons

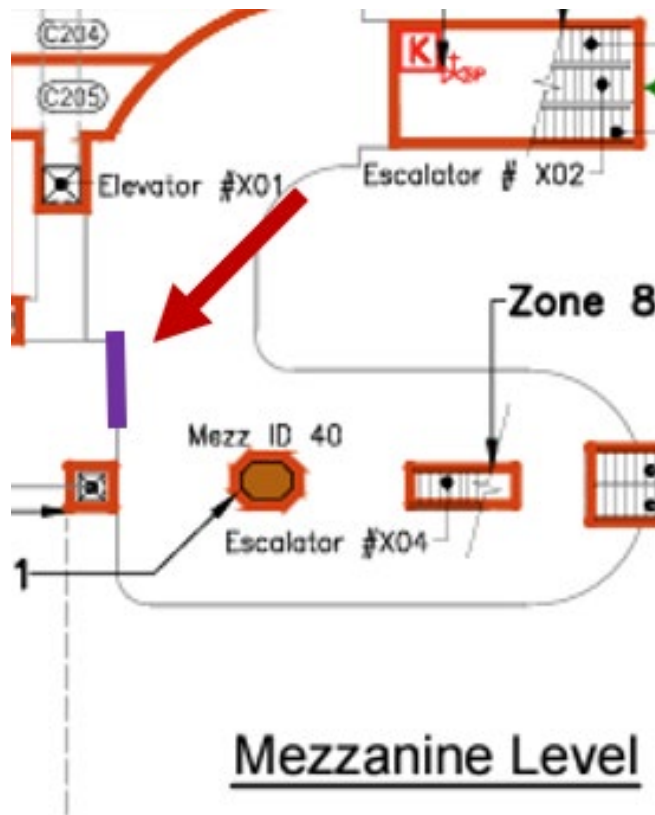
Field Sketch/Schematics

Foggy Bottom Station – Mezzanine Level Parapet Wall

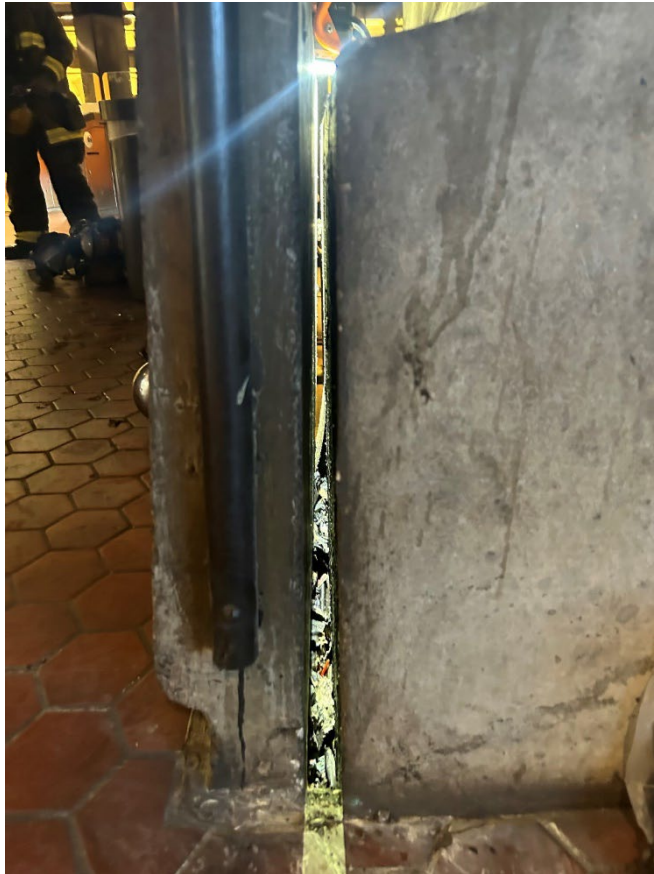
On Tuesday, October 8, 2024, at 11:33, smoke began to emit from a build-up of debris located in a crack on the parapet wall at Foggy Bottom Station mezzanine level above track 2.

Image 1 – Image of a gap in the parapet wall where debris accumulated.

DCFEMS began its investigation into the source of the smoke and the cause of the fire. Through their investigation, it was determined that there was a significant amount of trash that was burning in the crack between the parapet wall and the mezzanine structure. Pressurized water cans were utilized to attempt to extinguish the fire completely.

The probable cause of the Evacuation for Life Safety Reasons event on October 8, 2024, at Foggy Bottom Station was due to debris that had accumulated within a crack on the parapet wall.

Corrective Action Code	Description	Responsible Party	Estimated Completion Date
120462_SAFECAPS_Facilities_001	“Facilities Maintenance will evaluate a new telescoping vacuum cleaner to clean behind parapet walls and other possible cleaning solutions.”	Facilities Maintenance	12/31/2025

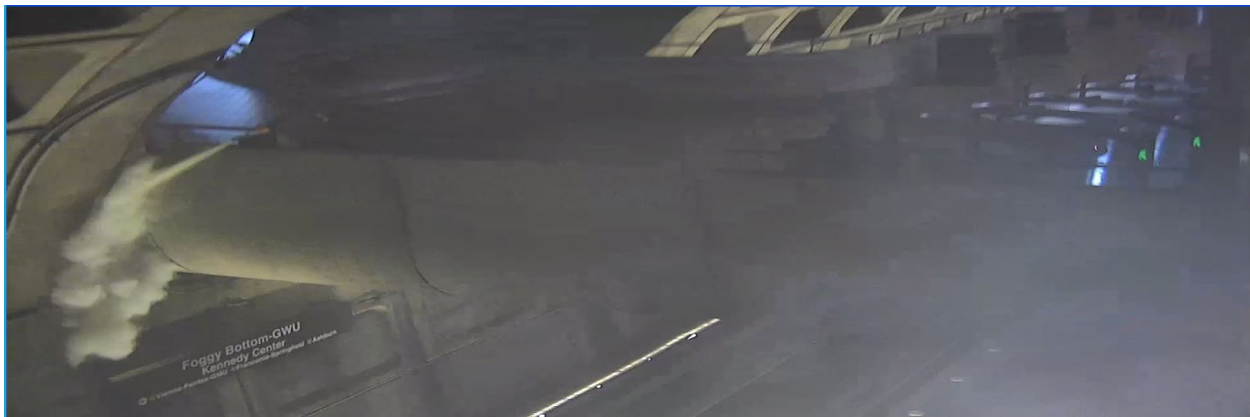
Image 2 – Image of the Station Manager utilizing a fire extinguisher.

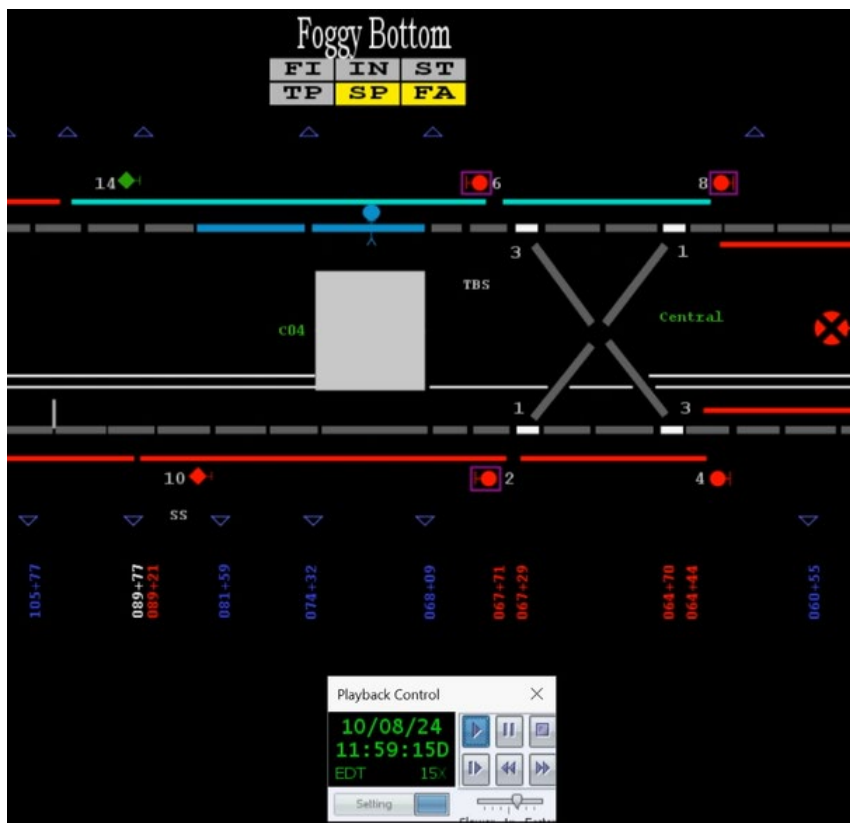
Figure 1 – AIMS depicting third rail power de-energized, blue block and human form in place at 11:59 hours.
