W-0410 – Improper Roadway Worker Protection at L'Enfant Plaza Station – December 12, 2024

FINAL REPORT OF INVESTIGATION A&I E24988

L'Enfant Plaza Station – Improper RWP

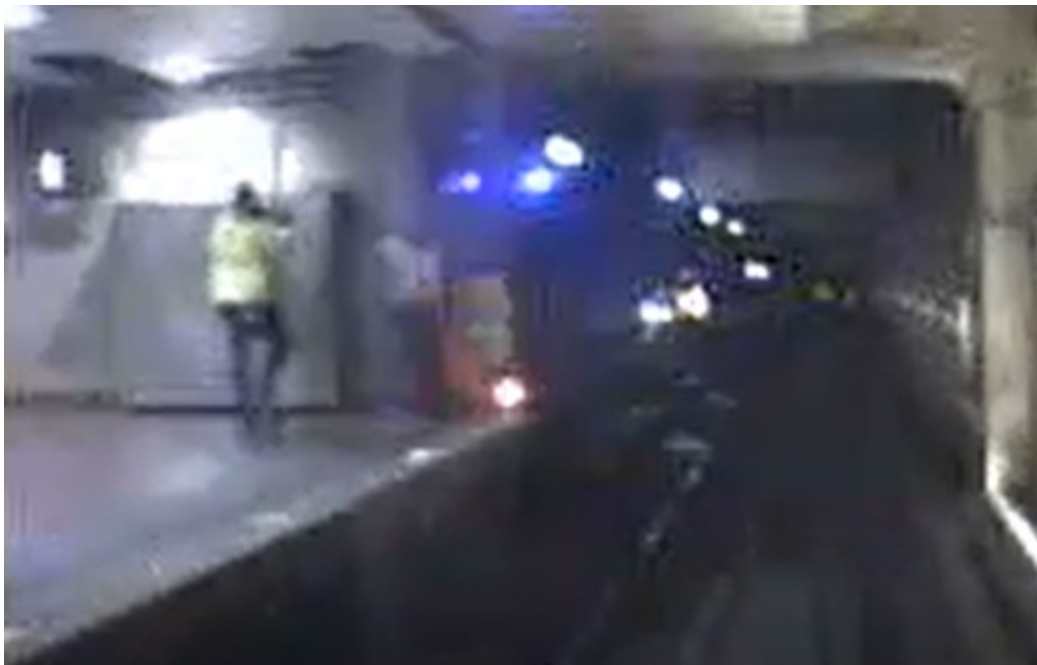
Closed Circuit Television (CCTV) footage showed that at 09:50 hours, Train ID 724 entered the L'Enfant Plaza Station platform limits and did not stop for a briefing from the Advanced Flagger.

Image 1 – Image of the Advanced Flagger at the 8-car Marker as Train ID 724 approached at 09:50 hours.

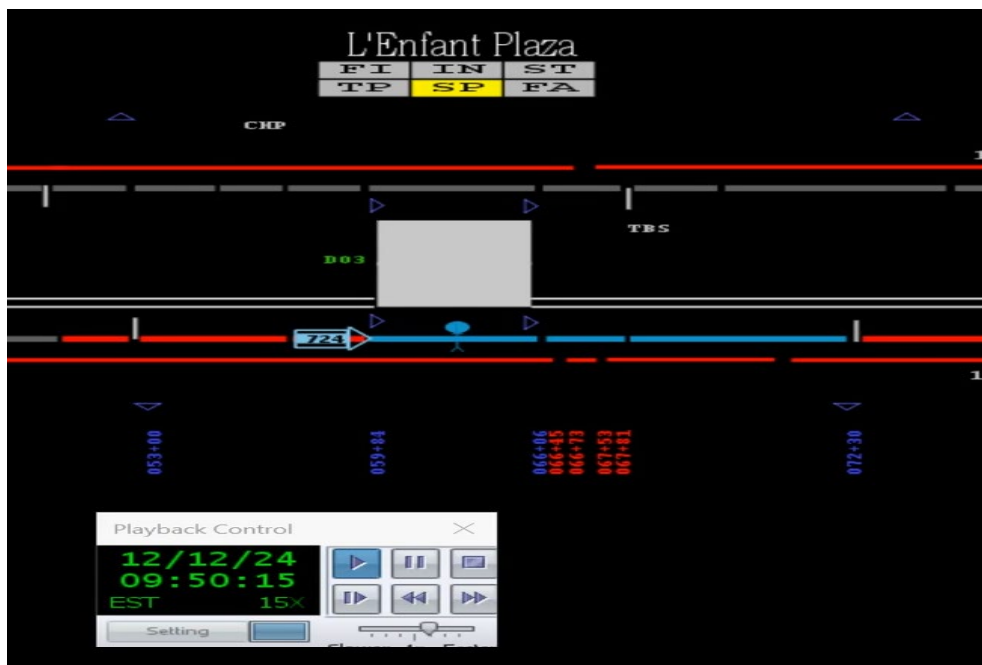
Figure 1 – Shows Train ID 724 entering L'Enfant Plaza Station platform limits on track 1.

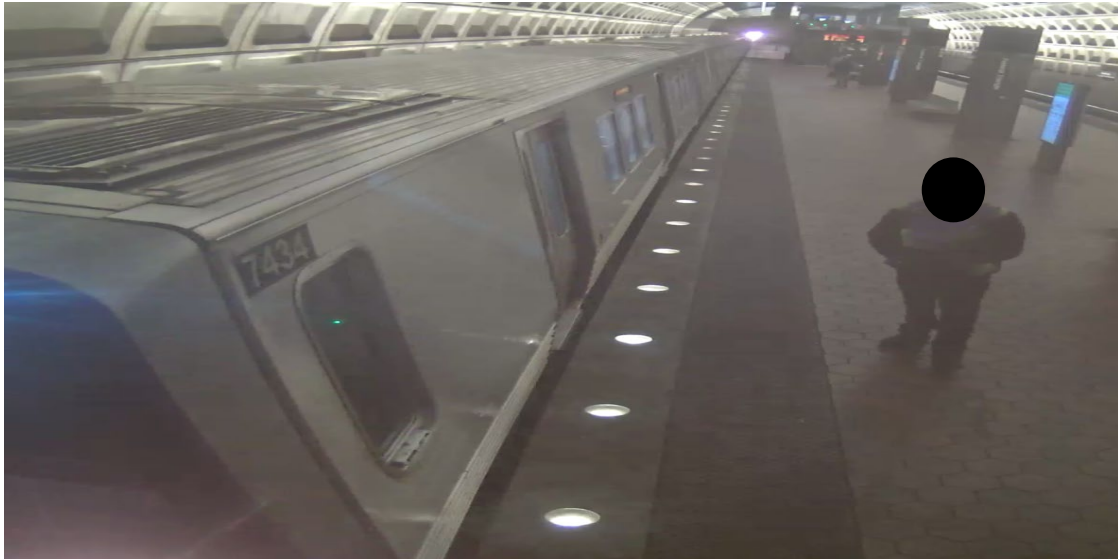
Figure 2 – Depicts Supervisor 1 being relieved at Federal Triangle Station by Supervisor 2 at 09:41 hours.

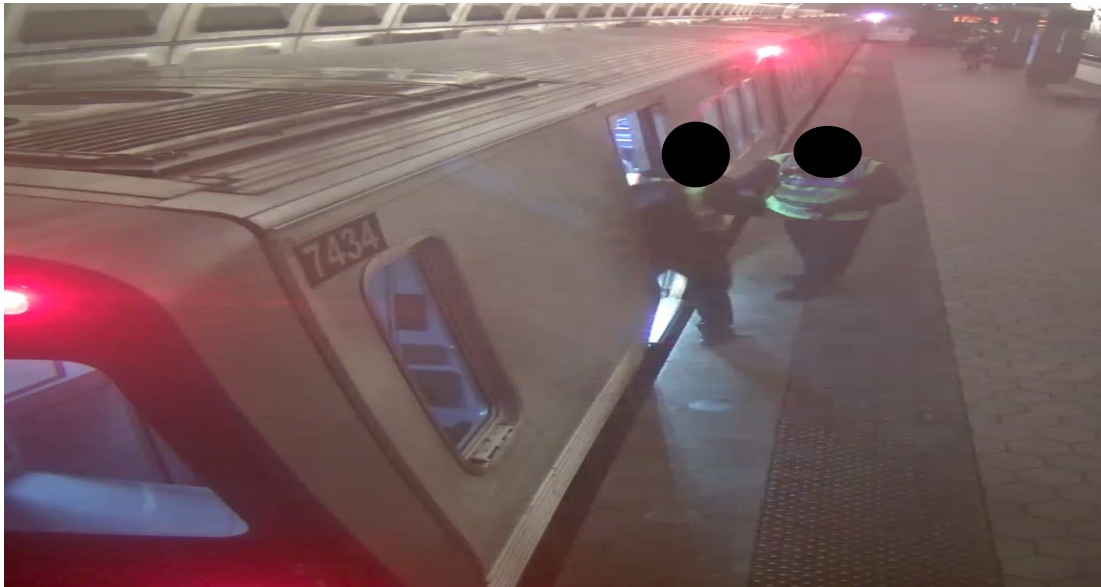
Figure 2 – Depicts visual and verbal exchange of Train ID 724.

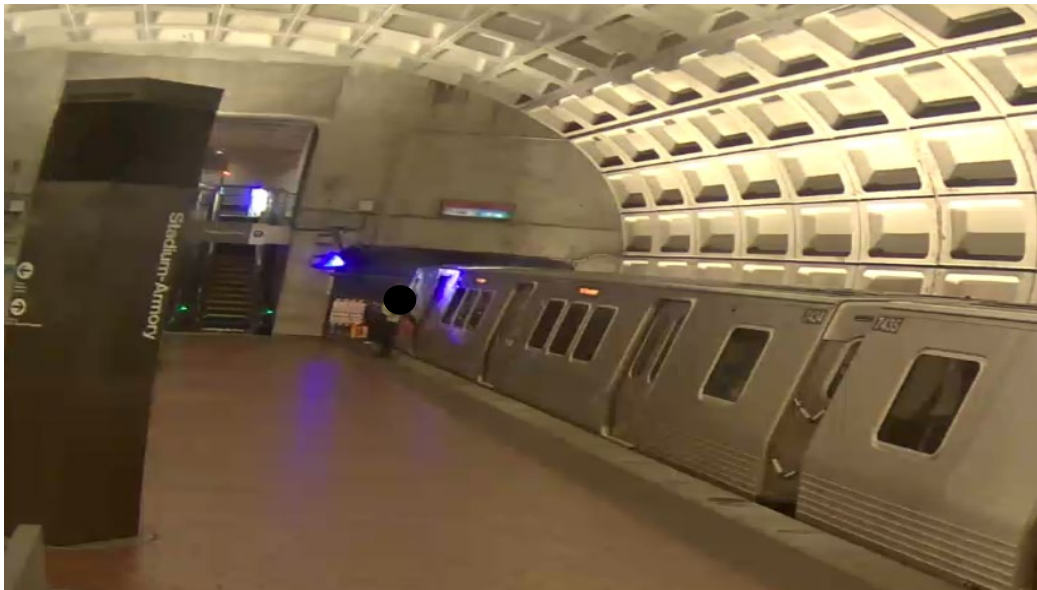
Figure 3 – Depicts Supervisor 3 relieving Supervisor 2 at Stadium Armory Station at 10:01 hours.
