## WMSC Inspection Report 20251106A

ISSUED 11/10/2025

Title: Rail Vehicle Operator (RVO) certification inspection at the Greenbelt Yard (E99)

Location: Greenbelt Yard (E99)

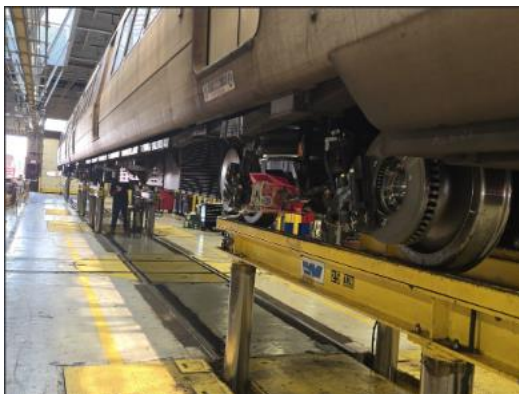
While in the Greenbelt S&I shop, WMSC Inspectors observed a car equipment employee performing work underneath elevated rail cars 3248-3249 on Track 6 south without any axles on either vehicle chocked. WMSC Inspectors examined both sides of the elevated consist and immediately notified the Greenbelt shop supervisor who was located in the office. The shop supervisor immediately went to Track 6 to reinstruct the technician and ensure the wheel chocks were installed.

Photo 1: (left) unchocked wheels.

**Hazard rating: 1B**

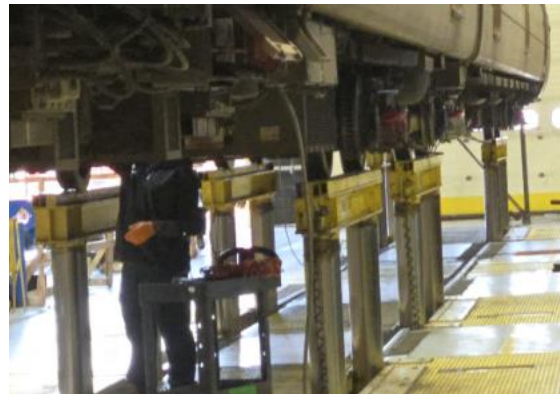
Photo 2: (Right) employee working under elevated railcar.

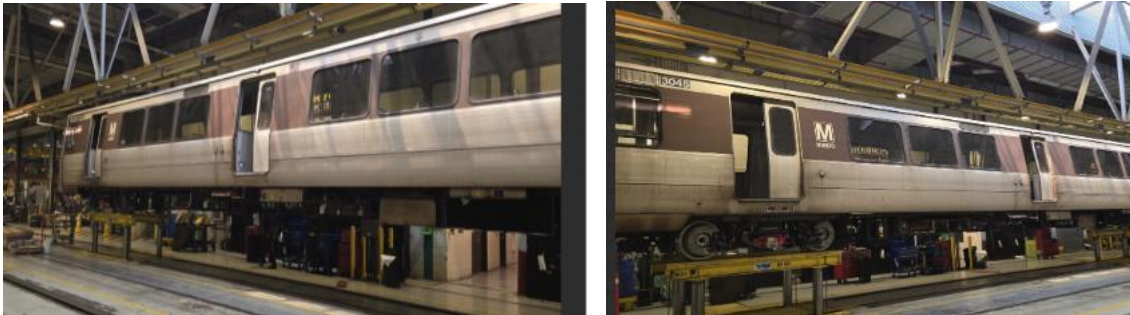
While in the Greenbelt S&I shop, WMSC Inspectors observed a car equipment employee performing work inside elevated rail cars 3045-3044 on Track 6 north without fall protection. Multiple doors open on both sides of the elevated consist. The WMSC Inspectors examined both sides of the elevated consist and immediately notified the Greenbelt shop supervisor who was located in the office.

Photo 1: (left) doors open on railcar without fall protection. Photo 2: (right) Other side of vehicle doors open without fall protection.

**Hazard rating: 1B**
