WMSC Inspection Report 20251118

Title: Greenbelt Yard (E99) and West Falls Church Yard (K99) S&I Shop Inspection

Location: Greenbelt Yard (E99), West Falls Church Yard (K99)

Date of Inspection: 11/14/25 and 11/18/2025

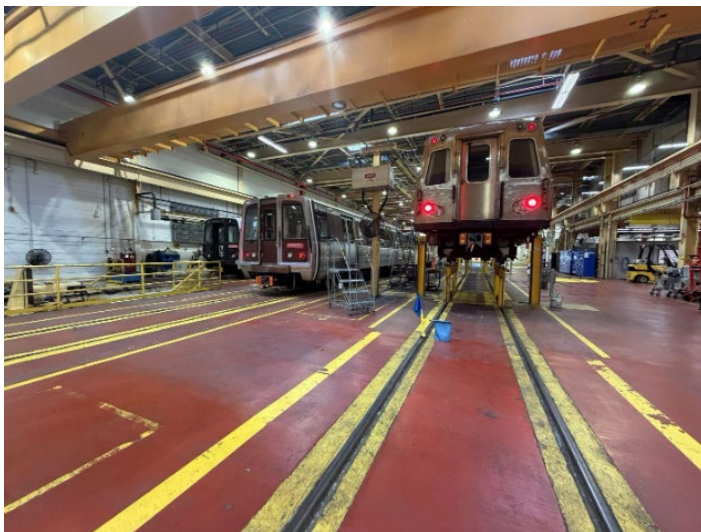
Similarly, in West Falls Church Yard (K99) WMSC Inspectors noted the shop's overall cleanliness and orderliness. Materials and shop equipment were stored neatly and methodically. Blue flag placement was inspected and found in accordance with Metrorail procedures.

Photo 1: Properly placed blue flags.

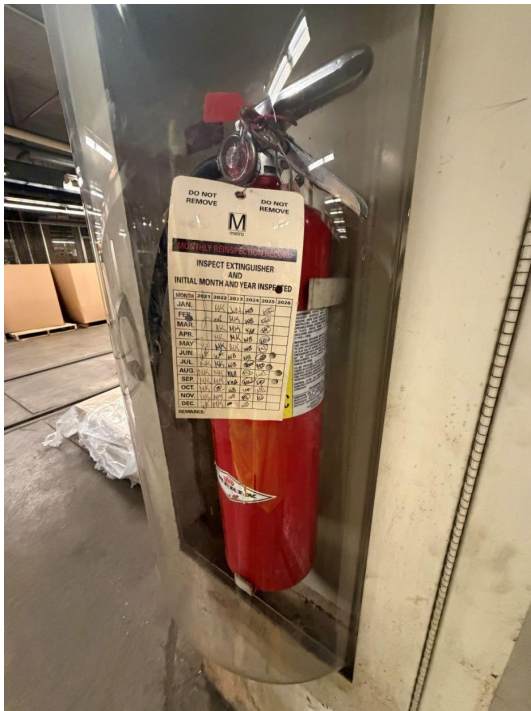
At West Falls Church Yard (K99) all fire extinguishers and eye washes were inspected and found they were inspected by Metrorail on time, logged, and expiration dates were within limits.

Photo 2: Example of one WFC shop fire extinguisher inspected which was properly maintained and unexpired. All fire extinguishers inspected were found to be in this condition.

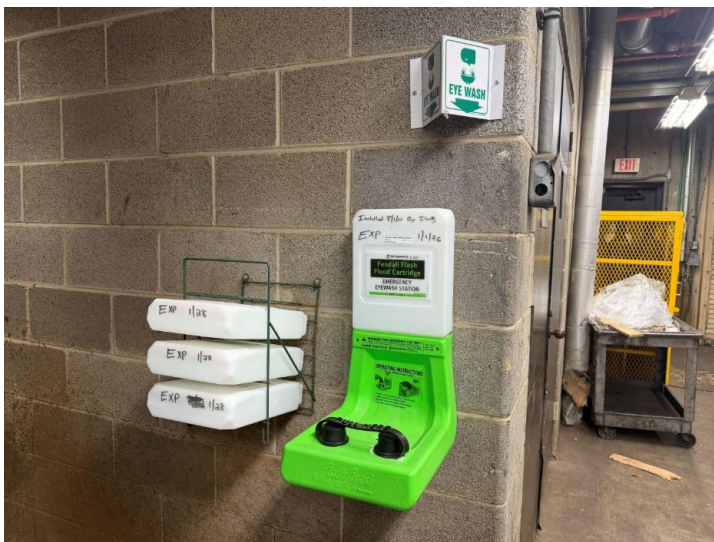
Photo 3: Similarly, all eye wash stations were actively maintained and did not have any expired materials or solutions.

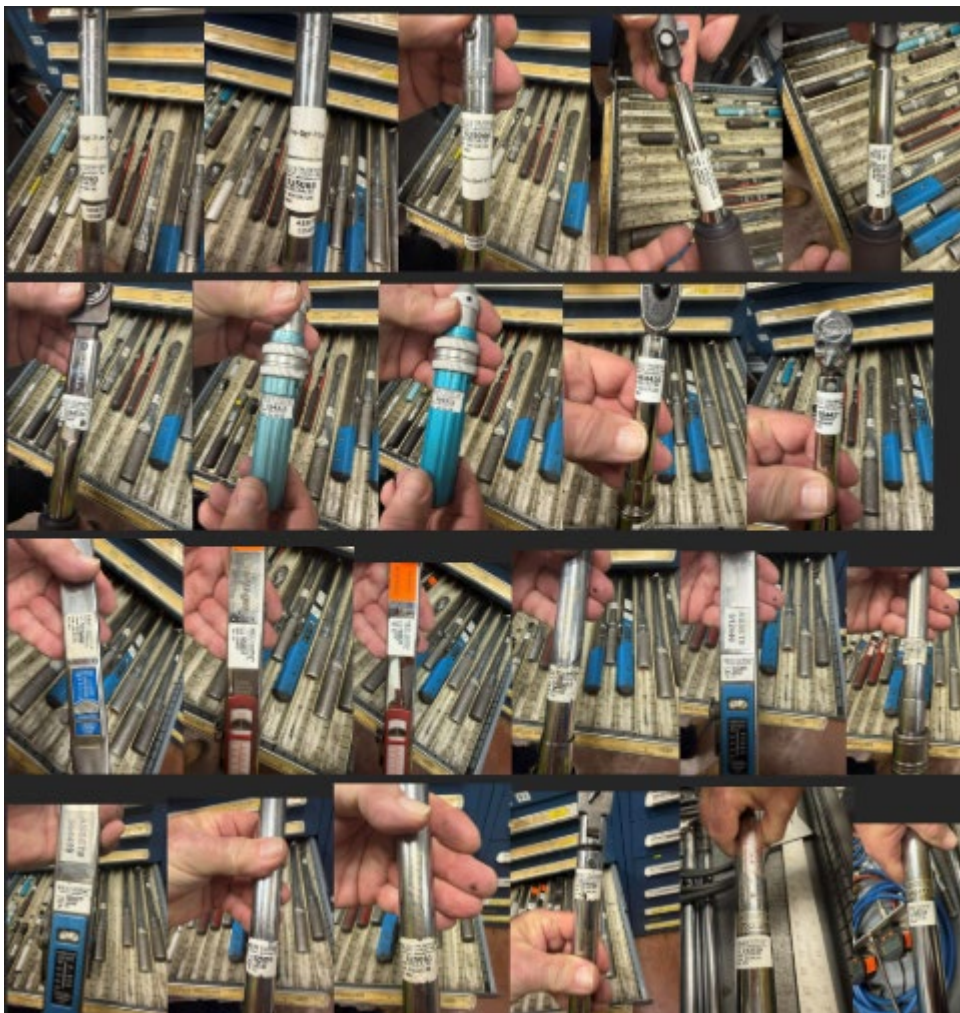
All torque wrenches were inspected at West Falls Church (K99), and all found to have valid certification dates and were neatly housed in a tool crib. (A tool crib is a designated storage area that ensures tools and equipment are stored in a secure area. The tool crib consists of modular cabinets designed for heavy duty industrial storage.)

Photo 4: Each inspected torque wrench.

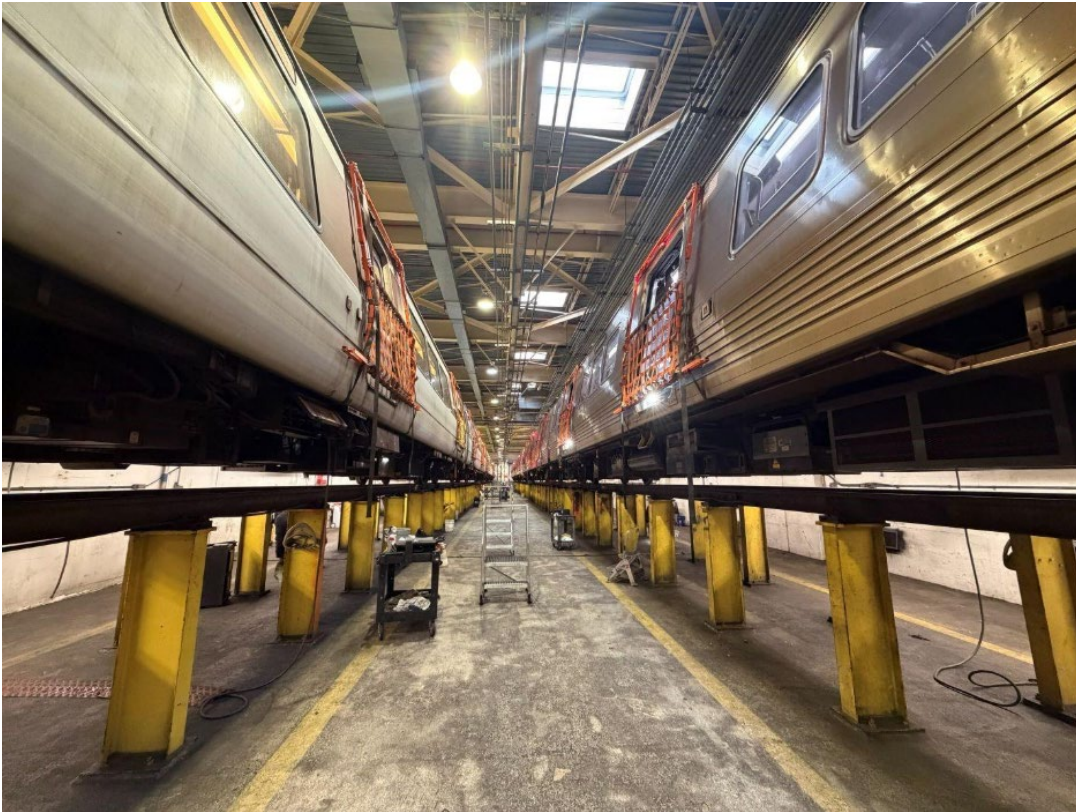
Photo 5:

All trains at West Falls Church (K99) within the shop either maintained closed doors or were equipped with door guards (fall protection). Railings on the platform side of the trains were also in place.

Properly secured fall protection on raised vehicles.

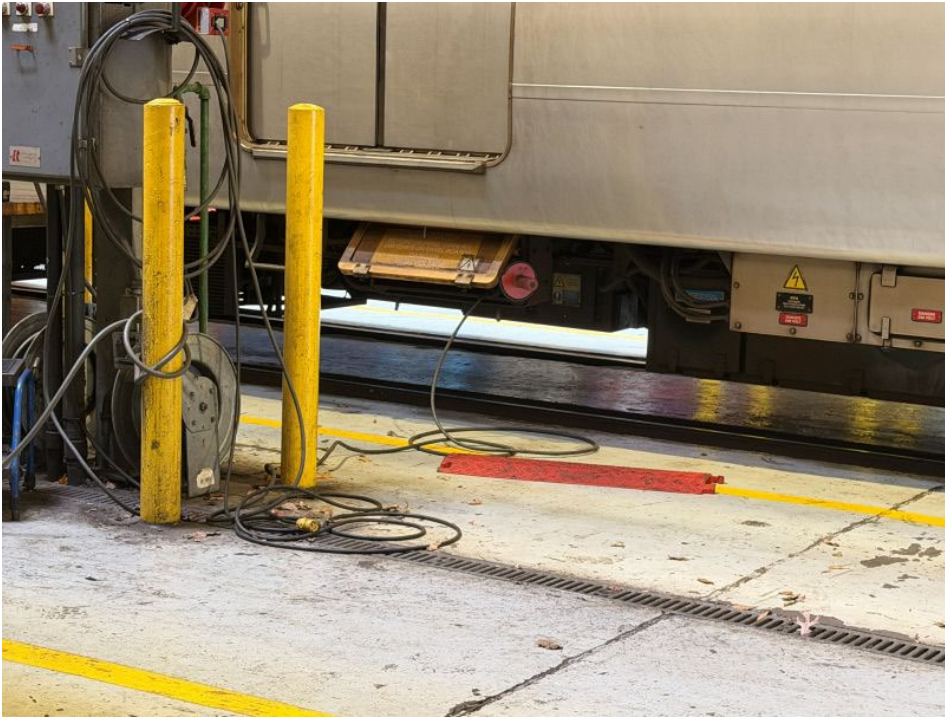
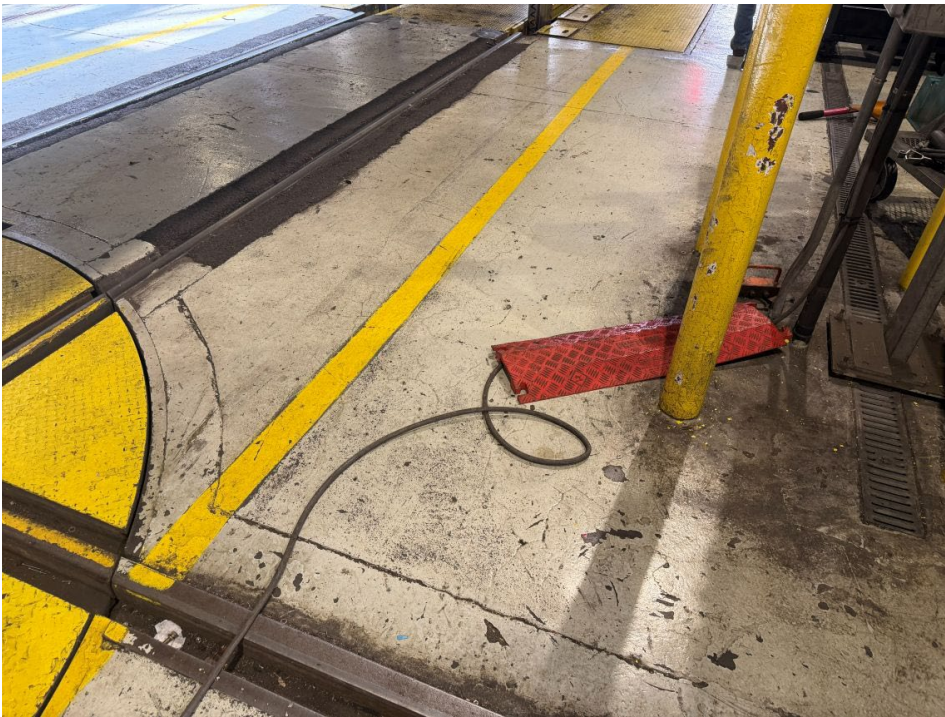
At Greenbelt (E99), the Shop Auxiliary Power cables that were running along the floors between the shop's power boxes and the auxiliary power plug on the train were uncovered in many places. Covers of the exposed power cables are required to avoid damage from being stepped on or run over with various equipment. Inspectors noted that the majority of the cables were exposed, and covers were not properly or not installed to provide protection.

Metrorail Special Alert SA-22-L Revision 00 Date: 12/21/2022, identifies the hazard of uncovered high voltage cable wires and the proper usage of high voltage covers in shop conditions.

Hazard Rating: 3B

Photo 6: Uncovered power cables at Greenbelt (E99).

Photo 7: Uncovered power cables at Greenbelt (E99).

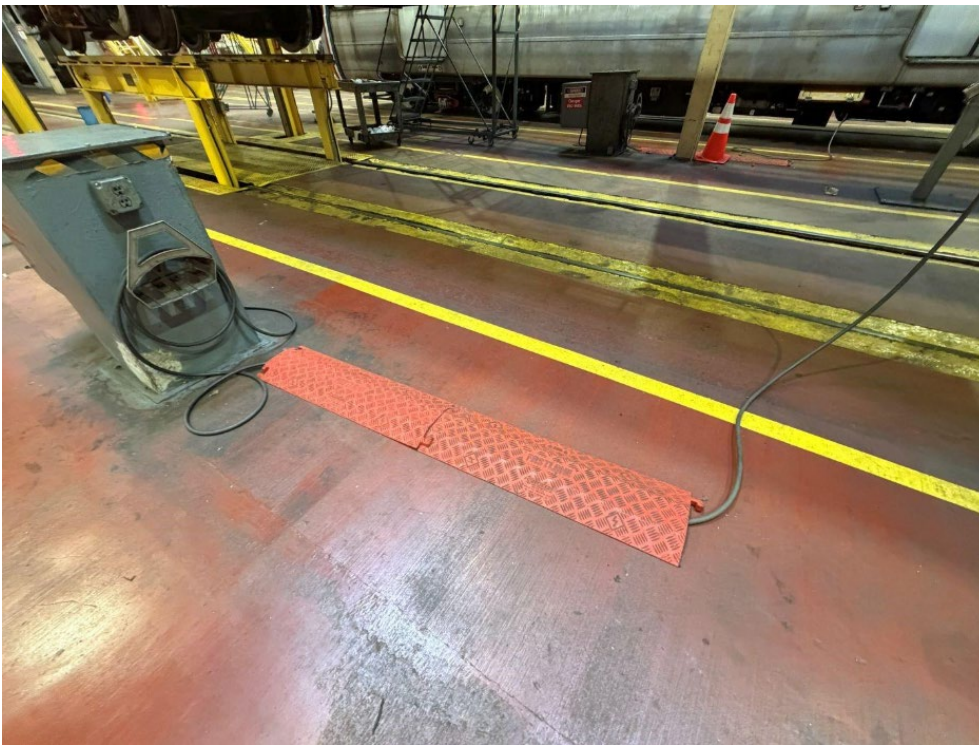
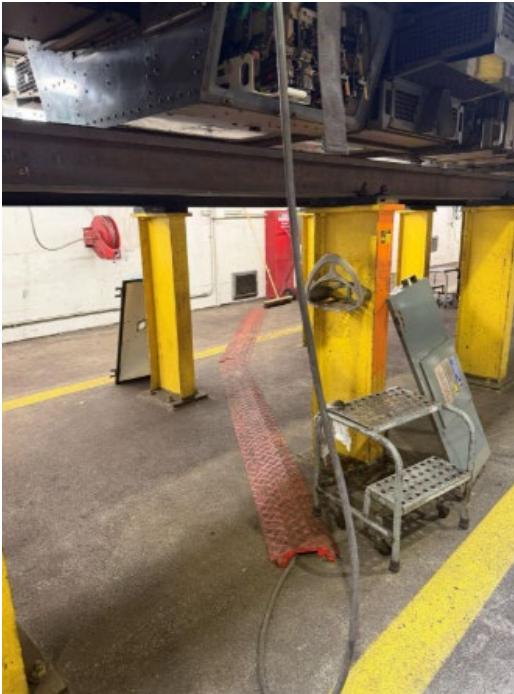
Photo 8: Properly covered high voltage cables.

Photo 9: Properly covered high voltage cable wires.

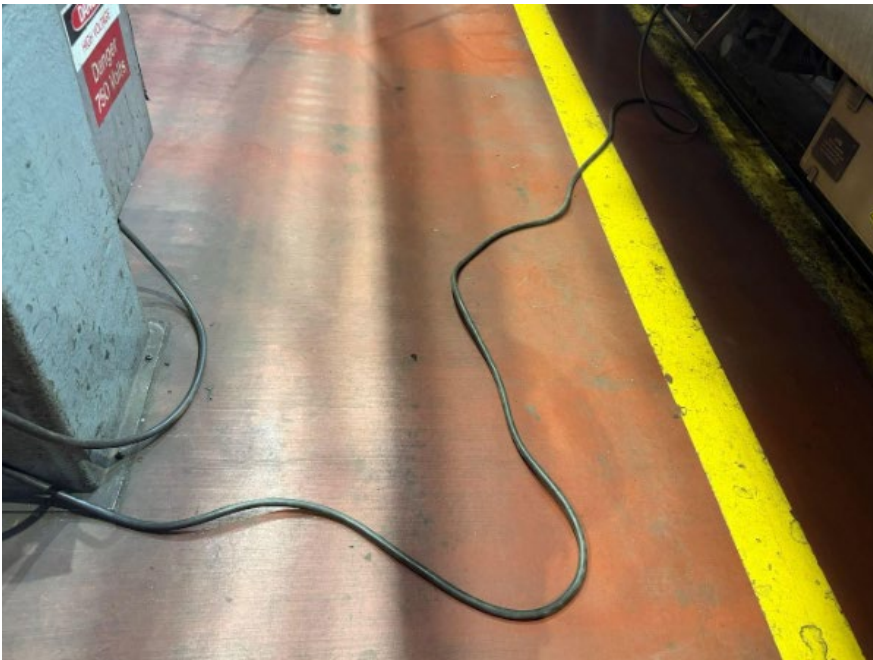
Similarly, at West Falls Church Yard (K99), auxiliary power cables, those that supply power to trains while in the shop, were inspected for use of high voltage covers. Positively, West Falls Church Yard (K99) shop cables were nearly all covered except for one area which was immediately mitigated with a high voltage cover while inspectors were onsite.

Metrorail Special Alert SA-22-L Revision 00 Date: 12/21/2022, identifies the hazard of uncovered high voltage cable wires and the proper usage of high voltage covers in shop conditions.

Hazard: 3B

Photo 10: The one area of exposed high voltage cable wires that were not covered but was mitigated onsite.

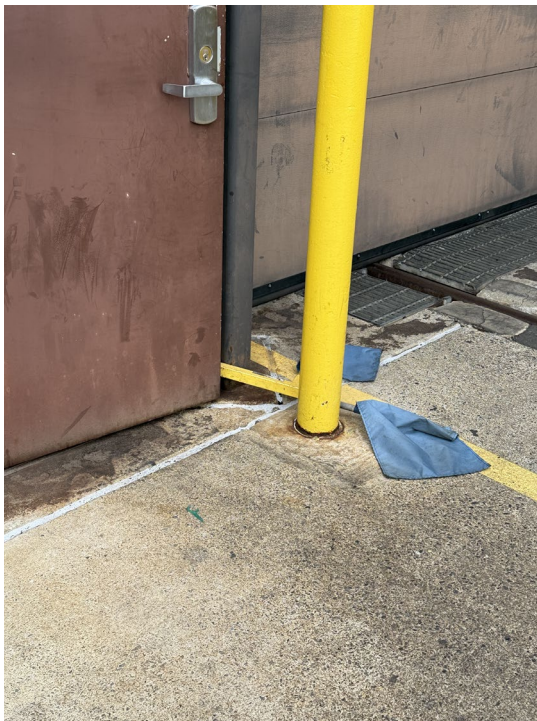
The Greenbelt Yard (E99) exterior door into the S&I Shop was being propped open by using blue flags. The door should be in a closed and secure position.

Hazard Rating: 3B

Photo 11: Propped exterior door at Greenbelt (E99).

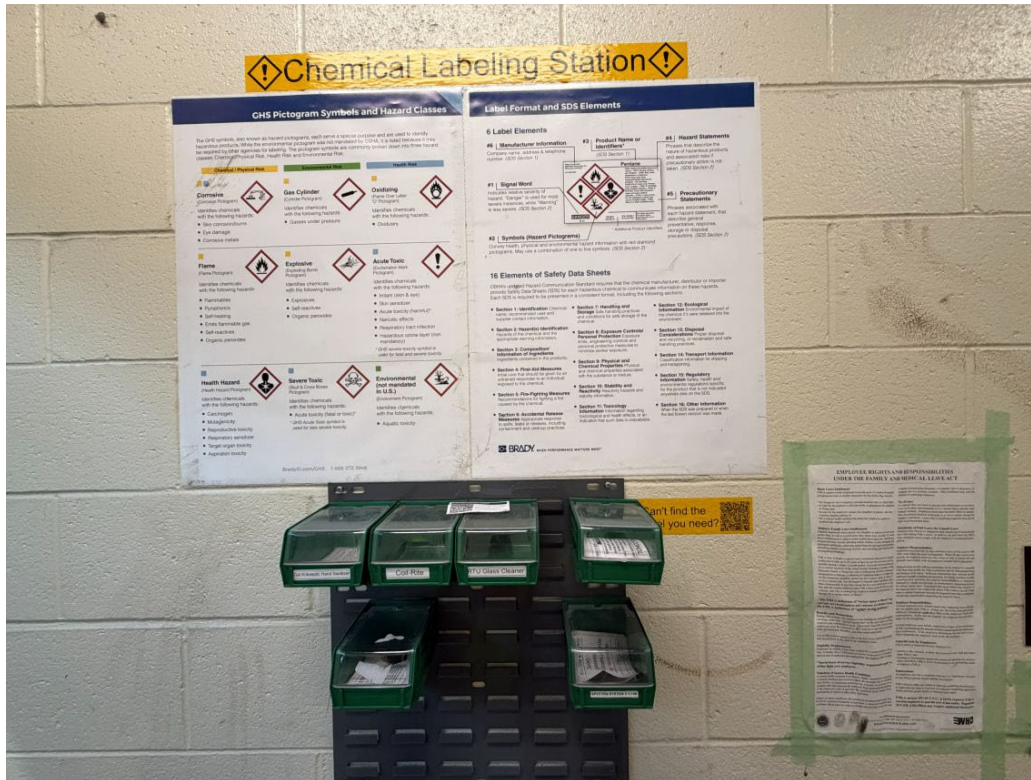
At Greenbelt Yard (E99) the chemical Labeling Station was out of some chemical labels. Meaning, workers would be unable to print a corresponding chemical label explaining a hazard or warning pertaining to that chemical in circumstances when the station was out of a particular label.

Hazard Rating: 3B

Photo 12: Chemical Labeling Station at Greenbelt Yard (E99).

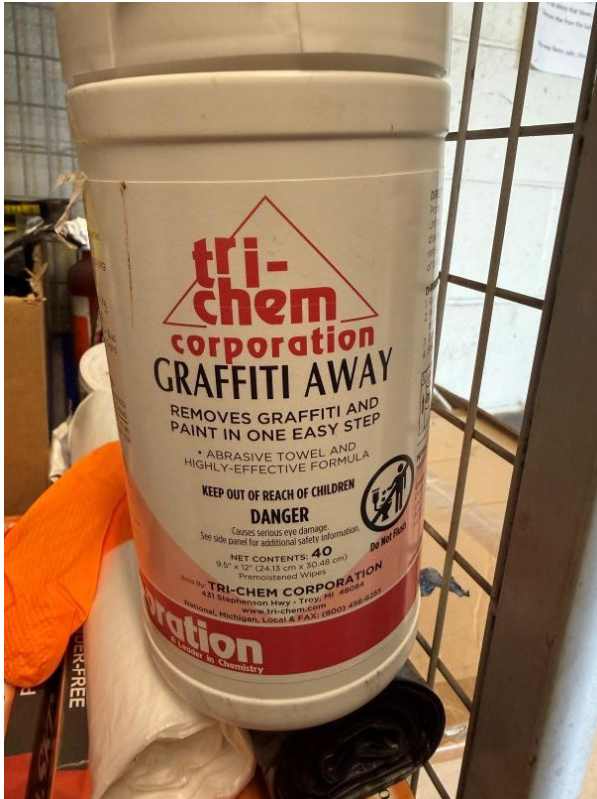
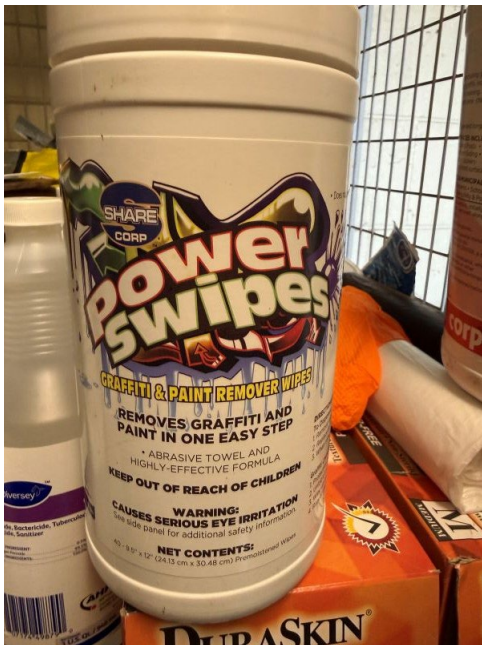
At the Greenbelt Yard (E99) train storage platform, car cleaning chemicals are stored, which are hazardous should the solution come into contact with a worker's eyes. This location did not have an eye wash station that was easily accessible from that location. Car cleaning solutions come in at least three types, all of which can cause eye damage should the solution or wipe come into contact with the eyes.

Hazard Rating: 3B

Photo 13: Hazardous cleaning chemicals at Greenbelt (E99) without a nearby eye wash station.

Photo 14: Hazardous cleaning chemicals at Greenbelt (E99) without a nearby eye wash station.

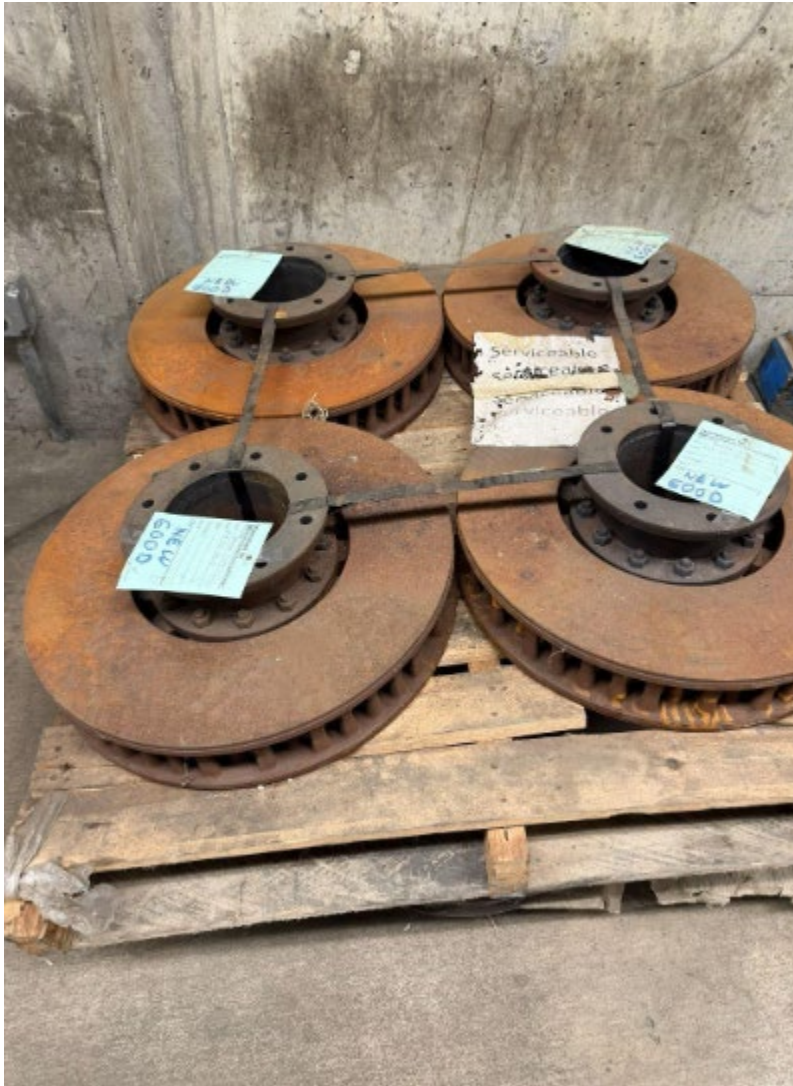
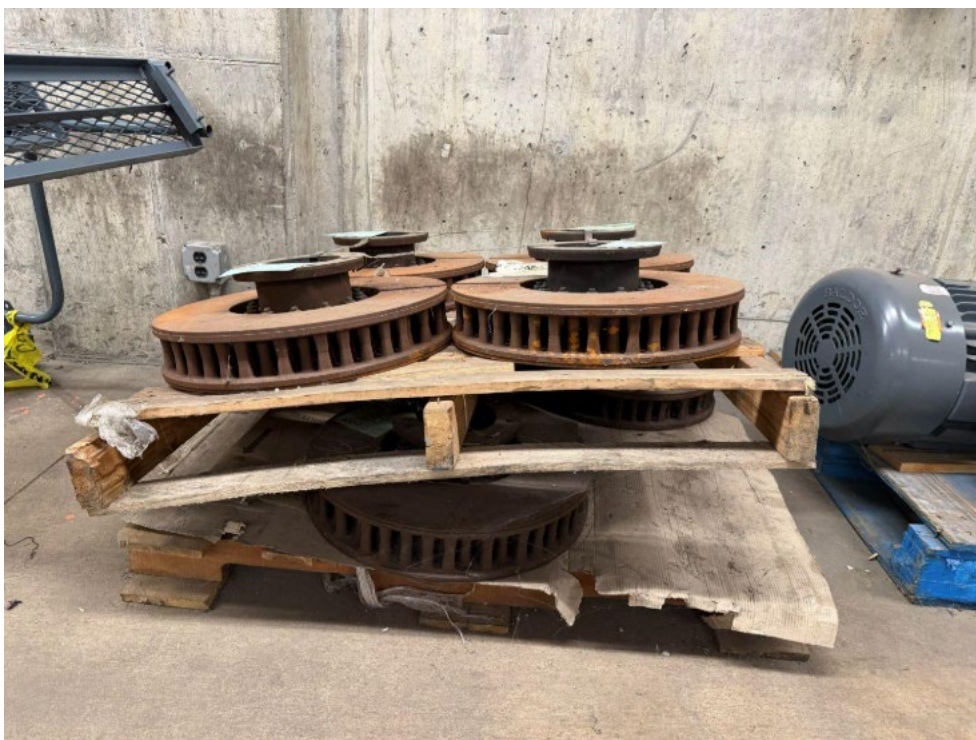
At West Falls Church (K99), WMSC Inspectors are concerned with the presented condition of some brake discs marked "NEW GOOD." See the photos below.

Photo 15: Brake discs marked "NEW GOOD;" however, the discs appear to be in poor condition.

Photo 16: Same brake discs from different angle marked as "NEW GOOD."
