WMSC Inspection Report 20251125

Title: Service Bulletin SBF-110 Implementation Inspection

Location: New Carrollton (D99) Yard Service and Inspection (S&I) Shop

Date of Inspection: 11/25/25

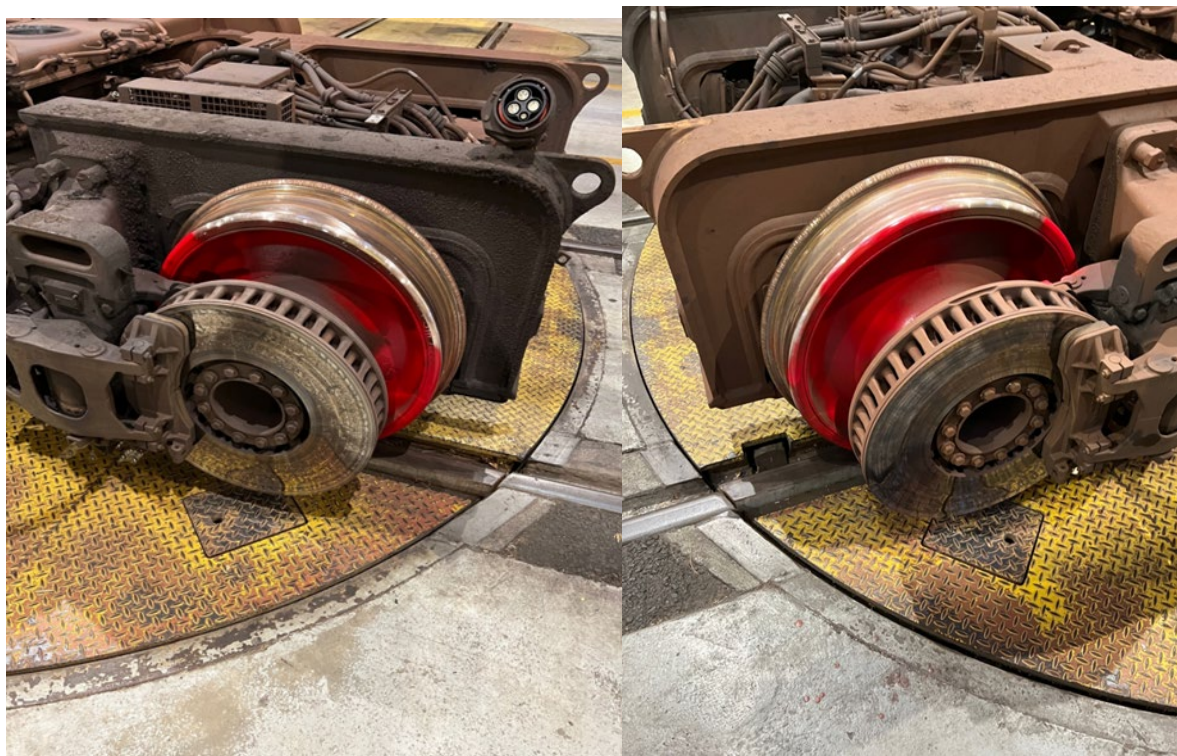
Upon arriving at New Carrollton (D99), rail cars 7586 and 7587 were on a lift and all of the vehicle's trucks were removed. Three of the four trucks were replaced with newly rebuilt trucks. The shop was waiting for the last truck to be delivered so that the new truck could be installed on the rail car. The defective trucks were isolated in part of the truck shop area, and the wheels on the defective axles were painted red in accordance with the instructions outlined in SB-F110.

Photos 1 (left) and 2 (right): Defective axles painted red per SBF-100.
