WMSC Inspection Report 20251203

Title: Roadway Worker in Charge (Level IV) Requalification

Location: Carmen Turner Facility (CTF)

Date of Inspection: 12/3/25

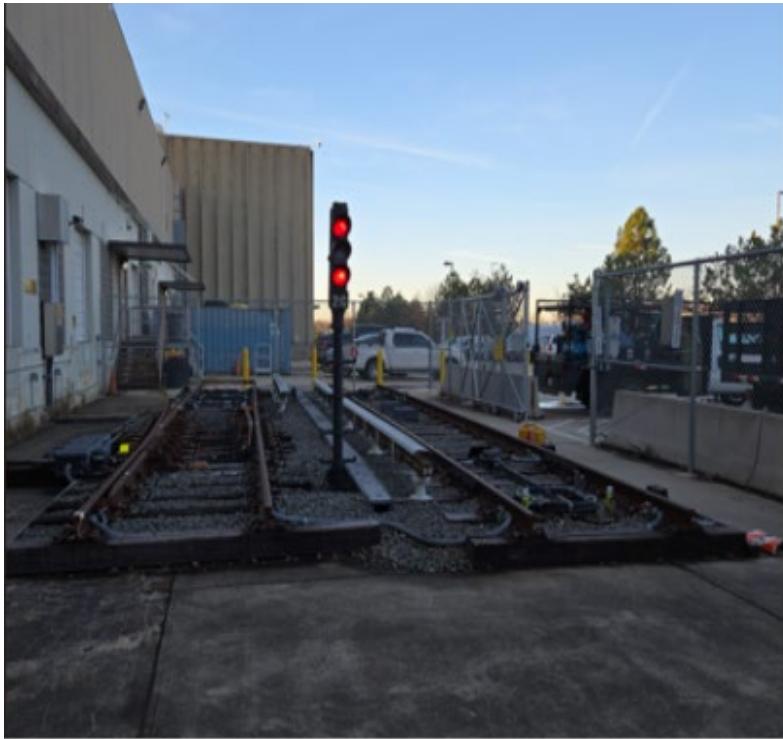
Photo 1: the RWP practical exam testing area.

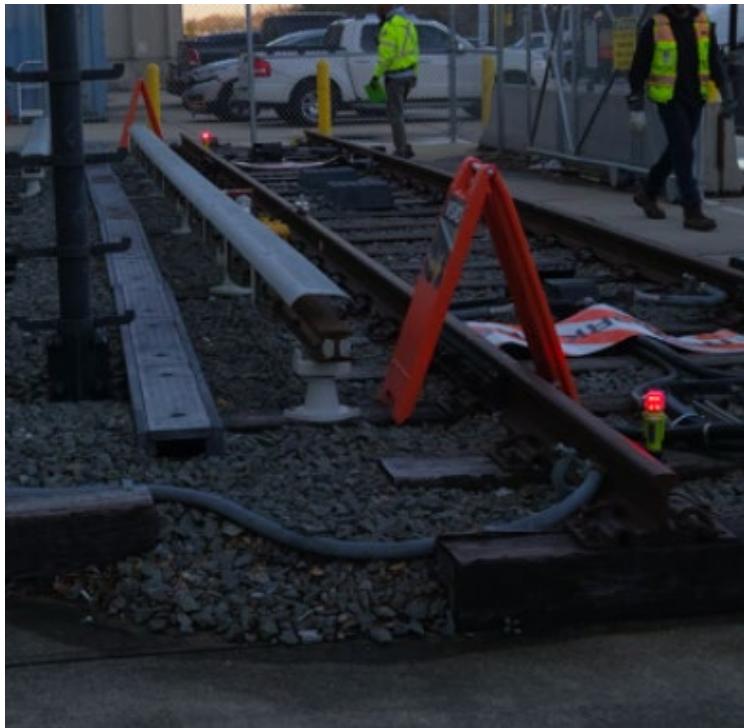
Observation of the examinee's practical exam on the exclusive track occupancy (ETO) work zone setup showed the student used the roadway worker safety equipment incorrectly, one example being the placement of the warning strobe and alarm device (WSAD) in the wrong position. The WSAD should be placed in the work zone, not outside the end area work mats,

which marks the end of an ETO work zone (See photo 2 – the orange A-frame represents the WSAD placement during the practical exam).

1. WSAD placement outside of the end area work mats within the 500 ft buffer zone area.
2. Incorrect setup and testing of the WSAD. The calibration and functioning of the WSAD was not checked. Metrorail states in SARE 05-0459 the proper installment and removal task to include check calibration date, press button to test WSAD strobe light and Press button to test WSAD siren. The red paddle of the WSAD was placed on the third rail first followed by the placement of the white paddle to the running rail. Additionally, the paddles were placed while the WSAD was laying in the horizontal position. The WSAD is to remain vertical until both paddles are installed. The WSAD is to only move to the horizontal position after activation of the WSAD, after the paddles are installed correctly and verification that the two indicator lights are lit confirming that the WSAD is installed in a working condition.

Photo 2: Incorrect examinee work zone set up.

The above-noted multiple errors only resulted in the loss of a single point. According to SARE-05-0463, an examinee is permitted to get multiple areas of the installation of safety equipment incorrect and can still be successful. Each area of the practical examination has a point value of one. Therefore, two areas deemed incorrect are equal to a deduction of two points which occurred in this case. Although the testing is simulated, the use of required PPE reinforces the understanding and requirements of Metrorail Operating Rulebook 17.11.2 "For safety and security reasons, all personnel (employees and contractors) shall wear WMATA approved and required PPE when they enter the roadway." The testing and the verification of the WSAD reinforces MOR 17.12.1 "Prior to use all safety and work equipment must be inspected, tested, and in good working order." and 17.12.2 "Certified safety or work equipment must clearly display a current certification date."

Metrorail examiners deemed this examinee's test successful; these points of concern, noted above, should be addressed. Metrorail must ensure that personnel serving in the capacity of a roadway worker in charge (RWIC) are adequately prepared and knowledgeable in every aspect of the performance of their duties. While this candidate technically passed the examinee did make significant mistakes during the practical which is concerning since a RWIC should have mastery of all skills related to their position which is responsible for the safety of the entire work crew.
