**W-0411 – Red Signal Overrun at West Falls Church Rail Yard – February 14, 2025****Document Purpose:**

**FINAL REPORT OF INVESTIGATION A&I E25252**

# West Falls Church Yard – Red Signal Overrun

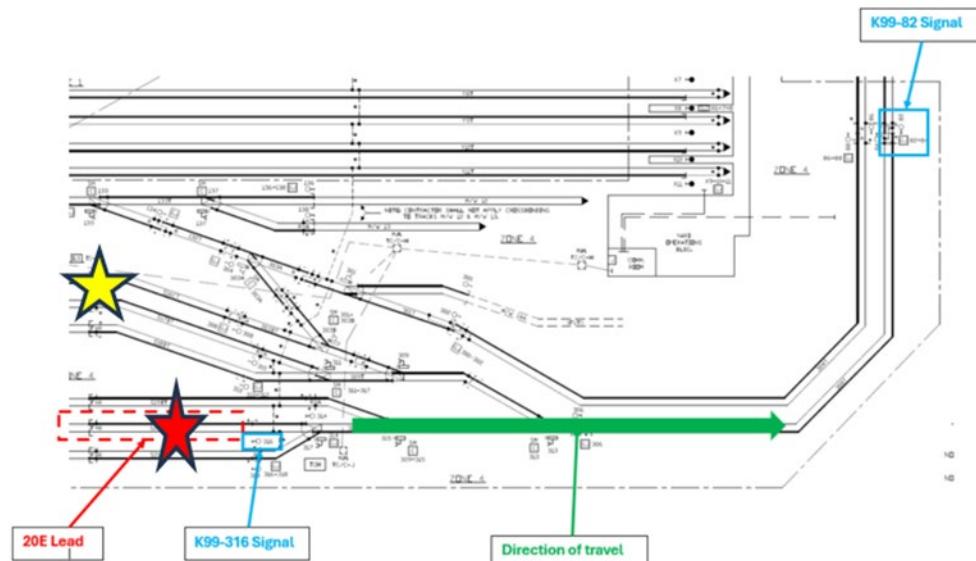
## Field Sketch/Schematics

West Falls Church Yard, Signal K99-316 on 20 East Lead

*This picture is not to scale. The red star indicates the approximate location of railcars 7595-94, and the yellow star indicates the location of the railcars that the RVO was instructed to board.*

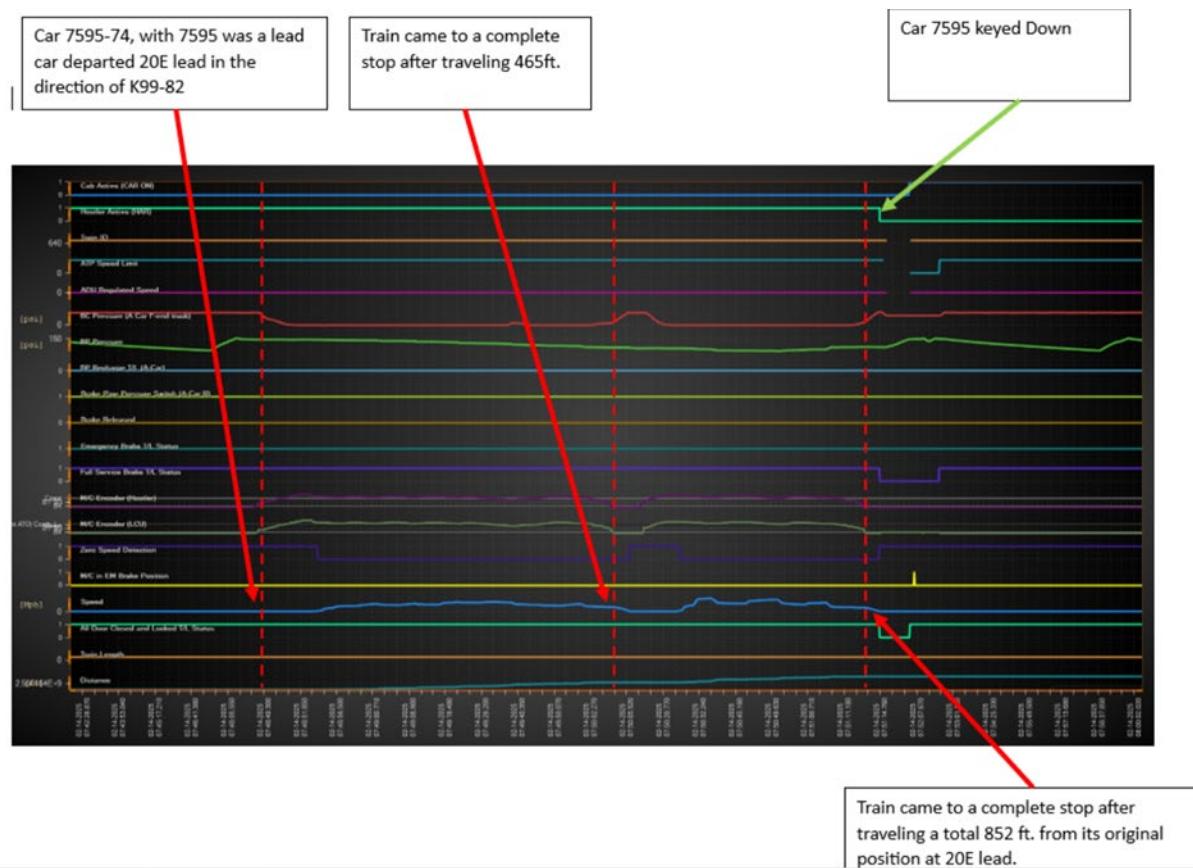
Figure 1 Data from railcar 7595

Railcars 7595-94 were reported for running red signal K99-316 when departing 20 East Lead in the direction of K99-82 signal. Based on Event Recorder (ER) data, railcar 7595's Hostler Panel was keyed up on the open end of 20 East Lead. The Hostler was moved to a P1-P4 Power position, and the train began to move away from the shop towards K99-82 Signal. The train traveled 465 feet before coming to a complete stop. The train traveled at speeds no greater than 5.9 MPH during that time. The Hostler was again placed in a P1-P4 Power position, and the train began to move in the direction of the K99-82 signal. The train traveled an additional 387 feet before coming to a complete stop, traveling no greater than 8.1 MPH during that time. The Hostler panel on railcar 7595 was then keyed down. Railcar 7594 was then keyed up on the opposite end. Railcar 7594 did not move and was keyed down. Based on ER and Vehicle Monitor Data Systems (VMDS) data, there was no fault with the train that contributed to the cause of this incident. The train performed as commanded.

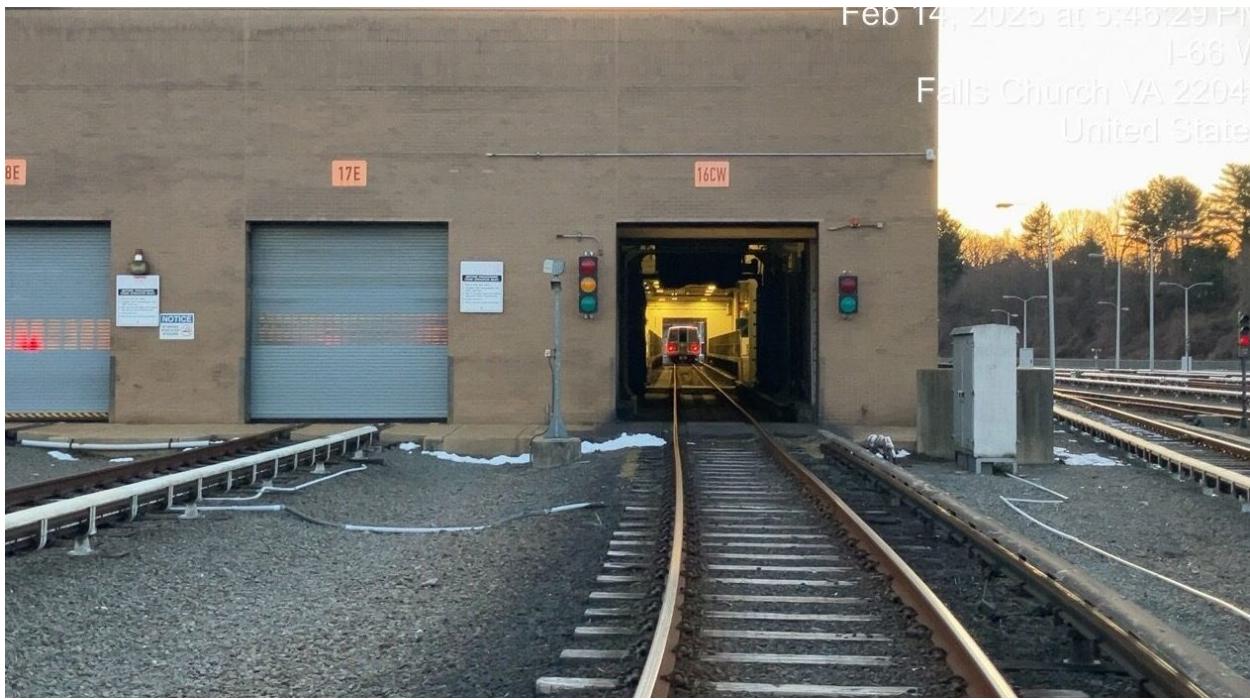
Figure 5 Carwash Track

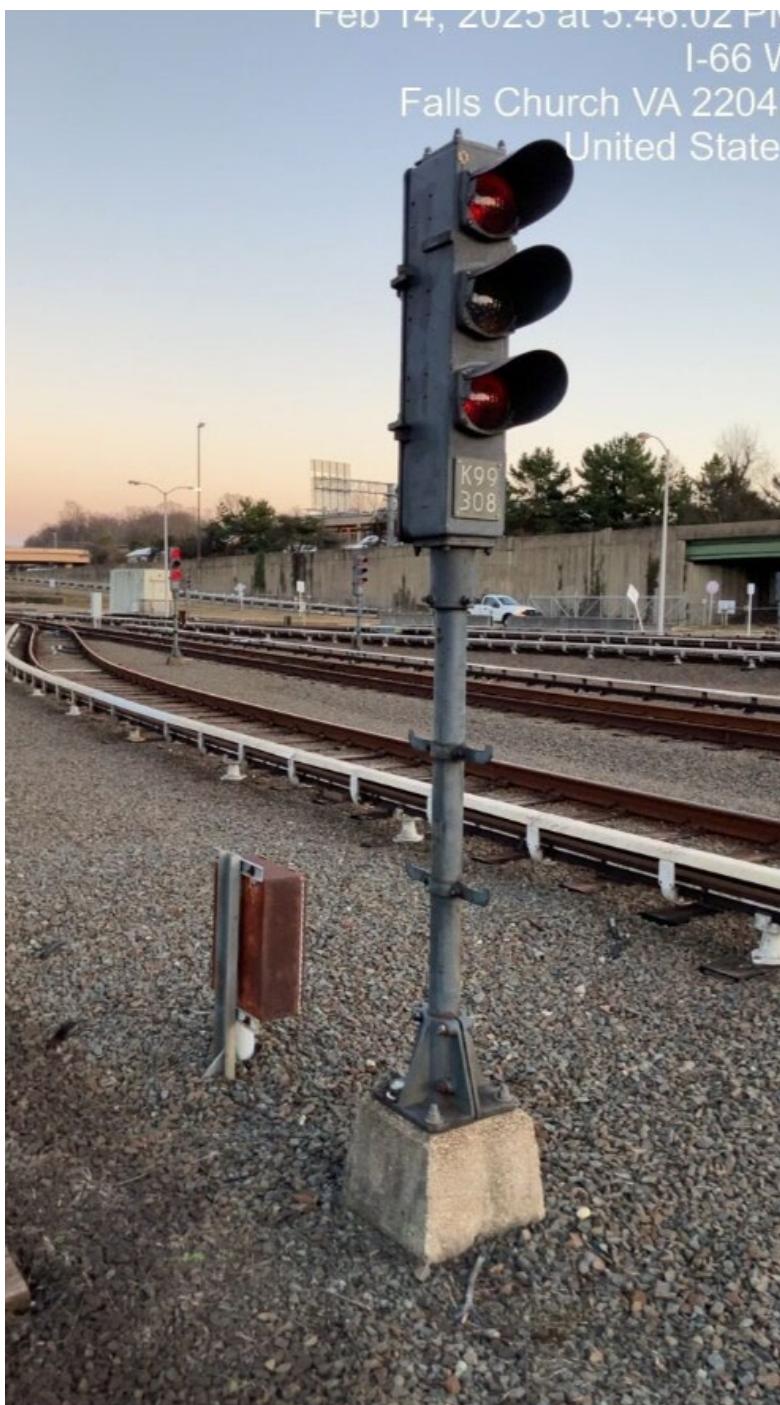
At 07:44 hours, the Student IO granted the RVO permission to pass signal K99-308 red and verify switch 303B was clamped and tucked in a normal position, but the RVO passed the incorrect red signal K99-316. The RVO was instructed to proceed at speeds no greater than 5 MPH over switches, with an absolute block no closer than 10 feet from red signal K99-82, key down, and reverse operating ends. The RVO repeated all instructions but moved the railcars on 20 East Lead instead of the assigned cars on the carwash track.

Figure 6 Signal K99-308

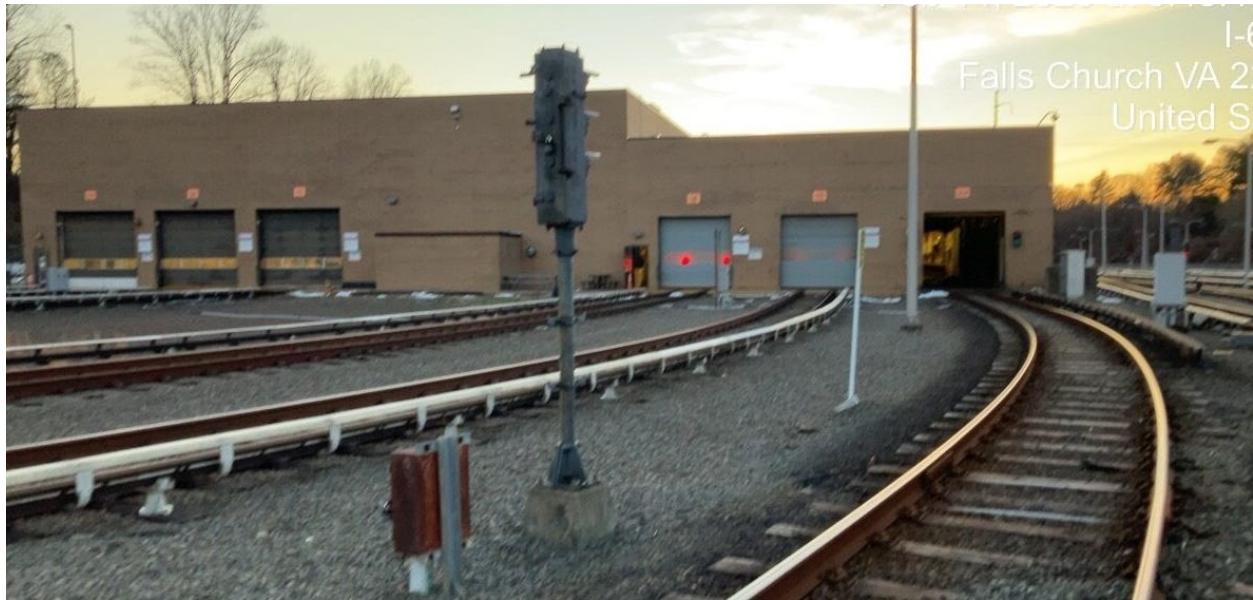
According to the formal interview, the RVO stated they saw railcars 7594-95 on the east side of the shop and boarded that train. At 07:44 hours, the Student IO granted the RVO permission to pass red signal K99-308. They were instructed to verify that switch 303B was clamped and secured in the normal position<sup>1</sup>.

Figure 7 East Side of the S&I Shop

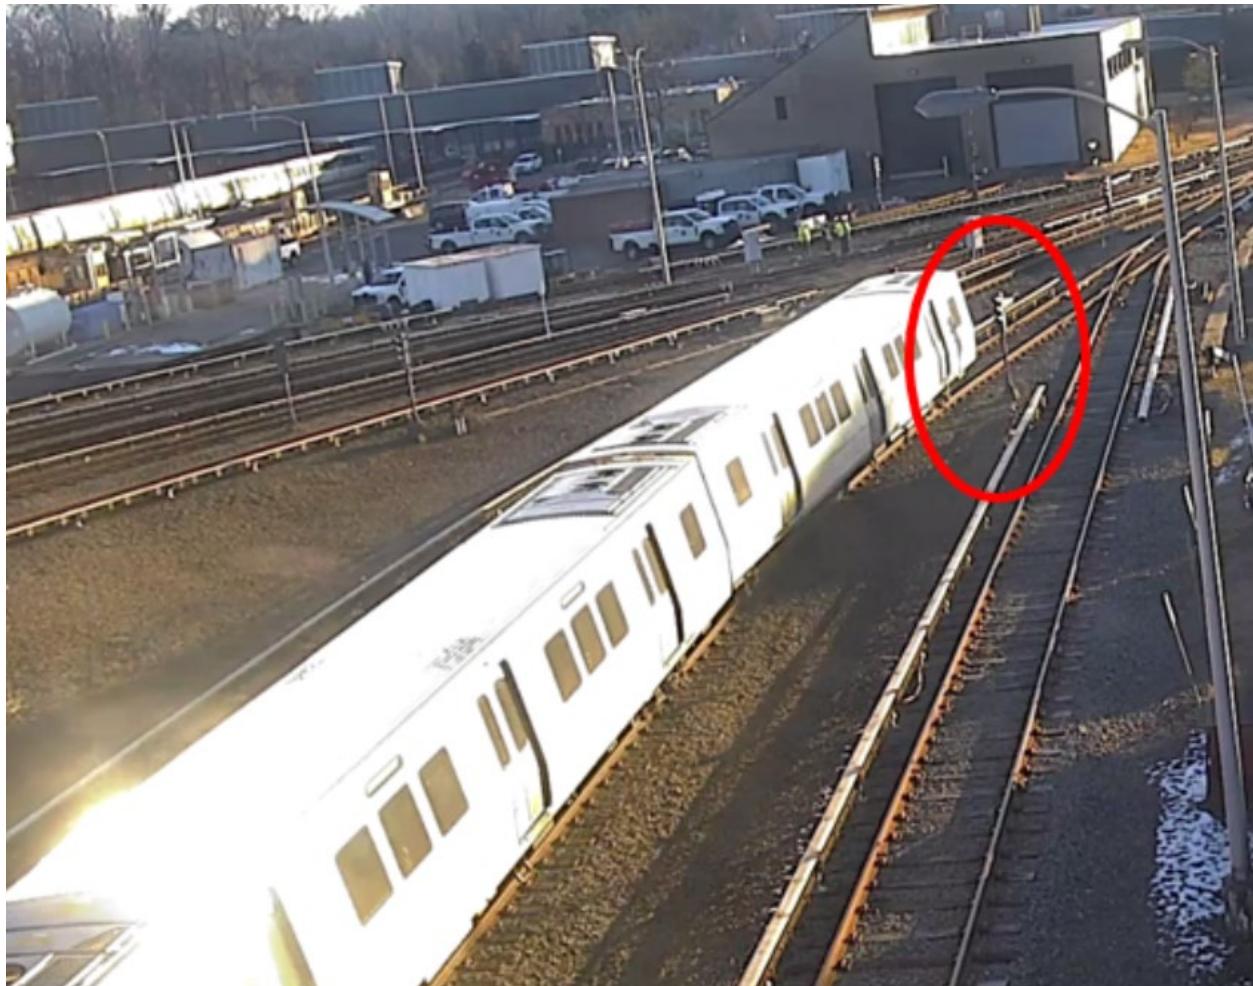
According to Closed Circuit Television (CCTV), at 7:49 hours, railcars 7595-94 passed red signal K99-316 eastbound on track 20 East Lead.

The probable cause for the Red Signal Overrun on February 14, 2025, at West Falls Church Yard track 20 East Signal K99-316 was the RVO's lack of awareness and inexperience. The RVO completed all their training at the Largo Division and was certified at the Alexandria Division. Additionally, the Student IO and IO were contributing factors because they failed to correct the RVO when the RVO mentioned being at the incorrect signal. Lastly, this event was not reported to the MICC within the prescribed timeframe.

Figure 8 Railcar 7594 passing signal K99-316 red

Corrective Action Code	Description	Responsible Party	Estimated Completion Date
123918_SAFE CAPS_RTRA 001	RVO will attend refresher training reviewing MOR 3.1 Passing a stop signal and 3.4 improperly aligned switches.	RTRA SRC	Complete
123918_SAFE CAPS_RTRA _002	IO will attend refresher training reviewing MOR 3.4.2 if a rail vehicle runs through an improperly aligned track switch, the RVO shall stop the vehicle immediately, and report the occurrence to the RTC or IO. All parties shall treat the situation as if the vehicle has derailed, and the vehicle shall not be moved. Subsequent movement of affected rail vehicles shall not be undertaken until investigated and determined to be safe by authorized personnel.	RTRA SRC	Completed

Corrective Action Code	Description	Responsible Party	Estimated Completion Date
123918_SAFE CAPS_RTRA _003	Student IO will attend refresher training reviewing MOR 3.4.2 if a rail vehicle runs through an improperly aligned track switch, the RVO shall stop the vehicle immediately, and report the occurrence to the RTC or IO. All parties shall treat the situation as if the vehicle has derailed, and the vehicle shall not be moved. Subsequent movement of affected rail vehicles shall not be undertaken until investigated and determined to be safe by authorized personnel.	RTRA SRC	Completed
123918_SAFE CAPS_RTRA _004	RTRA will develop and distribute a staying focused: Preventing red signal overruns and zero speed commands campaign	RTRA SRC	Completed

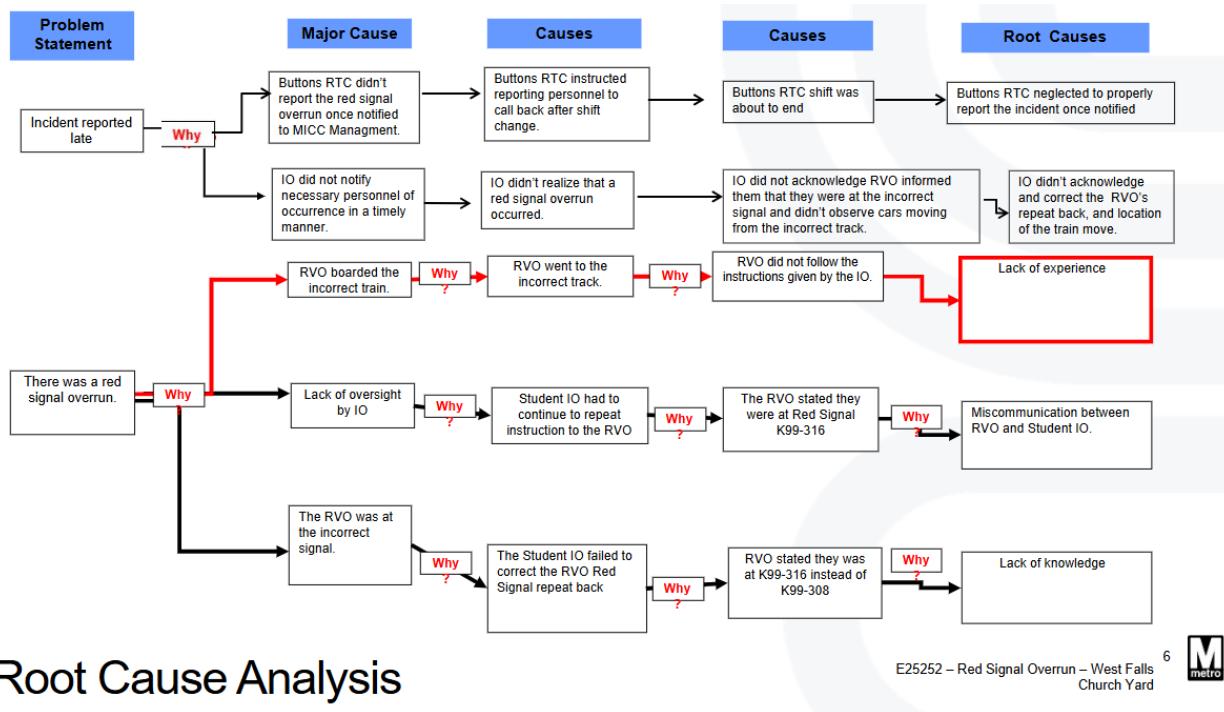
## Appendix E – Why-Tree Analysis

## Root Cause Analysis

E25252 – Red Signal Overrun – West Falls Church Yard
