**W-0412 – Improper Rail Vehicle Movement at Grosvenor-Strathmore Station – February 23, 2025****Document Purpose**

**FINAL REPORT OF INVESTIGATION A&I E25305**

<b>Date of Event:</b>	February 23, 2025
<b>Type of Event:</b>	O-7; Improper Rail Vehicle Movement
<b>Incident Time:</b>	16:50 Hours
<b>Location:</b>	Grosvenor Strathmore Station
<b>Time and How received by Safety:</b>	17:07 Hours, Safety Information Official (SIO)
<b>Washington Metrorail Safety Commission (WMSC) Notification Time:</b>	18:09 Hours
<b>Responding Safety Officers:</b>	None
<b>Rail Vehicle:</b>	Train ID#155 (L3043-42x3013-12x3060-61T)
<b>Injuries:</b>	None
<b>Damage:</b>	None
<b>Emergency Responders:</b>	None
<b>Safety Management System Incidents/Accidents (SMS I/A) Incident Number:</b>	20250228#124189

# Grosvenor Station – Improper Rail Vehicle Movement

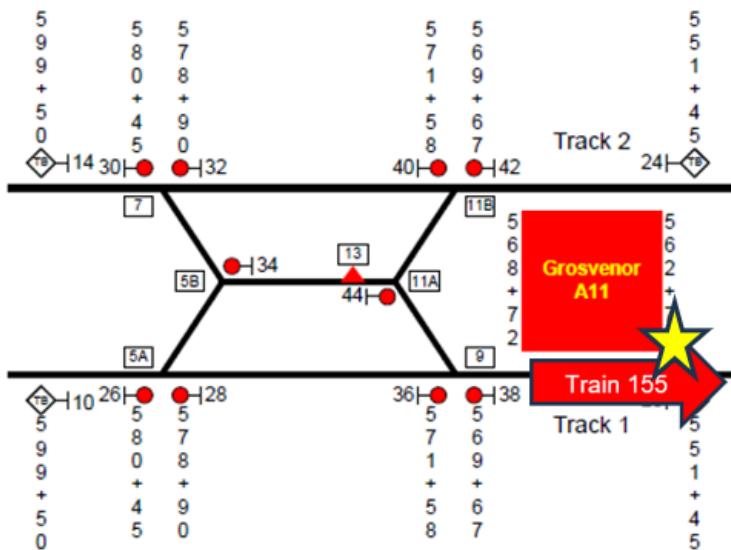
## Field Sketch/Schematics

\*This picture is not to scale. The yellow star indicates the approximate location where Train 155 moved without speed commands.

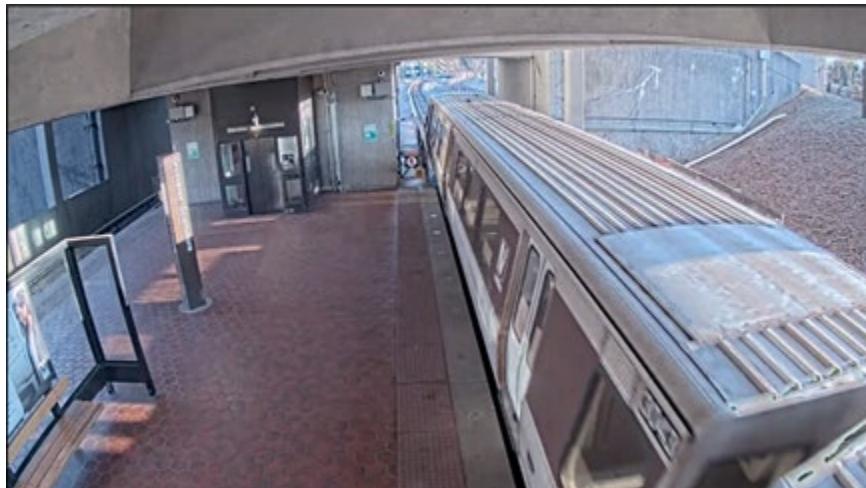
According to Closed Circuit Television (CCTV), at 16:50 hours, Train ID 155, a six-car 3000 series train (L3043-42x3013-12x3060-61T), stopped at end gate with all cars on the platform and serviced Grosvenor Station. Thirty-four seconds later, the RVO closed the train doors and departed the station southbound.

Figure 1 - Train ID 155 is exiting Grosvenor Station

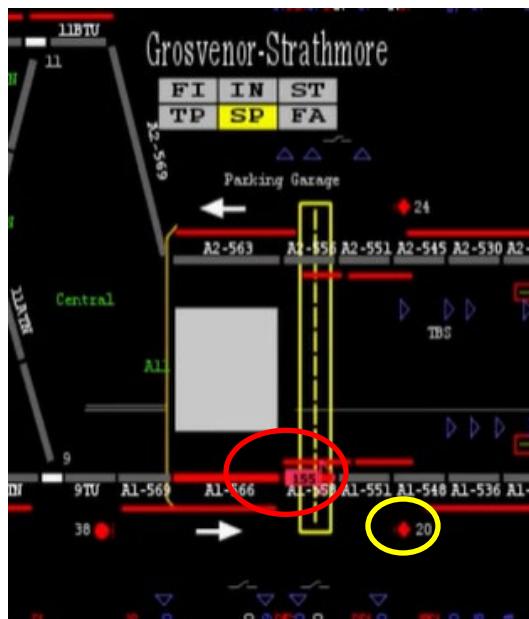
AIMS playback confirmed that at 16:51 hours, Train ID 155 began moving towards Medical Center Station on Track 1 while the turnback was still displaying a red aspect. The VMDS analysis revealed that the speed commands dropped to zero as the train stopped at Grosvenor Station.

Figure 2 - Showing Train ID 155 in manual operation mode the yellow circle shows the red turnback.

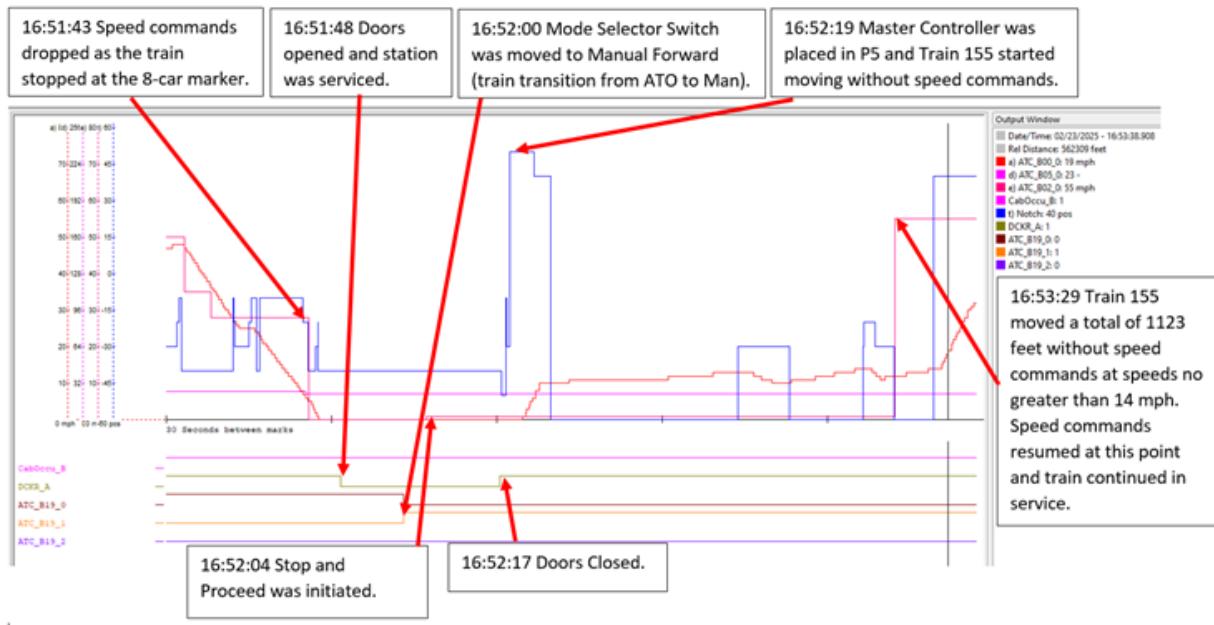
The Office of Chief Mechanical Officer (CMOR) and Incident Investigation Team (IIT) data download from Train ID 155 operating car 3043 revealed that at 16:52 hours, the mode selector switch transitioned from ATO to manual forward and Stop and Proceed was initiated while the train doors were open.

No mechanical defects that could have contributed to the incident were identified during the data analysis. The train operated as designed and responded to the commands entered through the Master Controller. In short, the speed commands were removed, the stop and proceed were initiated after the station was serviced, and the train proceeded to move inbound.

Figure 4 - Data Download from Train ID 155, lead car 3043.

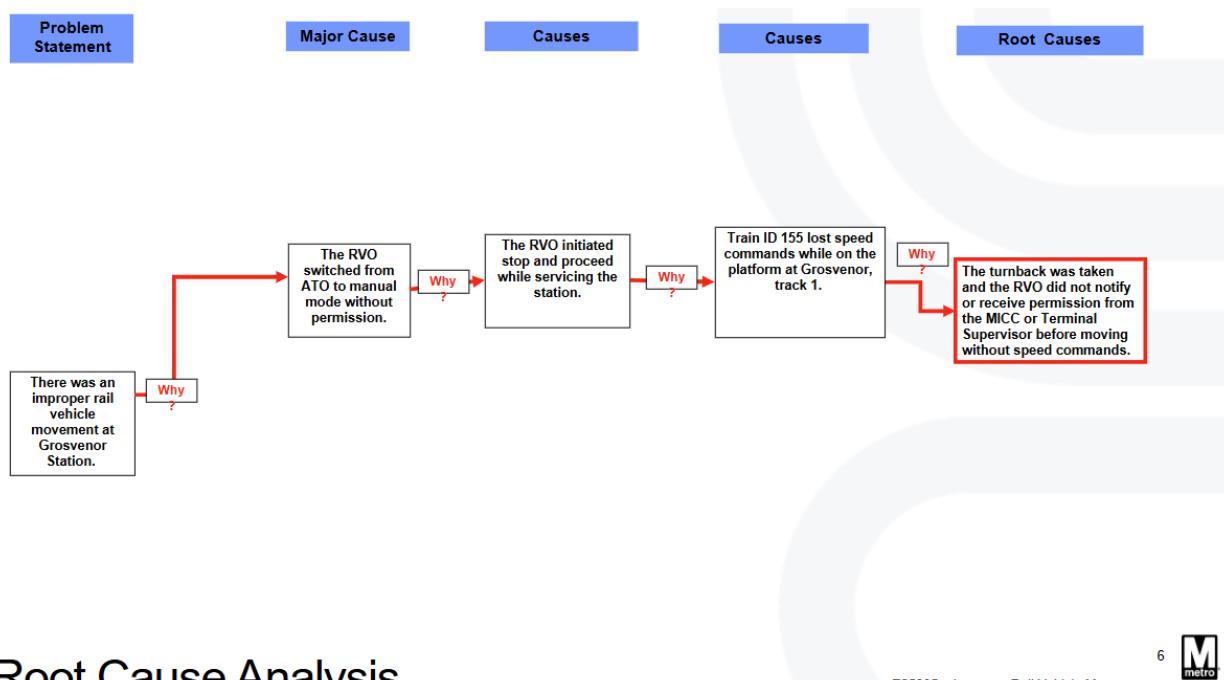
## Appendix D – Why-Tree Analysis

The probable cause of the Improper Rail Vehicle Movement event on February 23, 2025, at Grosvenor Station was that the RVO was rushing and not following the established procedures. The RVO did not contact the MICC to report that they did not have speed commands before activating stop and proceed.

Corrective Action Code	Description	Responsible Party	Estimated Completion Date
124189_SAFE CAPS_RTRA _001	RVO will attend refresher training to review MOR 9.8 Speed Commands, 9.8.1, 9.8.2, and 9.8.3. RVO will also review the RTRA personnel's Notice Red Signal/Zero Speed commands compliance.	RTRA SRC	Completed
124189_SAFE CAPS_RTRA _002	RTRA will develop and distribute a Staying Focused: Preventing Red Signal Overruns and Zero Speed Commands campaign.	RTRA SRC	Completed
