**W-0413 – Evacuation for Life Safety Reasons at Waterfront Station – February 25, 2025****Document Purpose:**

FINAL REPORT OF INVESTIGATION A&I E25320

Waterfront Station – Evacuation for Life Safety Reasons

February 25, 2025

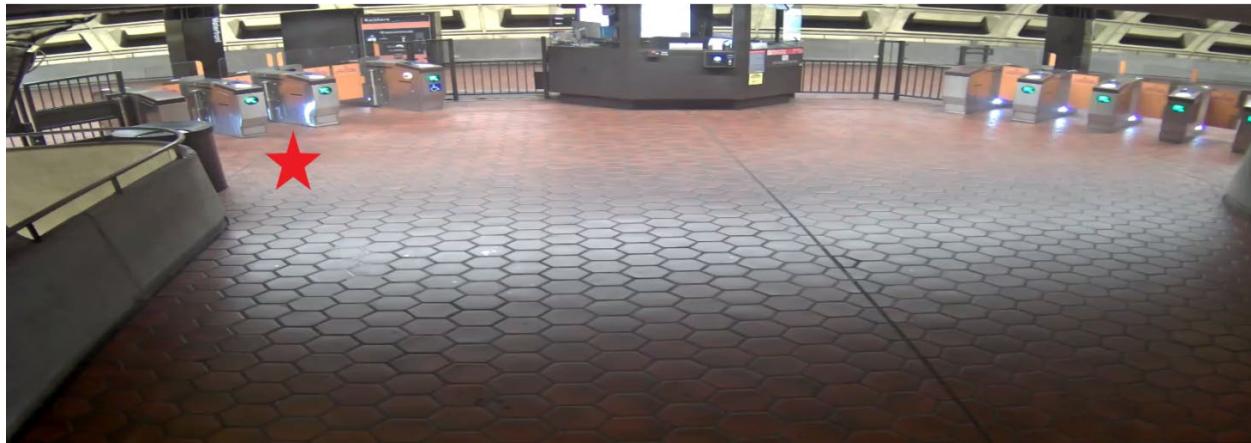
The probable cause for the Evacuation for Life Safety Reasons event on February 25, 2025, at Waterfront Station was due to a shooting on the mezzanine level.

Image 1: The red star indicates the area of the assault.
