WMSC Inspection Report 20251212

Title: Red Line - Life Safety Inspection

Location: Red Line (Farragut North (A02) to Van Ness (A06)

Date of Inspection: 12/12/2025

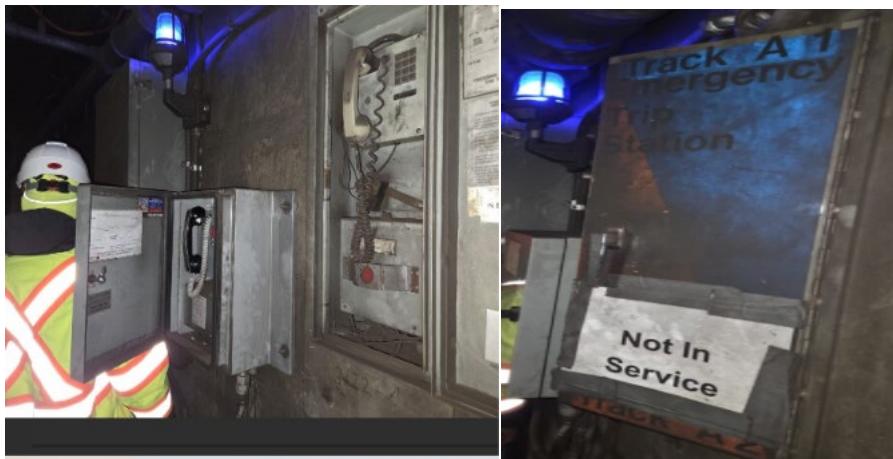
At Farragut North (A02), non-operational ETS Boxes are located at each end of the station platform and are not secured. There is a temporary/insubstantial paper sign attached with grey duct tape stating, “out of service” on one of the discontinued ETS boxes. The discontinued/non-operational ETS boxes must be secured to prevent these from being mistaken for functioning ETS boxes and being accessed or relied upon during an emergency event. A previous such condition noted by a WMSC inspection was mitigated by Metrorail as seen in the third photo below showing a mitigated discontinued non-operational ETS box at Judiciary Square.

Hazard Rating: 1D

Photo 1 (left): An open non-operational ETS box at Farragut North (A2).

Photo 2(right): A “Not in Service” sign on one of the non-operational ETS boxes at Farragut North (A2).

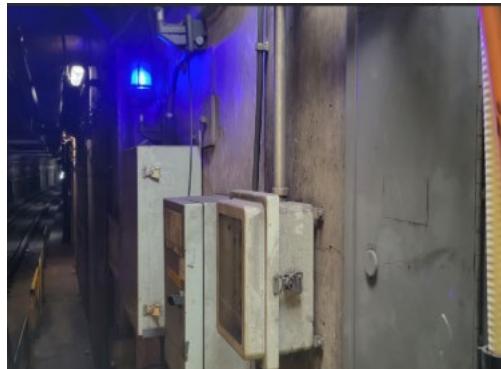
Photo 3: An example of a mitigated legacy non-operational ETS box that was sealed shut at Judiciary Square (B02).

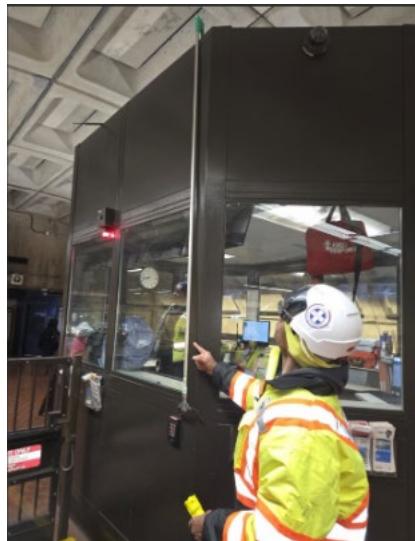
A long metal pole was hanging on the outside of the Station Manager's Kiosk on the upper level of the platform located at Dupont Circle (A03). The metal pole is a potential hazard should a patron or employee accidentally walk into the pole.

Hazard Rating: 2E

Photo 4: Unsecured metal pole used to retrieve fallen items at Dupont Circle (A03).

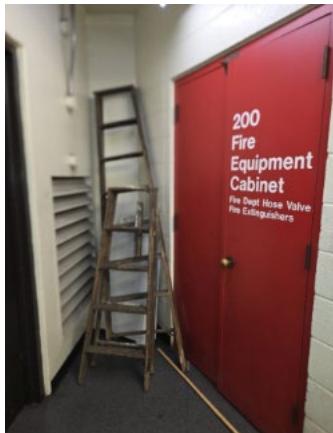
At Dupont Circle (A03), Fire Cabinet 200 located in the emergency equipment room is partially obstructed. In an emergency, access to the equipment inside of the cabinet would be restricted as a result of materials that are being stored as the photo shows - which would inhibit the response to an emergency.

Hazard Rating: 2D

Photo 5: Partially blocked fire equipment cabinet 200 at Dupont Circle (A03).

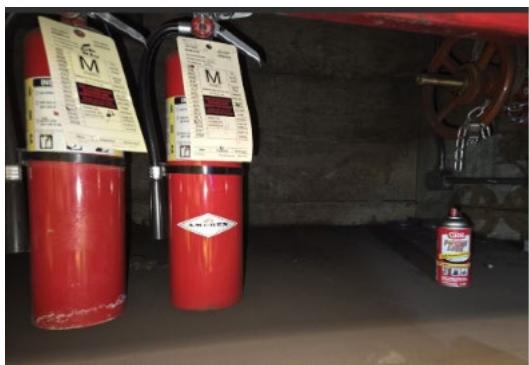
Fire equipment cabinet 108 at Dupont Circle (A03) contains an aerosol spray container stored with the two-fire extinguishers. The aerosol can is a combustible item and poses a fire hazard.

Hazard Rating: 4D

Photo 6: Contents of fire equipment cabinet 108 at Dupont Circle (A03).

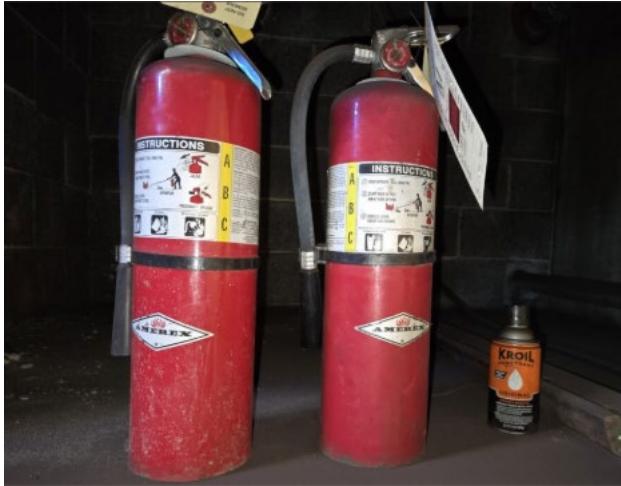
Fire equipment cabinet 101 at Woody Park (A04) contains an aerosol spray stored with the two-fire extinguisher. The aerosol can is a combustible item and poses a fire hazard. In addition, a piece of metal was improperly stored in the cabinet next to the fire extinguishers and aerosol spray container.

Hazard: 4D

Photo 7: Contents of fire equipment cabinet 101 at Woody Park (A04).

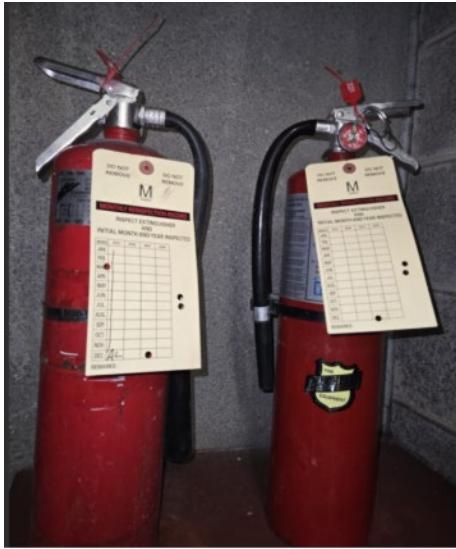
At Woody Park (A04), in fire equipment cabinet 101 located in room C-200, one of the two fire extinguishers has an inspection card with no signatures. Fire extinguishers are required to be inspected monthly. This extinguisher cannot be verified as functioning and up to date since it was never inspected shown by a lack of signatures on the inspection card that was attached. Not inspecting fire extinguishers introduces the risk of the extinguisher not being functional during an emergency condition.

Hazard: 2D

Photo 8: Fire extinguisher (right) missing inspection signatures in fire equipment cabinet 101 in room RMC-200 at Woody Park (A04).

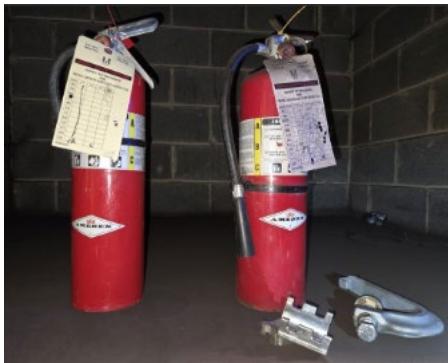
Fire equipment cabinet 101 at Cleveland Park (A05) contains miscellaneous items stored with the two fire extinguishers. Fire Equipment cabinets are to be used only for storage of fire related emergency equipment and not the storage of miscellaneous items.

Hazard: 4D

Photo 9: Miscellaneous items stored in fire equipment cabinet 101 at Cleveland Park (A05).

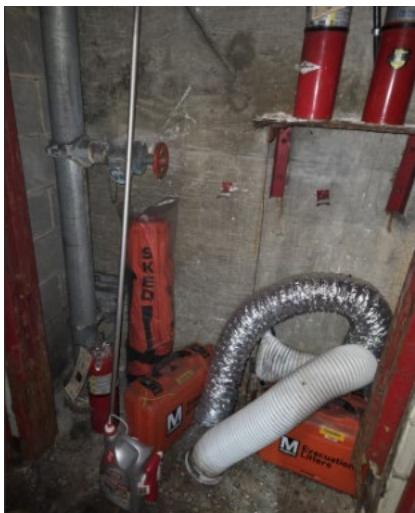
Fire equipment cabinet C-204 located on the mezzanine level at Cleveland Park (A05) also showed trash and debris stored with the emergency equipment and fire extinguishers. Fire equipment cabinets are to be used only for storage of fire-related emergency equipment and not the storage of trash and other miscellaneous items. Such storage practices could inhibit the access to life safety equipment in this cabinet during emergencies.

Hazard Rating: 2D

Photo 10: Contents of fire equipment cabinet C-204 at Cleveland Park (A05).

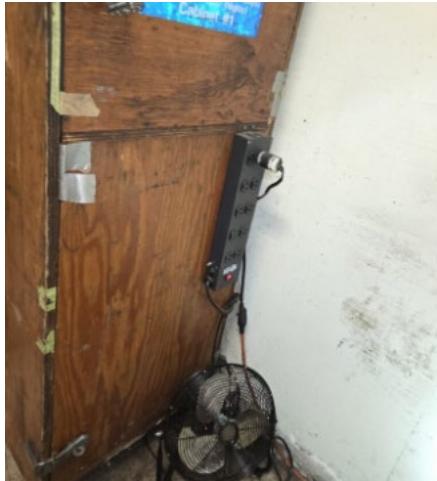
At Cleveland Park (A05), in the emergency equipment room 202 located on the mezzanine level, several fire hazards were identified. For example, a microwave oven was plugged into an extension cord; another extension was plugged into a secondary cord power strip; and a secondary power strip was plugged into a surge protector. Each one of the separate cords should be connected to an individual electrical outlet, thereby eliminating the fire hazard.

Hazard Rating: 2D

Photo 11: Secondary power strip plugged into a surge protector at Cleveland Park (A05).

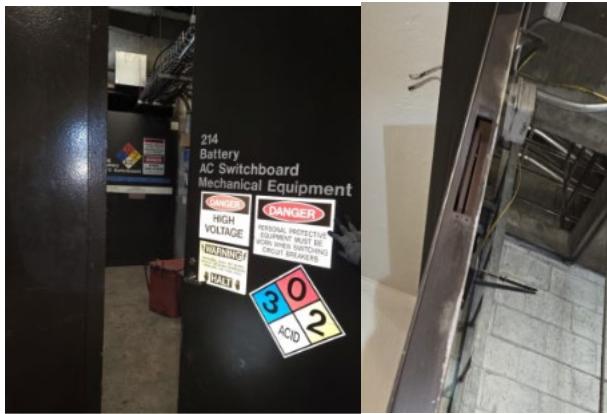
In the emergency equipment room 202 on the mezzanine level at Cleveland Park (A05), the battery AC switchboard mechanical equipment Room 214 is located. Room 214 has “Danger” and “High Voltage” sign and a NFPA diamond sign warning personnel that the contents in the room are extremely corrosive and requires special handling. However, the door to this room 214 is malfunctioning and not able to be locked and secured. This is an area that is frequented by customers as the customer bathrooms are in the same area.

Hazard Rating: 1D

Photos 12 and 13: Unsecured AC switchboard mechanical room at Cleveland Park (A05).

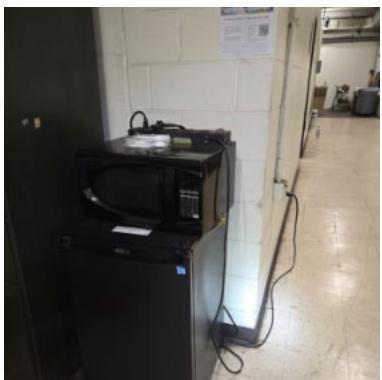
At Van Ness UDC (A06), a microwave oven and refrigerator are plugged into a power strip located in the emergency equipment room on the mezzanine level. Overloading power supplies is a fire hazard. Cooking devices are required to be plugged directly into outlets.

Hazard Rating: 2D

Photo 14: microwave plugged into a power strip.
