WMSC Inspection Report 20251217

Title: Brentwood Yard (B99) Inspection

Location: Brentwood Yard (B99)

Date of Inspection: 12/17/25

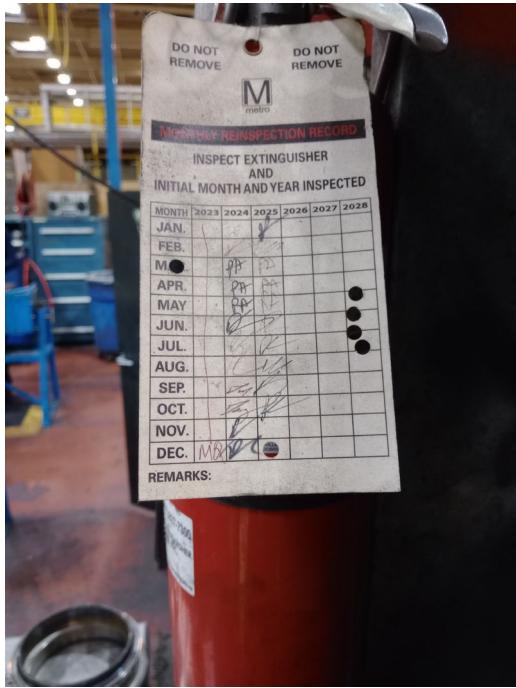
WMSC Inspectors examined extinguishers at the Brentwood Yard (B99) Service and Inspection (S&I) shop. Three extinguishers were not in compliance. Two fire extinguishers were identified as not having been inspected in the required period, and one fire extinguisher did not have an inspection tag. For a fire extinguisher without an updated inspection tag, it is not possible to verify its last inspection date.

Metrorail's Procedure Number: 4900-3-01/00, Portable Fire Extinguishers, states that "7.3. Fire extinguishers shall be inspected manually at intervals not exceeding 31 days."

Hazard Rating: 1E

Photo 1: Fire Extinguisher last inspected in October 2025.

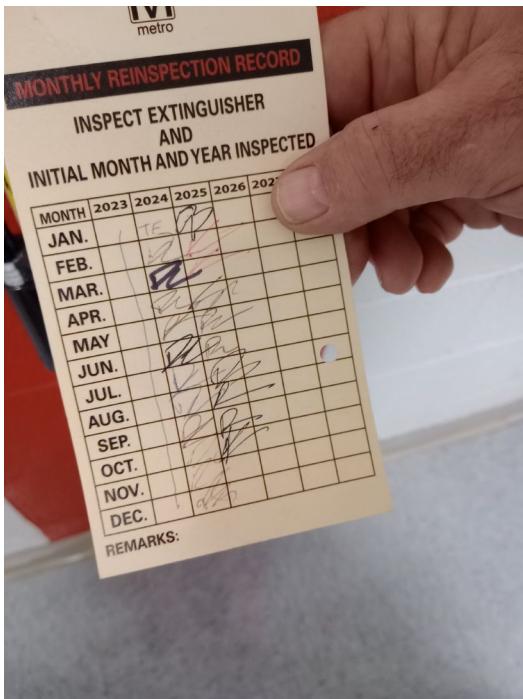
Photo 2: Second Fire Extinguisher last inspected in October 2025.

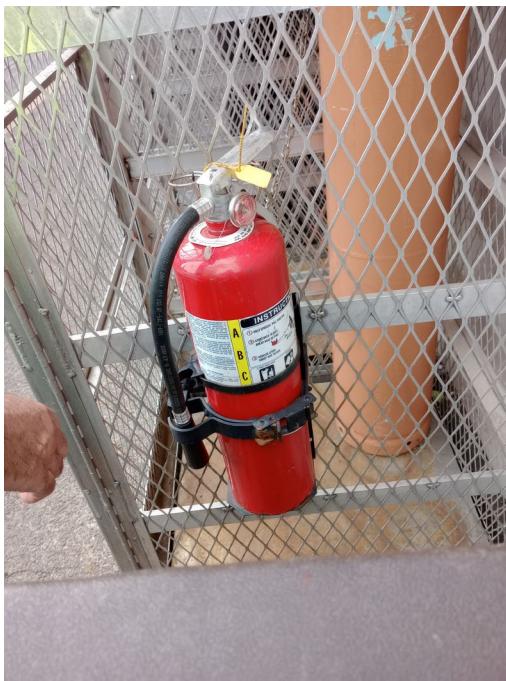
Photo 3: Fire Extinguisher, attached to propane cylinder cage, with no tag.

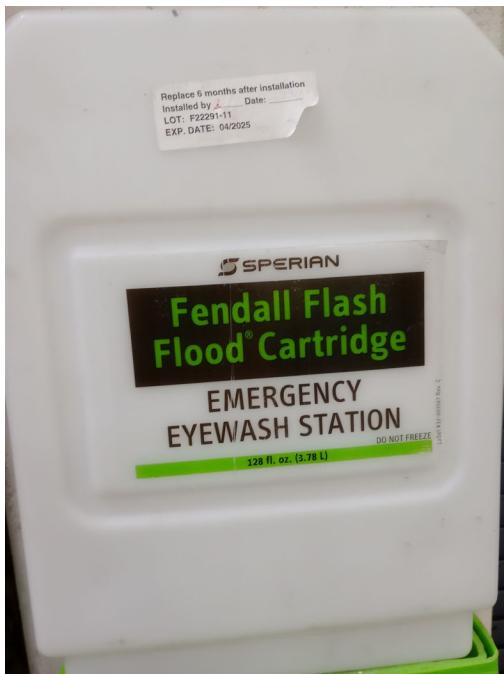
WMSC Inspectors checked eye wash stations and observed issues with three stations within the Brentwood Yard (B99) Service and Inspection (S&I) Shop. This included one blocked station, and two stations with expired cartridges.

Metrorail's Standard Number: 4480-2-02/01, Personal Protective Equipment (PPE) Program, states "6.5.5. Emergency eyewash facilities will be provided (within 10 seconds or 55 feet) in all areas where there is a risk of hazardous chemical splash."

Hazard Rating: 3B

Photo 4: Eye Wash Station label showing expiration date of April 2025.

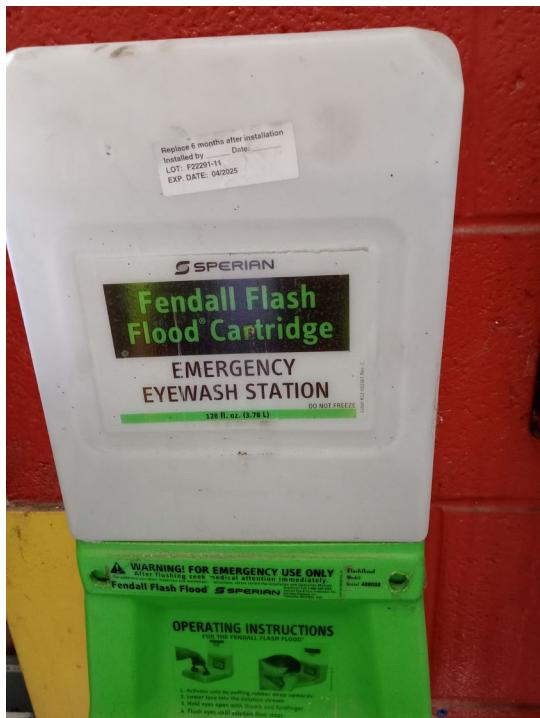
Photo 5: Second Eye Wash Station label showing expiration date of April 2025.

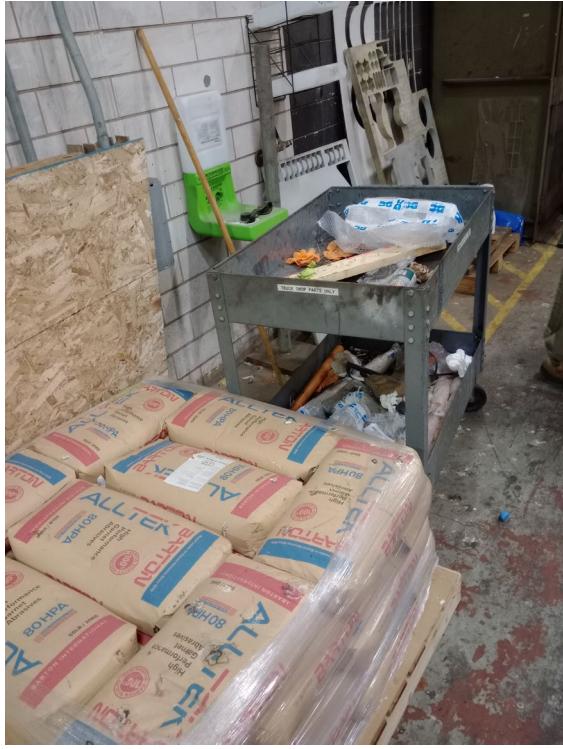
Photo 6: Blocked Eye Wash Station.

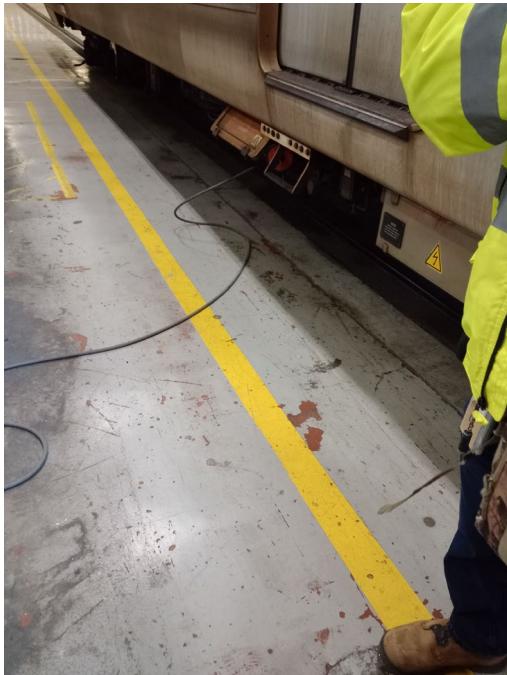
At the Service and Inspection (S&I) Shop the shop's auxiliary power cables that run along the floors between the shop's power boxes, and the auxiliary power plug on the train were uncovered in many places. Covers of the exposed power cables are required to avoid damage from foot traffic or damage from various equipment riding over exposed cables. Cable covers were available but were not being used.

Metrorail Special Alert SA-22-L Revision 00 Date: 12/21/2022, identifies the hazard of uncovered high voltage cable wires and the proper usage of high voltage covers in shop conditions.

Hazard Rating: 3D

Photo 7: Shop auxiliary power cable crossing a walking path without a cover.

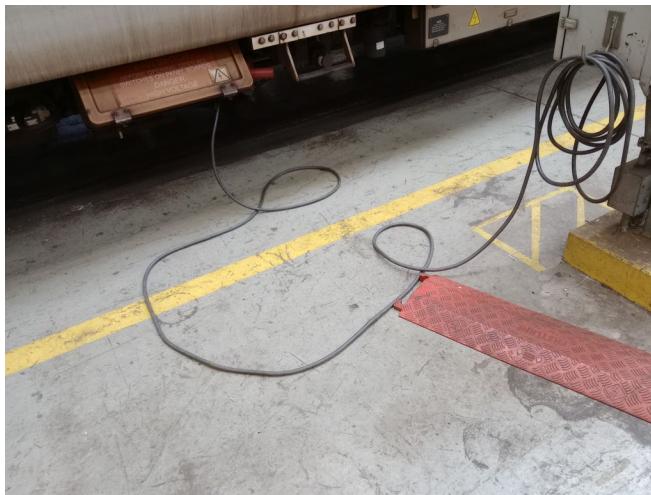
Photo 8: Shop auxiliary power cable crossing walking path without cable cover. Cover available for use.

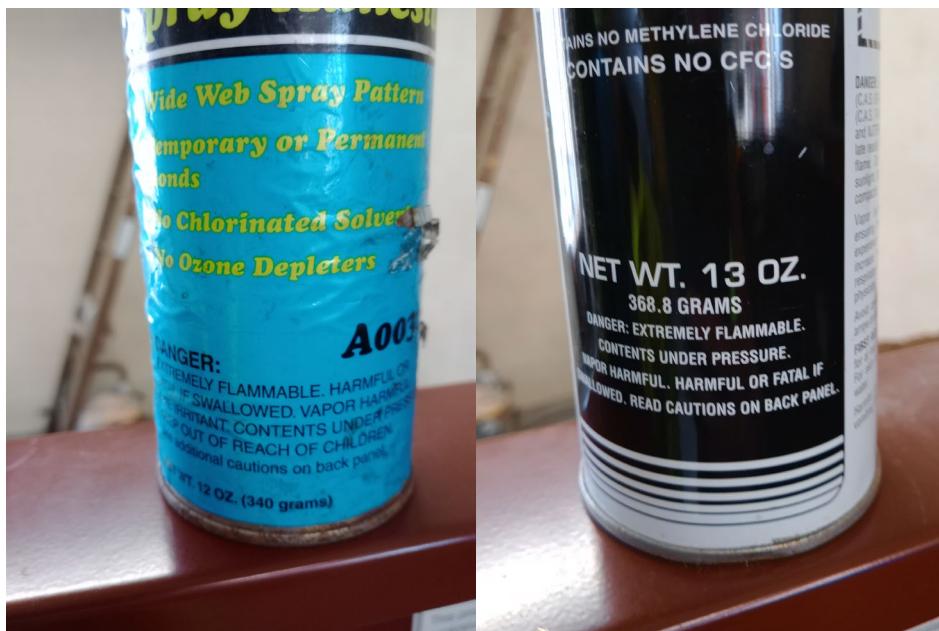
At the Service and Inspection (S&I) Shop, WMSC Inspectors found materials marked as "Extremely Flammable" being stored in a cabinet located in a HVAC room on the second floor of the facility. This cabinet is marked with a warning label stating that "This product is not designed for storing or transporting flammables, explosives, hazardous wastes or

hazardous materials such as containers of solvents, gun powder, dynamite, gasoline, propane, or acetylene tanks, etc.”

Hazard Rating: 3B

Photos 9 and 10: Flammables found in a non-flammables storage cabinet.

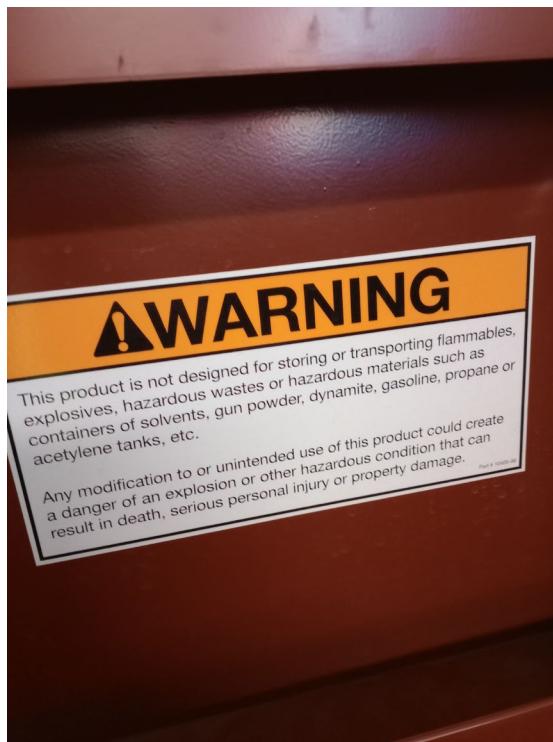
Photo 11: Non-flammables storage cabinet being used to store flammable materials.

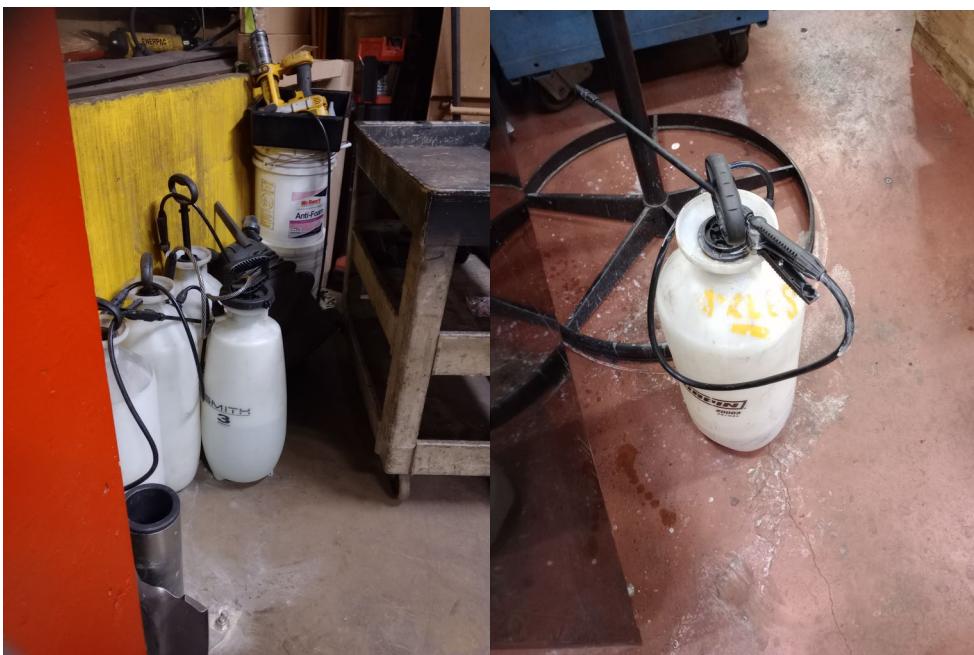
At the Service and Inspection (S&I) Shop, WMSC Inspectors found handheld tank sprayers containing unknown liquids with no identifying labels. The sprayers did contain a liquid, but the contents could not be identified. WMATA's Environmental Standard Operating Procedure (ESOP) Manual states that "The second rule is that all containers must have labeling. Keep the original manufacturer labels and any OSHA/DOT/NFPA stickers intact and legible. If you transfer a hazardous material from a large container to a small one, the small container must be marked with its contents and labeled with either an OSHA or NFPA label."

Hazard Rating: 3B

Photos 12 and 13: Handheld tank sprayers without identifying labels.
