WMSC Inspection Report 20251222

Title: Metrorail Winter 2025 Shutdown Site Inspection

Location: U Street (E03) to Georgia Ave-Petworth (E05)

Date of Inspection: 12/22/2025

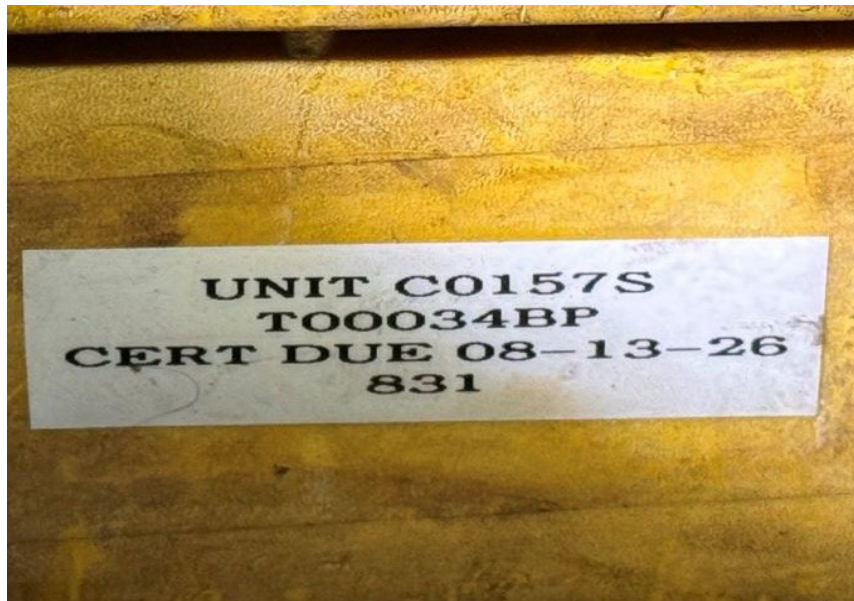
WMSC inspected seven Warning Strobe and Alarm Device (WSAD) and found that all seven were within calibration.

Photo 1: WSAD shown to be in compliance.

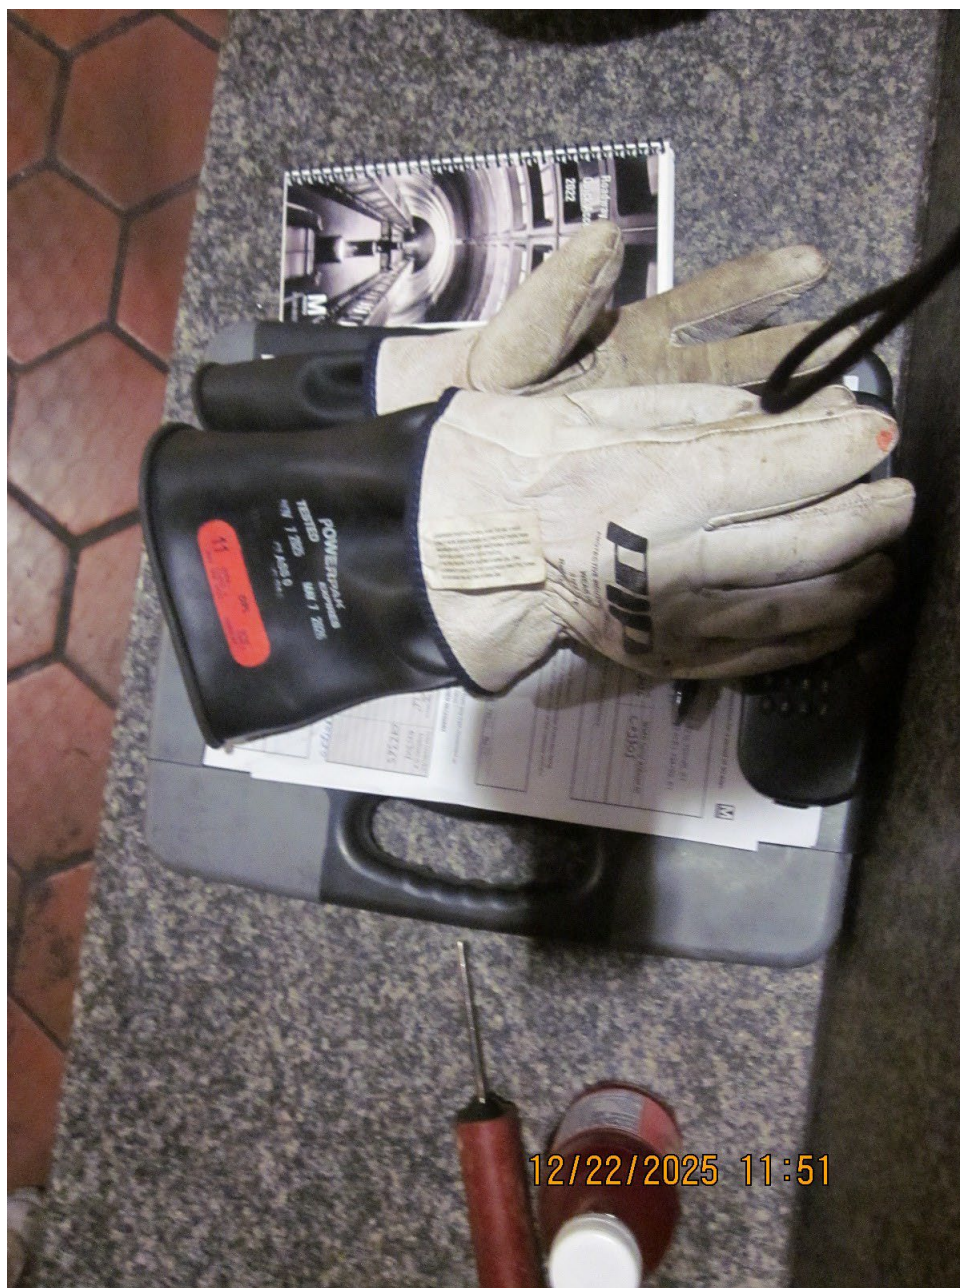
WMSC inspected one pair of insulated gloves. The gloves noted a testing date of November 7, 2025, and an expiration date of May 2026. These gloves were within calibration.

Photo 2: Insulated Third Rail Glove in compliance.

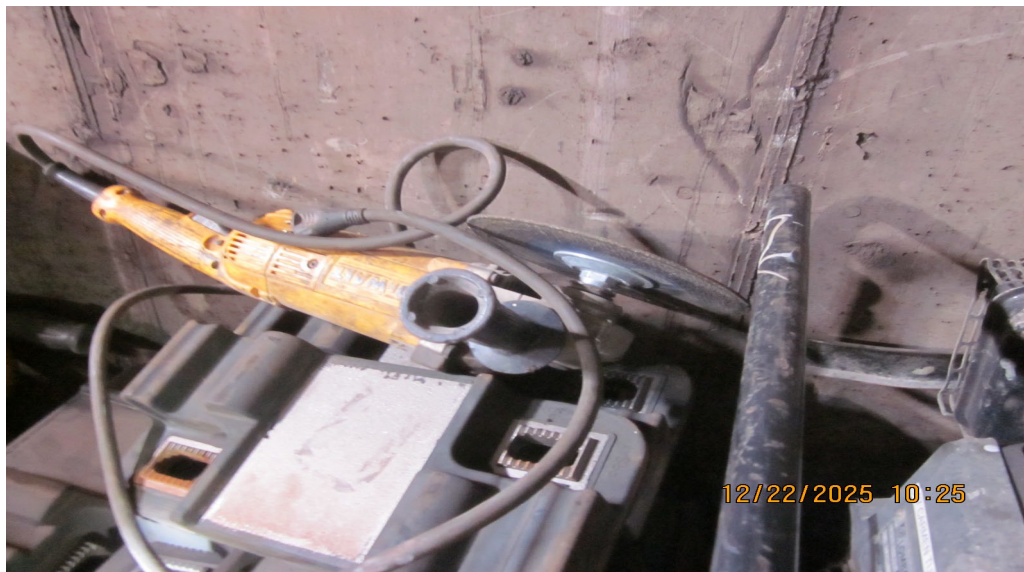
Rail welders were using hand grinders without the proper guards in place. Metrorail's Standard Number: 4443-2-01/00, Machine Guarding Program (Rev. 0, November 1, 2024), section 6.7.1.1 states "If tools are designed with a guard, the guard shall not be removed or modified." Safety guards protect personnel from injury (both the workers and those nearby) because of hazards such as flying debris, sparks, and broken wheel fragments if the grinder wheel shatters.

Hazard Rating: 2C

Photo 3: Grinder shown with no guard.

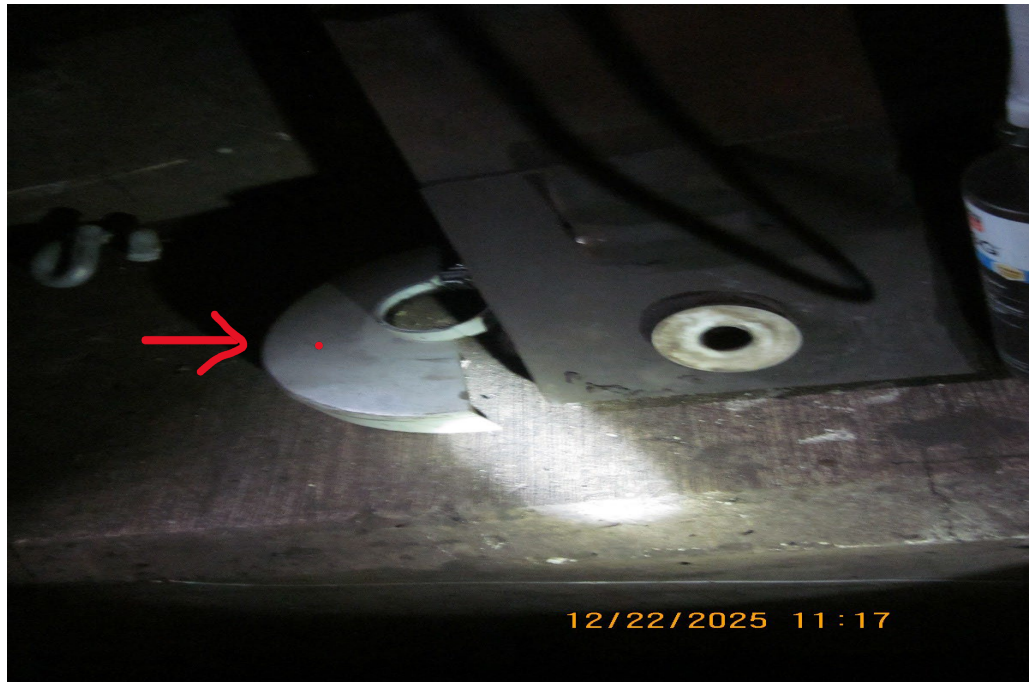
Photo 4: Shows the guard detached from the grinder.

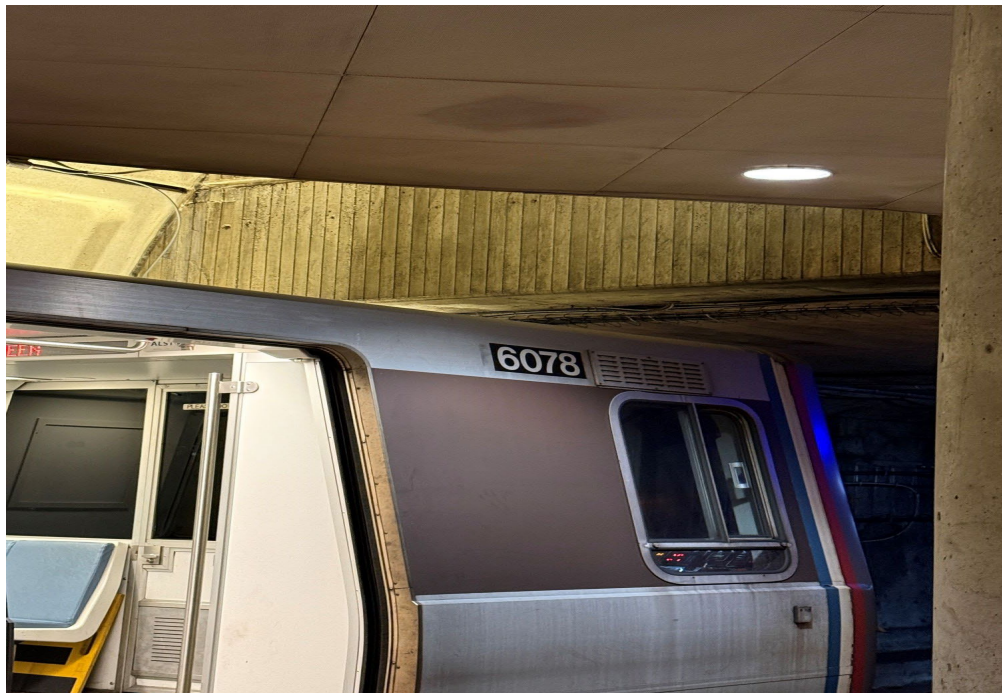
For the duration of the WMSC inspection, several trains operating in the single-track area were observed not complying with Metrorail Operating Rulebook (MOR 8.3) Reverse Movement on Controlled Tracks rule, which states:

“8.3.1 When trains are operated against the normal direction of traffic, the Rail Vehicle Operator shall alert customers on the platform by sounding the horn in a series of short blasts prior to station entry and until the train is berthed in the station.”

Hazard Rating: 2C

Photo 5: Train #1 was observed at 10:33 am, not sounding the horn at U Street Station.

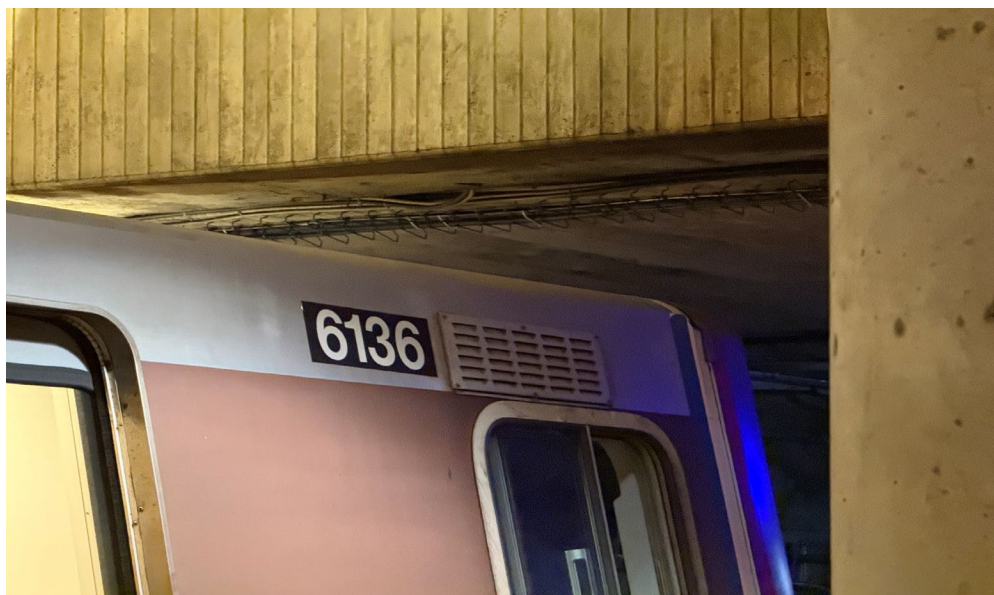
Photo 6: Train #2 was observed at 10:48 am, not sounding the horn at U Street Station.
