WMSC Inspection Report 20260113

Title: Metrorail Station Fire Life Safety Inspection – Green Line

Location: Archives Navy Memorial - Penn Quarter Station (F02) & Waterfront Station (F04)

Date of Inspection: 1/13/2026

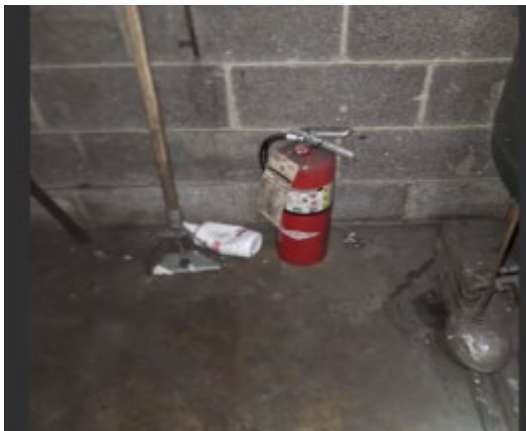
At the Archives – Penn Quarter (F02) station, in the cleaner ejector room 105, the fire extinguisher is located on the floor and not properly installed. International Fire Code (IFC) 906.2 – Portable fire extinguishers shall be selected, installed, and maintained (In accordance with NFPA 10).

Hazard Rating: 1D

Photo 1: Portable fire extinguisher

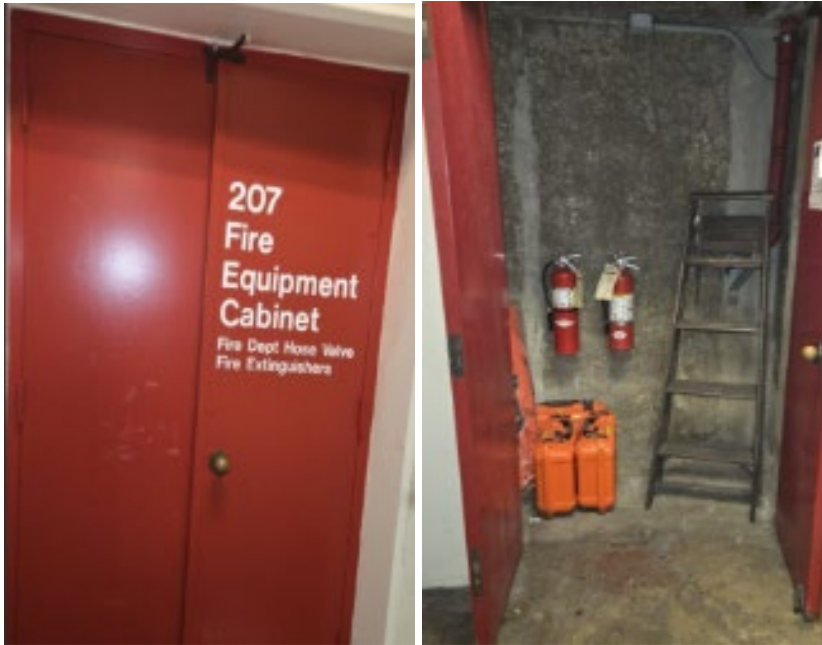
At Archives Navy Memorial – Penn Quarter (F02), fire equipment cabinet 207 located in room 201 of the mezzanine level is being used to store a ladder. The fire equipment cabinet is to be used to store the required safety equipment.

Hazard Rating: 1D

Photo 2: Miscellaneous equipment stored in fire equipment cabinet 207.

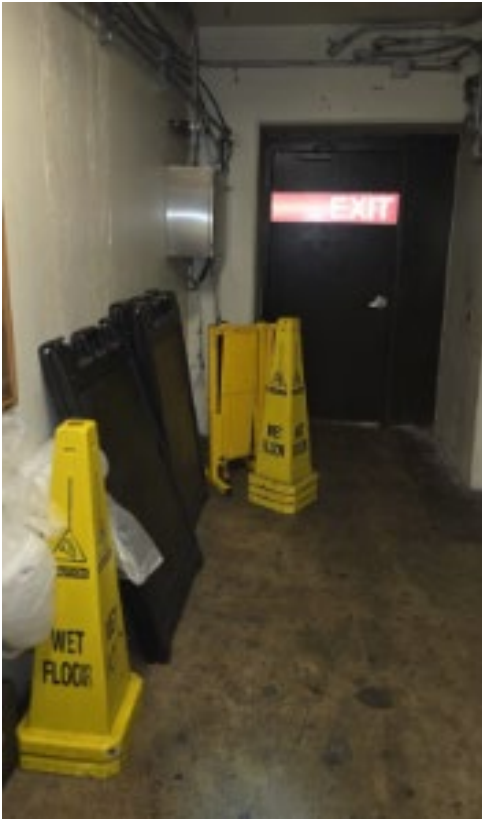
At Archives Navy Memorial – Penn Quarter (F02) the mezzanine level room 201 miscellaneous equipment is stored near the exit door which creates a partially blocked condition. This exit door can be used by the public, first responders, and employees.

Hazard Rating: 1D

Photo 3: Partially blocked Exit door.

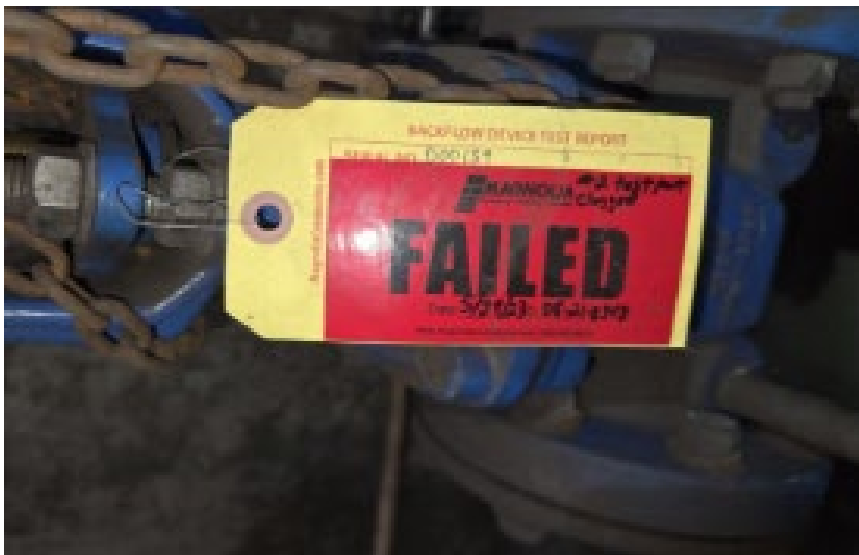
At the Archives Navy Memorial – Penn Quarter (F02) station, the mezzanine level room 201 (Maintenance Room), the backflow protection valve is noted as failing its inspection on May 29, 2023.

(IFC 912.6) - Backflow Protection: The potable water supply to sprinkler and standpipe systems shall be protected against backflow.

Hazard Rating: 1D

Photo 4: Failed Backflow Protection Valve.

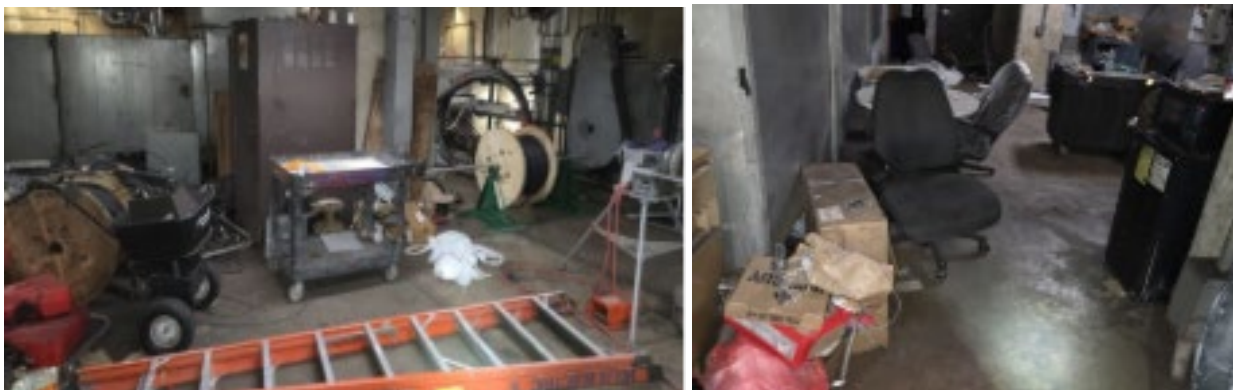
At Archives Navy Memorial – Penn Quarter (F02) station, the mezzanine level room 201 (Maintenance Room), showed accumulated combustible waste materials and trash.

Hazard Rating: 1D

Photo 5: Stored combustible waste materials and trash which is a fire hazard.

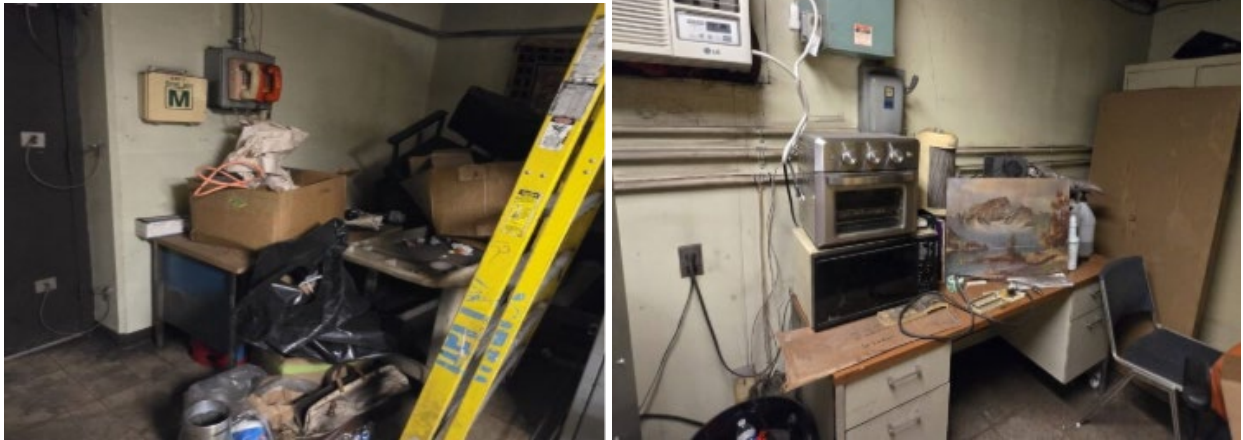
At Archives Navy Memorial – Penn Quarter (F02) station, the platform level operations room 111 showed accumulated combustible waste materials and trash.

Hazard Rating: 1D

Photo 6(left) and photo 7 (right): Operations room 111 - Stored combustible waste materials and trash.

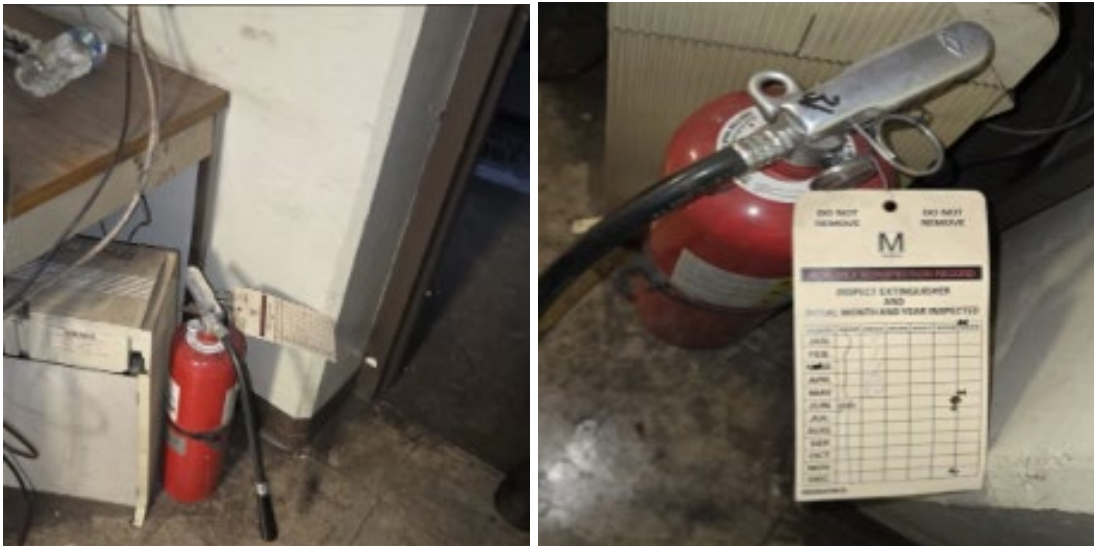
At Archives Navy Memorial – Penn Quarter (F02) station, in the platform level operations room 111- the portable fire extinguisher is past due for its monthly inspection. The last inspection was May 2025.

IFC 906.2 – Portable fire extinguishers shall be selected, installed, and maintained (In accordance with NFPA 10).

Hazard Rating: 1D

Photo 8 (left) and photo 9 (right): Fire extinguisher not mounted and past its monthly inspection.

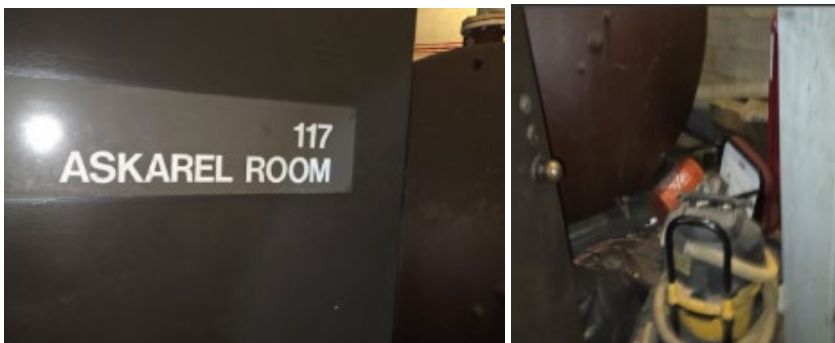
At Archives Navy Memorial – Penn Quarter (F02) station, platform level Askarel¹ room 117 showed accumulated combustible waste materials and trash.

Hazard Rating: 1D

Photo 10: Debris Blocking access to Room 117.

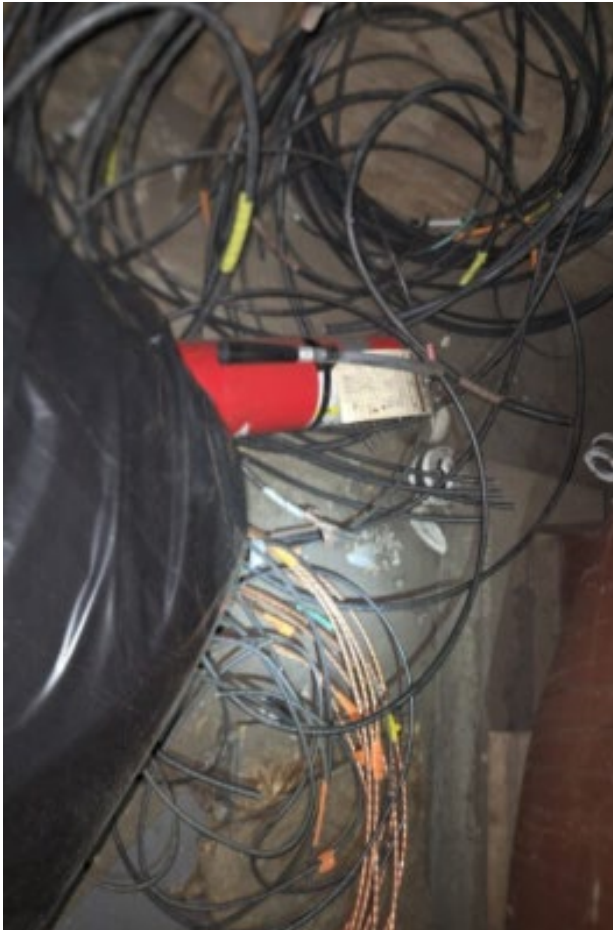
Additionally, IFC 906.2 – Portable fire extinguishers shall be selected, installed, and maintained (In accordance with NFPA 10).

Photo 11: Debris in room and fire extinguishers not mounted.

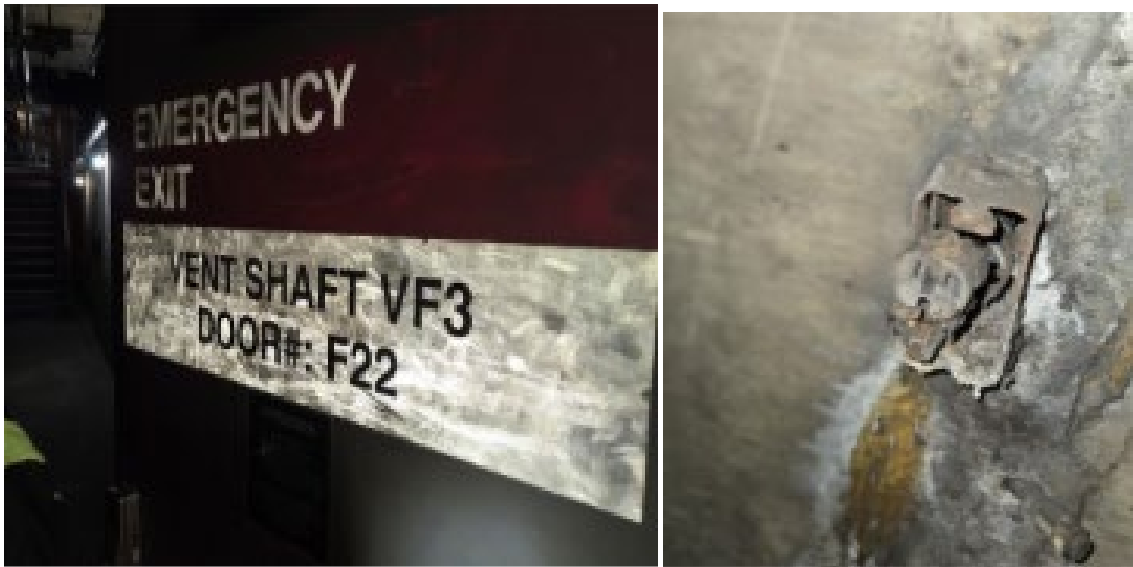
At Archives Navy Memorial – Penn Quarter (F02) station, located on the wall behind emergency exit VF3, vent shaft door # F22, is an open condition electrical outlet.

IFC 604.6 - Unapproved conditions.

Hazard Rating: 1D

Photos 12 (left) and 13 (right): Electrical outlet. Plus IFC 604.6 – Unapproved conditions.

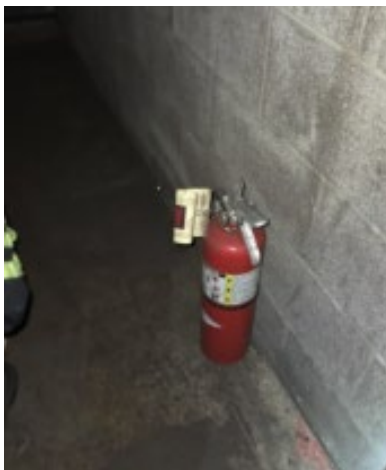
At Archives Navy Memorial – Penn Quarter (F02) station, in mechanical equipment room 110, the fire extinguisher is located on the floor and is not installed and mounted.

IFC 906.2 – Portable fire extinguishers shall be selected, installed, and maintained (In accordance with NFPA 10).

Hazard Rating: 1D

Photo 14: Fire extinguisher not mounted.

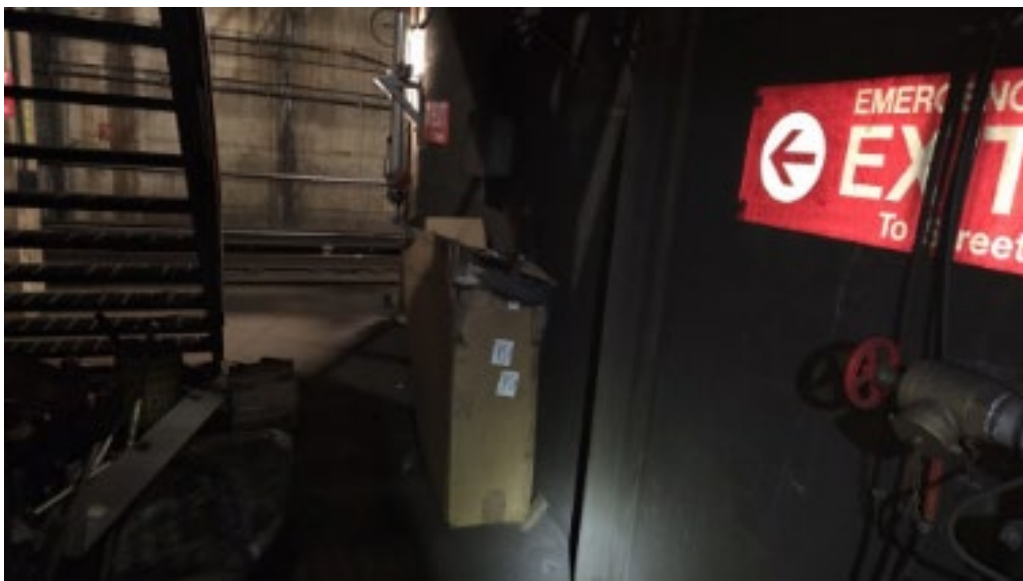
At Archives Navy Memorial – Penn Quarter (F02) station, the emergency exit route to the street is partially obstructed, which poses a safety risk in the event of evacuation for life safety. Additionally, miscellaneous items were stored underneath the emergency stairs.

IFC 315.3.2 - Combustible storage not permitted in exits, stairways, or ramps.

Hazard Rating: 1D

Photo 15: Combustible storage is not permitted in exits, stairways, or ramps.

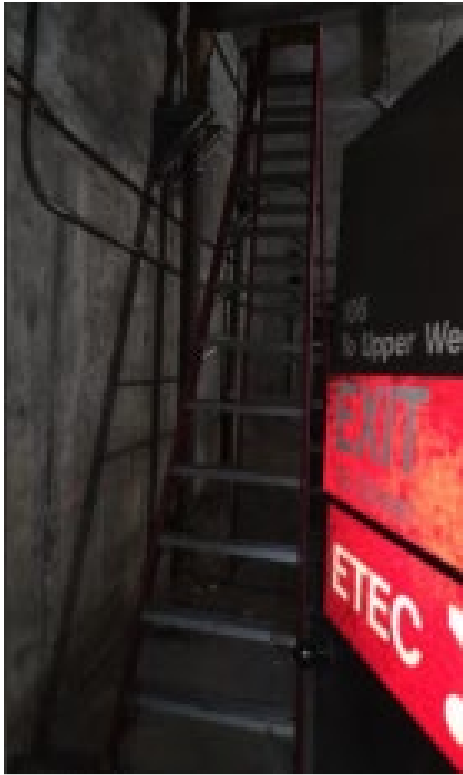
At Waterfront station (F04), in room 106 to the upper west hall, the exit to the street and Emergency Transport Equipment Cart (ETEC) cart are partially obstructed due to an open ladder and items being stored which poses a safety risk in the event of evacuation for life safety. An ETEC cart is a folding platform with wheels designed for the transportation of patients and equipment.

Hazard Rating: 1D

Photo 16: Door 106 - Partially block exit to street.

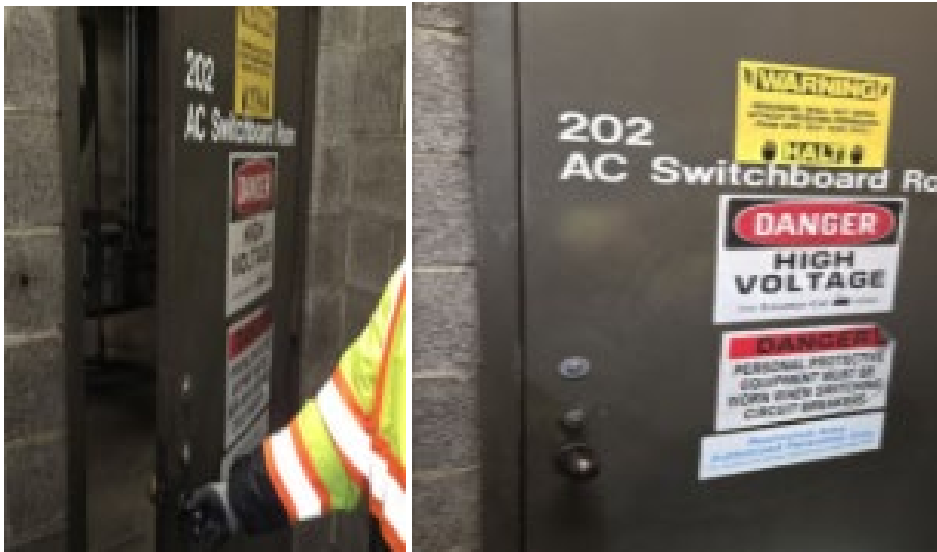
At Waterfront station (F04), the AC switchboard room 202 was not secured allowing access to an area of high voltage. Metrorail identified this area as requiring specialized Personal Protective Equipment (PPE) due to the electrical hazard. In addition, signage on the door states that personnel shall not enter without permission from the Maintenance Operation Center (MOC). Before leaving, the WMSC ensured that the door was properly closed and secured.

Hazard Rating: 1D

Photos 17 (left) and 18 (right): Open door to high voltage AC Switchboard Room 202, room closed and secured by the WMSC.

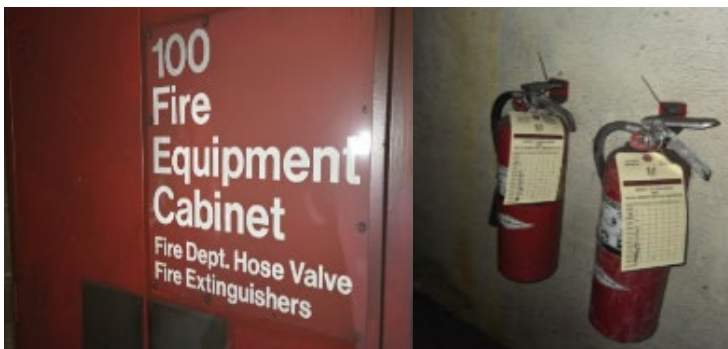
At Waterfront station (F04), fire extinguishers in equipment cabinet 100 are past due for their monthly inspection.

(110 IFC 906.2) Portable fire extinguishers shall be selected, installed, and maintained (In accordance with NFPA 10).

Hazard Rating: 1D

Photos 19 (left) and 20 (right): The cabinet with the expired fire extinguishers. The past due extinguishers themselves.

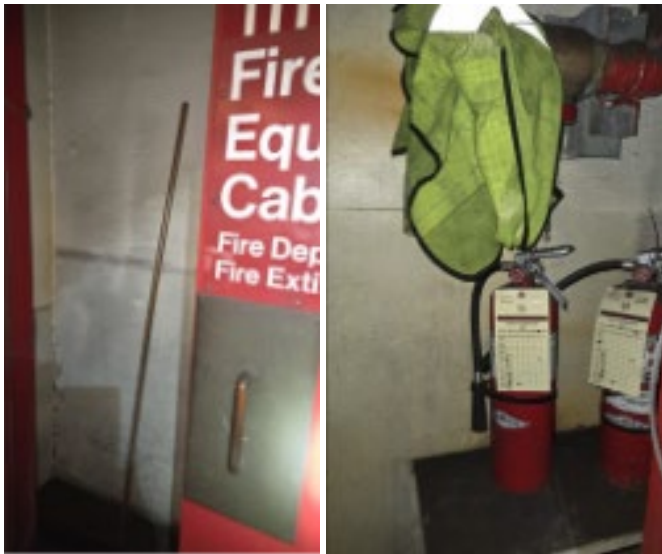
At Waterfront station (F04), inspectors noted improper storage of a broom and vest in fire equipment cabinet 111. Two fire extinguishers are also past due for their monthly inspection.

(110 IFC 906.2) Portable fire extinguishers shall be selected, installed, and maintained (In accordance with NFPA 10).

Hazard Rating: 1D

Photos 21 (left) and 22 (right): The cabinet with the defects and the extinguishers.

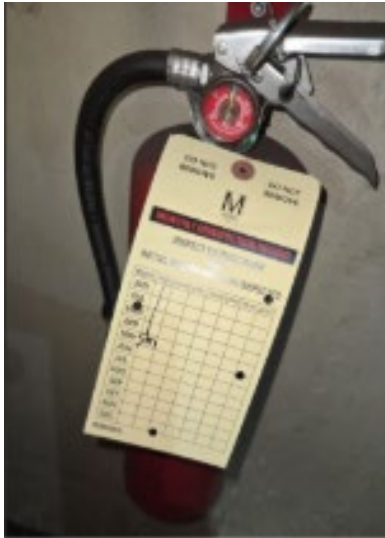
At Waterfront station (F04), in operations room 105, the portable fire extinguisher is past its monthly inspection. The last inspection was May 2025.

(110 IFC 906.2) Portable fire extinguishers shall be selected, installed, and maintained (In accordance with NFPA 10).

Hazard Rating: 1D

Photo 23: Portable fire extinguisher.

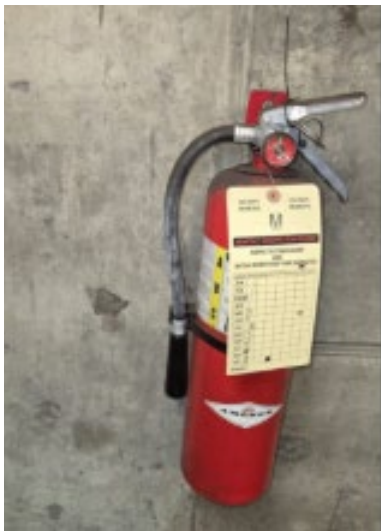
At Waterfront station (F04), in room 207, which leads to lower-level service rooms exit to the track level, the portable fire extinguisher is past due for its monthly inspection.

(110 IFC 906.2) Portable fire extinguishers shall be selected, installed, and maintained (In accordance with NFPA 10).

Hazard Rating: 1D

Photo 24: Portable fire extinguisher.

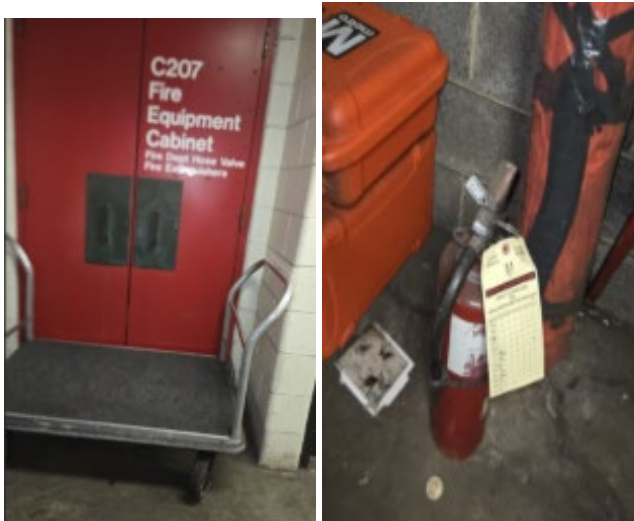
At Waterfront station (F04), in room C202 to the equipment cabinet, fire equipment cabinet C207 was blocked by a cart, restricting access to the emergency equipment. The WMSC mitigated the obstruction by moving the cart. However, a hazard remained since access to the customers' restroom and other rooms are now partially obstructed by the new location of the cart. The emergency cabinet contained three fire extinguishers; one of the three extinguishers was past due for an inspection.

Portable fire extinguishers shall be selected, installed, and maintained (In accordance with NFPA 10).

Hazard Rating: 1D

Photos 25 (left) and 26 (right): Cart blocking access and portable fire extinguishers due for inspection.

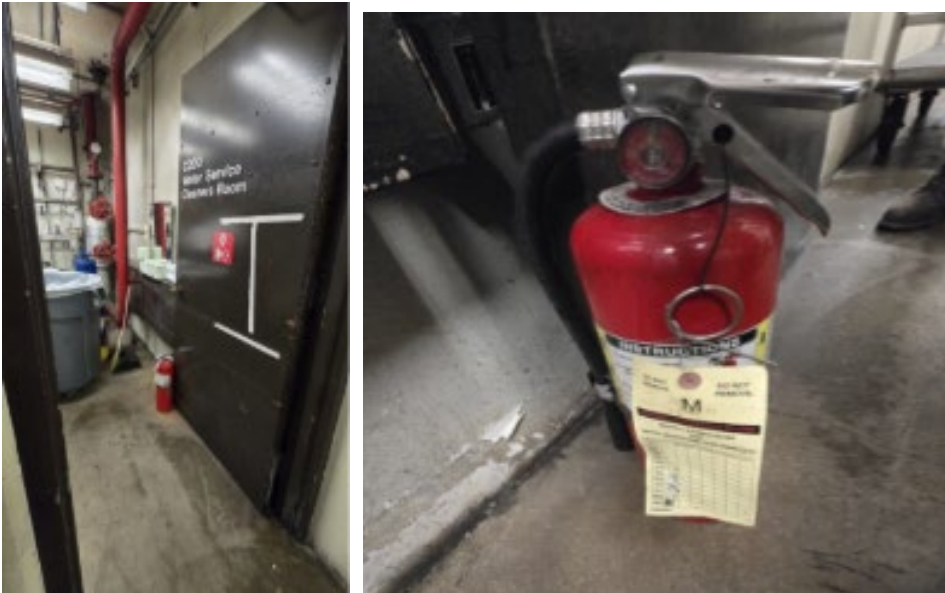
At Waterfront station (F04), in room C200 water service cleaning room, a fire extinguisher is being used as a doorstop. Additionally, the fire extinguisher is past due for its monthly inspection, and the fire extinguisher had the safety pin pulled.

(110 IFC 906.2) Portable fire extinguishers shall be selected, installed, and maintained (In accordance with NFPA 10).

Hazard Rating: 1D

Photos 27 (left) and 28 (right): Portable fire extinguisher on floor. The safety pin has been removed.

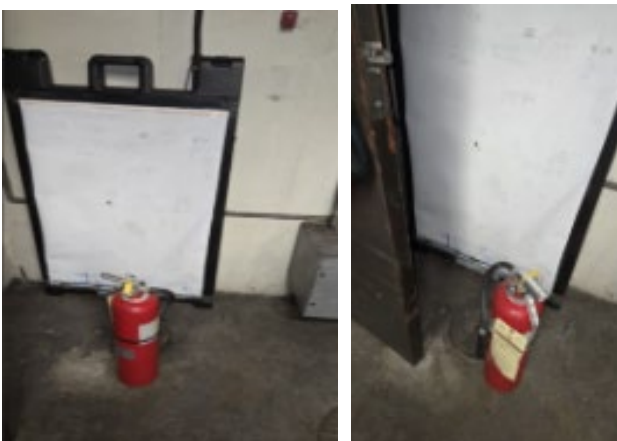
At Waterfront station (F04), in room C206, the mechanical equipment room, the fire extinguisher is not properly mounted and is stored on the floor to be used as a doorstop.

Portable fire extinguishers shall be selected, installed, and maintained (In accordance with NFPA 10).

Hazard Rating: 1D

Photos 29 (left) and 30 (right): Portable fire extinguisher on floor.

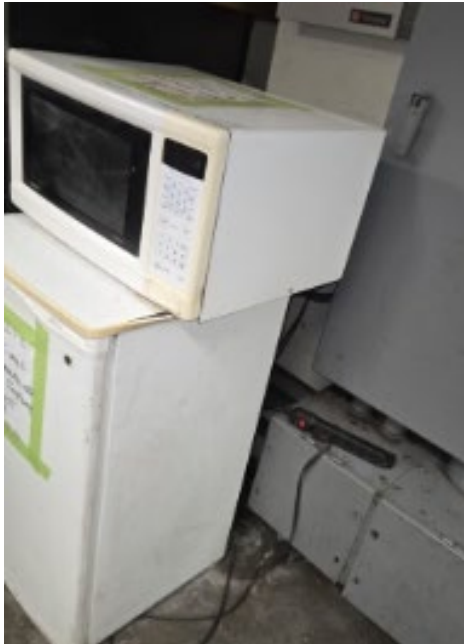
At Waterfront station (F04), in room C206 mechanical equipment room, appliances are not directly plugged into the wall outlet, creating a fire hazard, per IFC 603.6.

Hazard Rating: 1D

Photo 31: Appliances not directly plugged into the wall outlet.

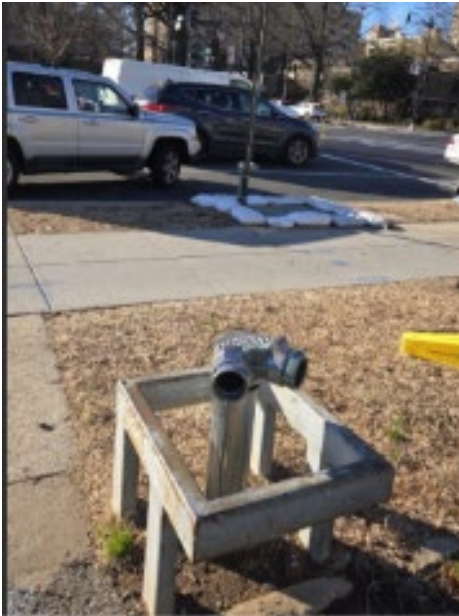
At Waterfront station (F04), standpipes located in the exterior of Waterfront station are missing the covers. These covers prevent debris and trash from entering.

Hazard Rating: 1D

Photo 32: Standpipe missing protective covers.
