WMSC Inspection Report 20260114B

Title: Train Control Room (TCR) B Line Reinspection

Location: A01, B01, B02, B03, B04, B05, B06, B07, and B35

Date of Inspection: 1/14/2026

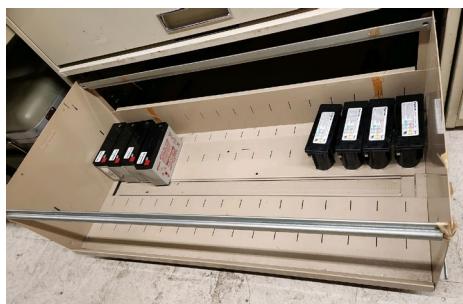
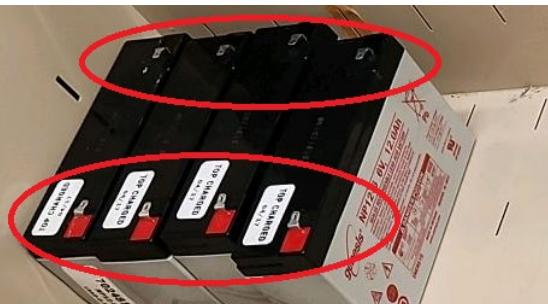
At the NoMa – Gallaudet U Station (B35) lead acid batteries were stored without required safety mitigations. Specifically that the battery terminals were not taped. As outlined in Metrorail's Environmental Standard Operating Procedure (ESOP) #5-3, Hazardous Material Storage (February 2025), "Non-leaking batteries **less than or equal to 9 volts** can be placed in the plastic container with terminals uncovered. (EXCEPT LITHIUM AND LEAD-ACID BATTERIES. THESE BATTERIES MUST HAVE THEIR TERMINALS TAPED NO MATTER THE VOLTAGE)"

Photo 1 (left) and 2 (right): Lead-Acid batteries stored without required mitigations at B35.

The batteries were removed by Metrorail personnel during the inspection.

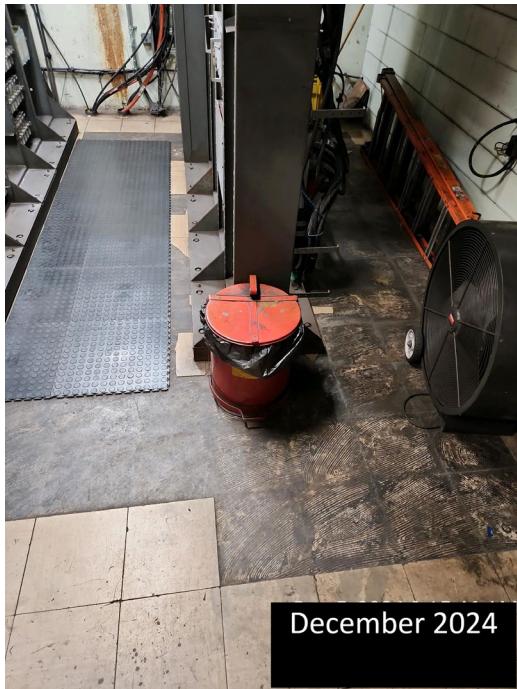
Photo 3: The 2024 Metro Center Station (A01) TCR room flooring in December 2024.

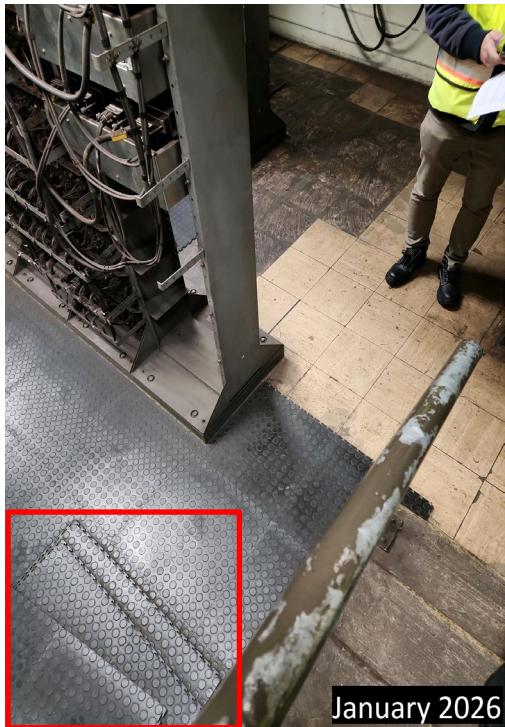
At the Metro Center Station (A01), the missing TCR flooring tiles have not been reinstalled after their discovery during the [2024 inspection](#) of this room. Currently, multiple layers of flooring are exposed in the room with different finishes and slight changes in elevation, which present a slip, trip, or fall hazard.

Photo 4: 2025 Metro Center Station (A01) Missing TCR flooring in January 2026.

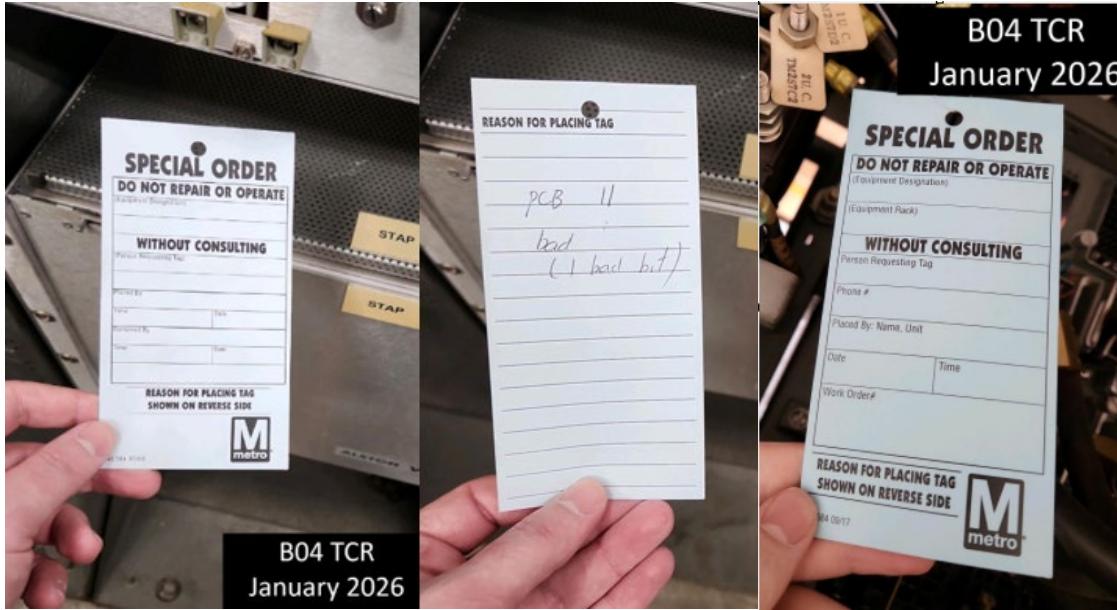
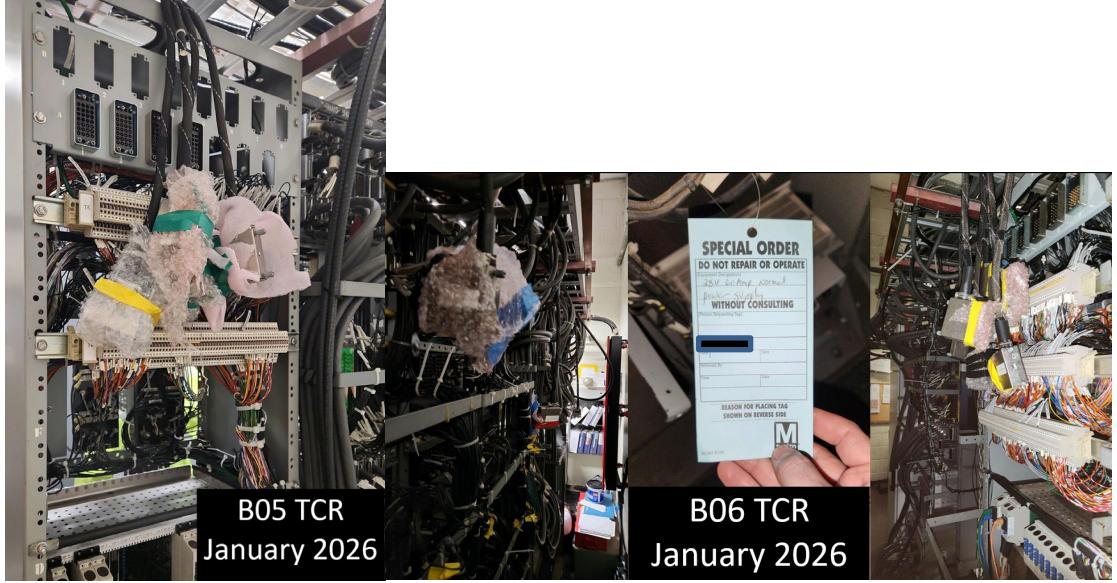
At Rhode Island Ave – Brentwood (B04), Brookland (B05), Fort Totten (B06), and Takoma (B07) Stations there were wiring connections (jumpers, loose wires, and couplers) found without proper blue tagging to indicate why these abnormal conditions exist.

Photos 5 to 9: Improper blue tagging.

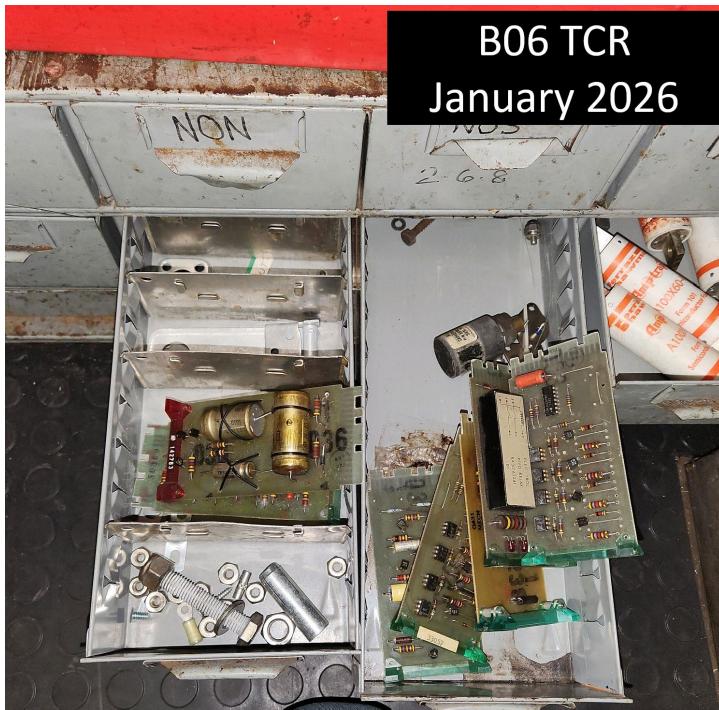
Various model printed circuit boards were found improperly stored and in unknown functional condition at Fort Totten Station (B06). The boards were removed by Metrorail personnel during the inspection for reconditioning.

Photo 10: Improperly stored various model printed circuits.

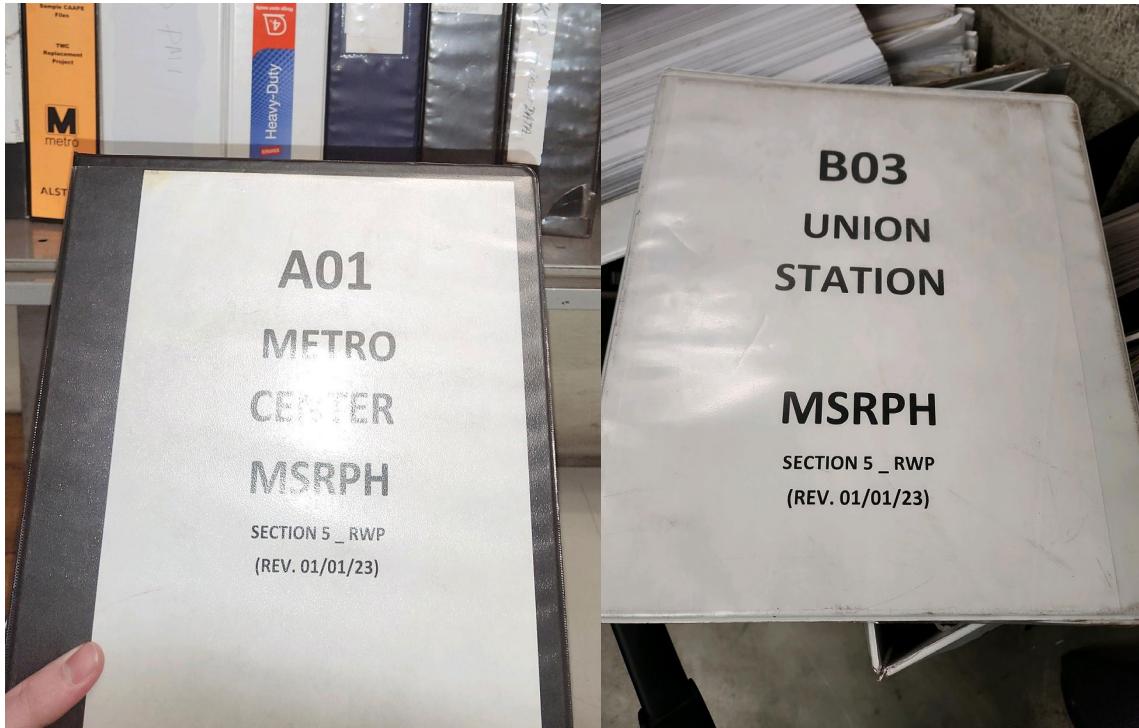
Outdated roadway worker protection documents were found at Metro Center (A01) and Union Station (B03) TCR locations. Metrorail's Safety Bulletin SB 25-04-B, Elimination of Obsolete Roadway Worker Protection Documents (Version #1, April 18, 2025), states, "All departments must remove obsolete materials from circulation and discontinue use to ensure compliance with current safety procedures."

Photos 11 (left) and 12 (right): Outdated roadway worker protection documents were found at A01 and B03 TCR locations

Obsolete materials were removed by Metrorail personnel during the inspection.
