WMSC Inspection Report 20260114C

Title: Dulles Rail Yard Service and Inspection Shop Inspection

Location: Dulles Rail Yard S&I (N99)

Date of Inspection: 1/14/2026

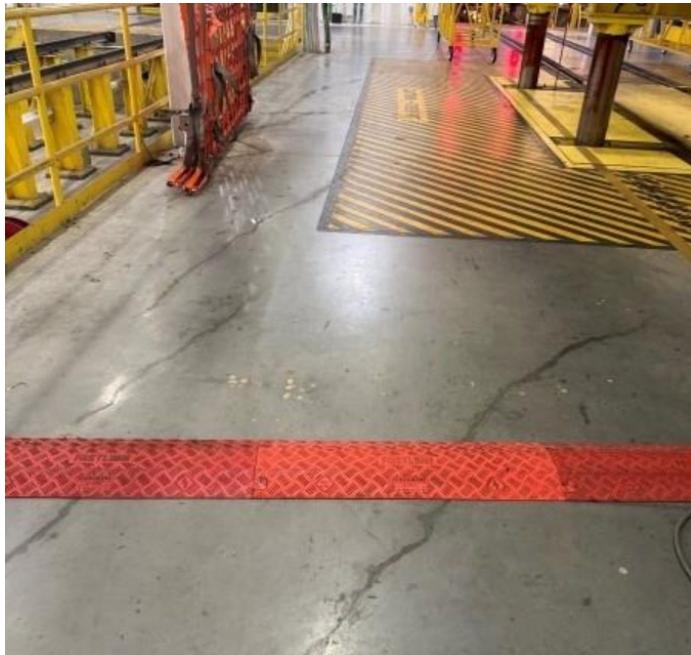
Photo 1: Power cables are orderly covered and protected.

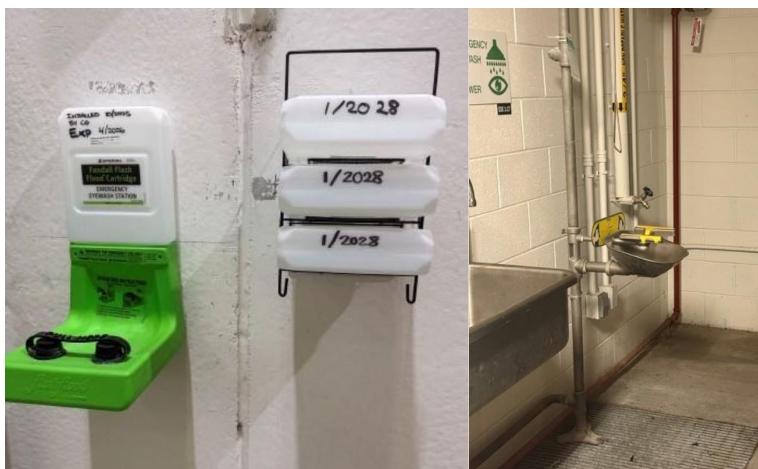
Photos 2: (left) and 3 (right): inspected and up-to-date eye wash stations.

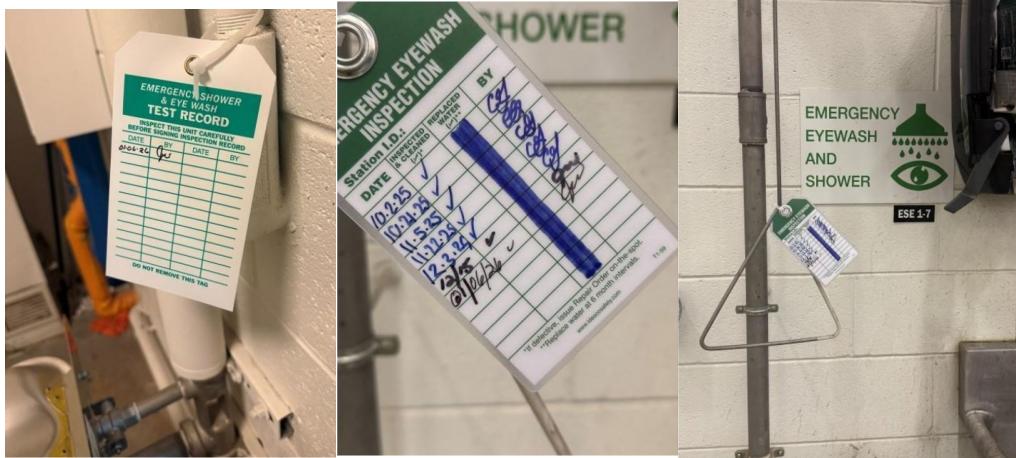
Photos 4 (left), 5 (center), and 6 (right): Sophisticated eye and body decontamination systems. All up to date with inspections.

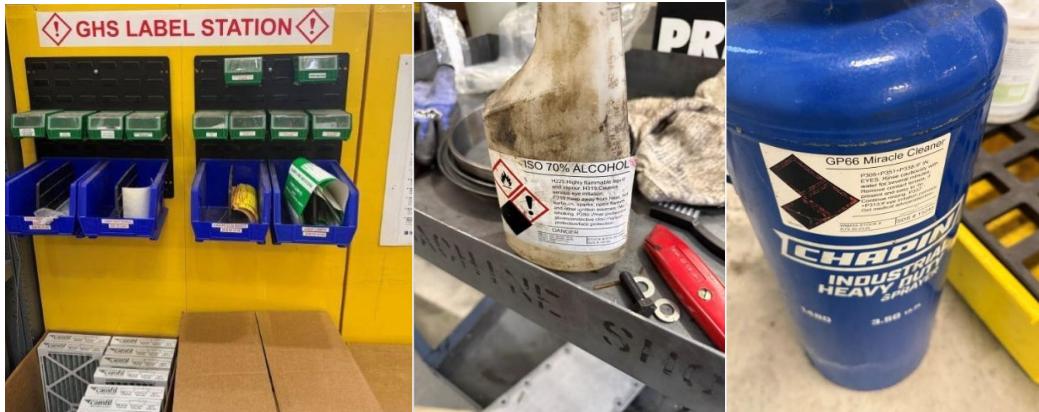
Photo 7 (left), 8 (center), and 9 (right): Functioning and properly used chemical labeling stations and an example of proper use of labeling identifying hazards of the chemicals contained therewithin.

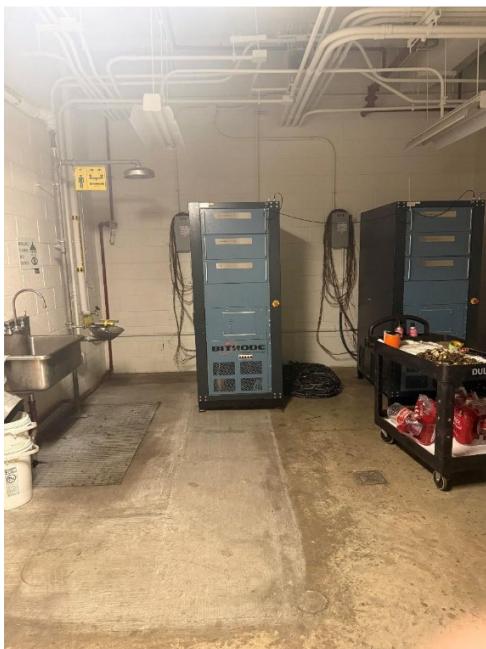
Photo 10: Inspected Battery Room.

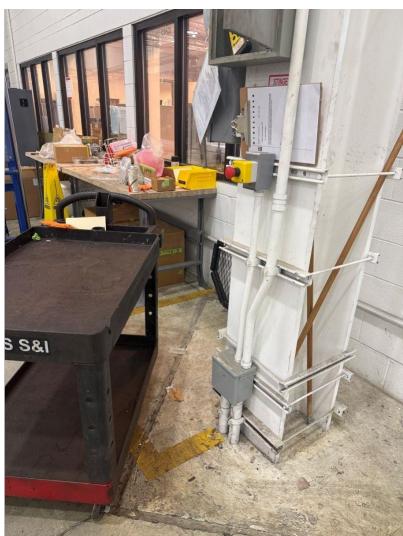
A stinger emergency stop button was blocked by a movable cart. The Inspector mitigated the defect by moving the obstacle.

Hazard Rating: 1D

Photo 11: A movable cart blocking the emergency button to stop stinger electrification.

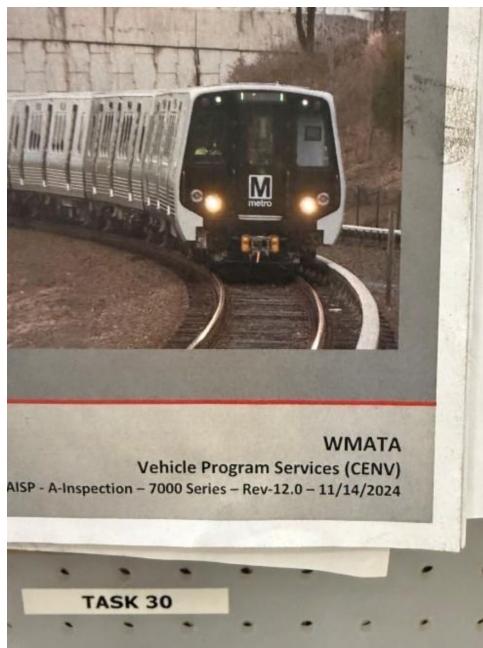
The Inspector found that Periodic and Inspection task documents are not all up to date. The Inspector pulled one, 7k "A" inspection Task 30, and found that it was out of date; it was the 2024 version. The latest revision was Rev. 13.0 which was published November 2025. The Inspector conducted this one spot check and did not inspect all the PI task procedures onsite. It is critical that engineers work from the most recent and published PI task procedures.

Hazard Rating: 2D

Photo 12: Metrorail Vehicle Program Services (CENV) A-Inspection – 7000 Series document is out of date. (Dated 11/14/2024) The current version (Rev. 13.0) was published on 11/24/25.

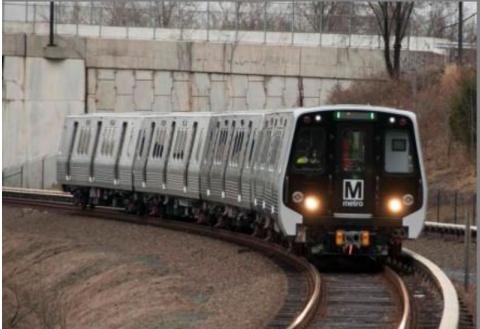
Photo 13: The current Metrorail Vehicle Program Services (CENV) A-Inspection – 7000 Series document which was not present with the “7K PI Procedures” documents at Dulles (N99). (Dated 11/24/2025)

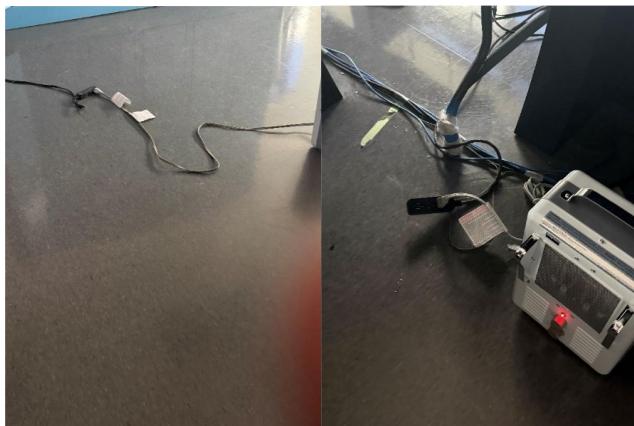
The Inspector found a fire hazard in Yard Control Room N99F 213. Two portable heaters are plugged into extension cords, creating risk of electrical fire. Appliances must be plugged directly into the wall outlet per International Fire Code (IFC) 603.6.1.

Hazard Rating: 1D

Photos 14 (left) and 15 (right): portable heaters plugged into extension cords.

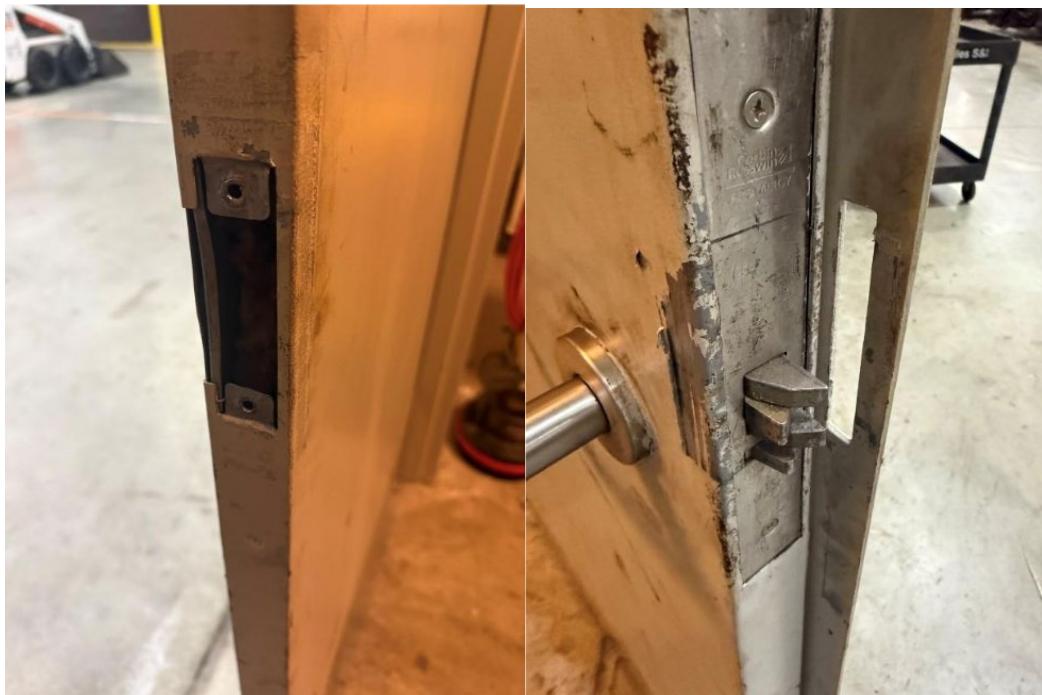
The Grease Room Double Door is damaged and not secure, including the Astragal.¹ The Grease Room contains flammable items, and the damaged door could lead to fire and/or smoke penetrating outside the Grease Room should there be a fire emergency. The broken, damaged, or missing door seals require immediate repair or replacement. (IFC NFPA 80)

Hazard Rating: 3D

Photos 16 (left) and 17 (right): Unsecured Grease Room double door.
