Improper Vehicle Movement
At or Near Shady Grove Station and Union Station
March 25, 2025 and March 28, 2025

FINAL REPORT OF INVESTIGATION A&I E25437

Shady Grove – Improper Rail Vehicle Movement

Union Station – Improper Rail Vehicle Movement

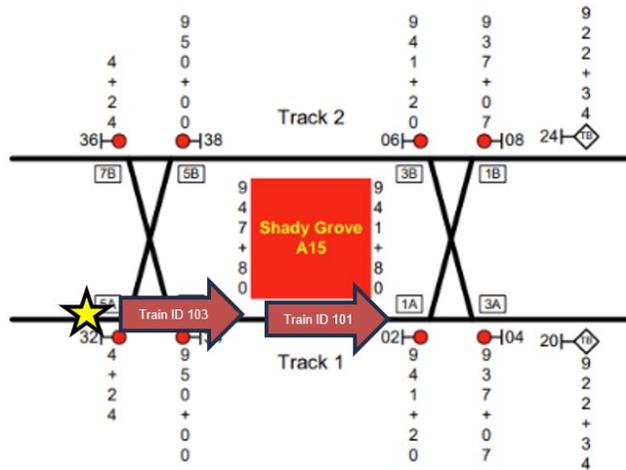
Figure 1 This picture is not to scale. The yellow star indicates the approximate location where Train 103 was given an absolute block to hold its position.

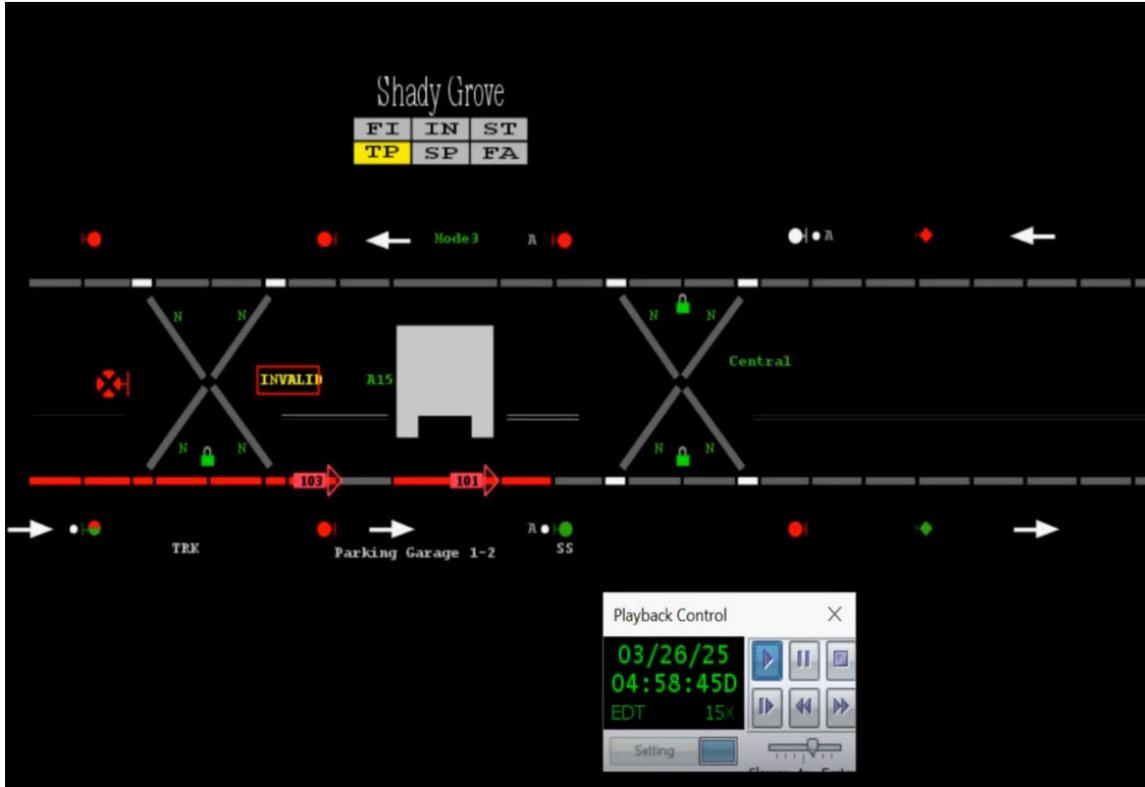
Figure 2 This picture is not to scale. The picture shows Train ID 103 past A15-32 signal while Train ID 101 is properly berthed on Shady Grove, track 1 with the doors open.

Based on the Video Management System (VMS), Train ID 103 was moved from the yard to past A15-32 signal. The train entered Stop and Proceed in the yard and continued to move towards the station. The train only had an absolute block to A15-32 signal. No fault could have contributed to the cause of this incident, the train operated as designed.

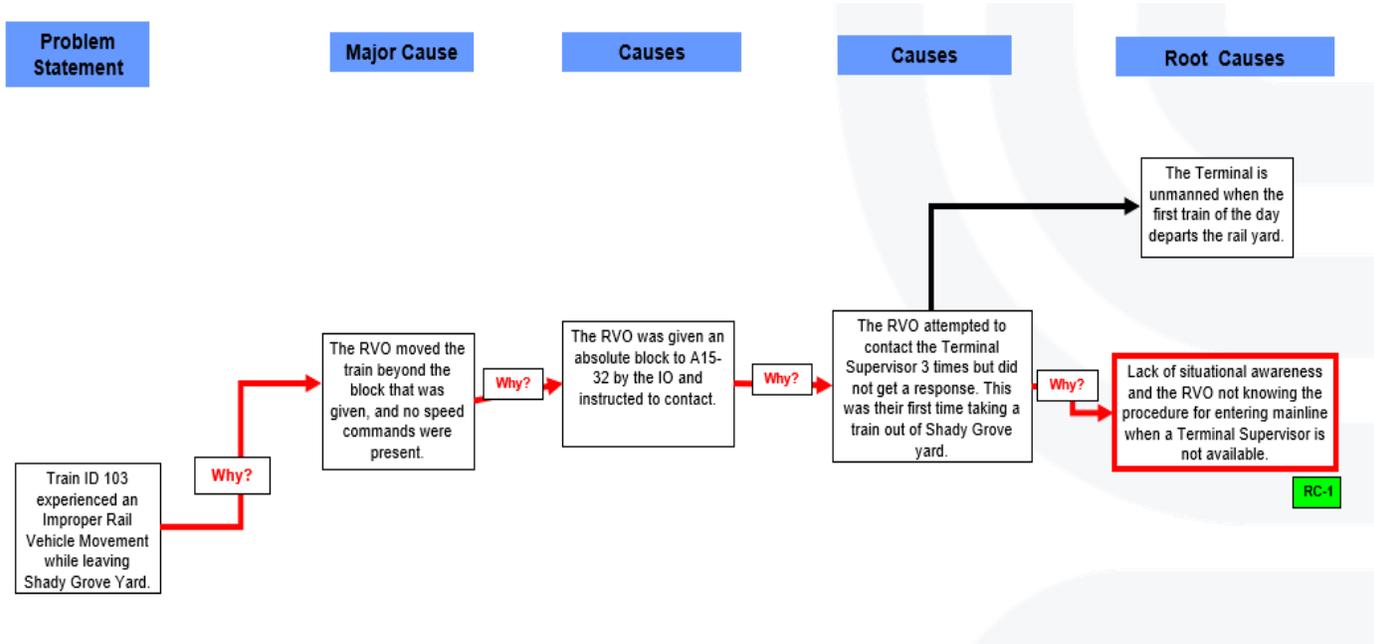
Appendix B – Why-Tree Analysis

The probable cause of the Improper Rail Vehicle Movement event on March 26, 2025, at Shady Grove Station was the Rail Vehicle Operator's lack of communication, awareness, and failure to follow the Metrorail Operating Rulebook (MOR). Contributing factors were that the Interlocking Operator failed to inform the RVO to contact the MICC, and the RVO failed to contact the Radio RTC to report that they were holding at A15-32 signal when they did not receive a response from the Shady Grove Terminal Supervisor.

Corrective Action Code	Description	Responsible Party	Estimated Completion Date
125114_SAFE CAPS_RTRA _001	Video Campaign "Staying Focused: Preventing Red Signal Overruns and Zero Speed Command Violations."	RTRA	Ongoing
125114_SAFE CAPS_RTRA _002	Rail Vehicle Operator to attend re-instruction training.	RTRA/ROQT	Completed

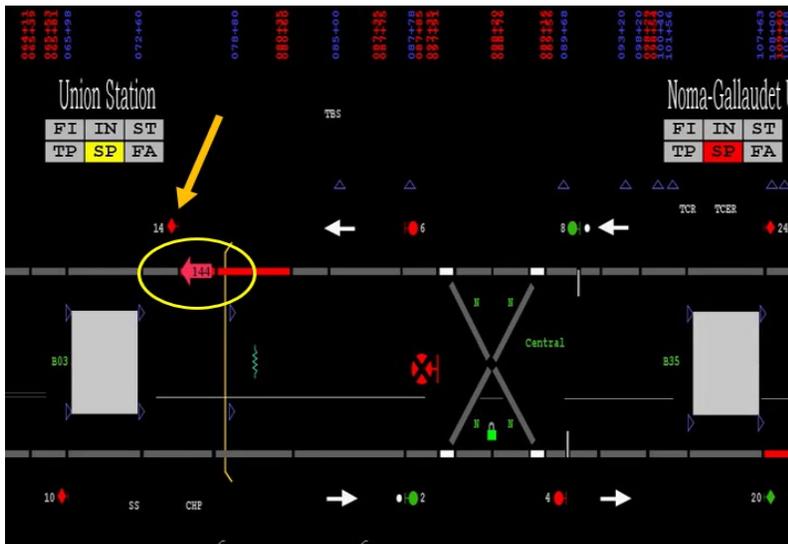
Figure 1 - (orange arrow) depicts red turnback-no speed commands. (yellow circle) depicts train is operating in ATO - shaded triangle at 13:47 hours.

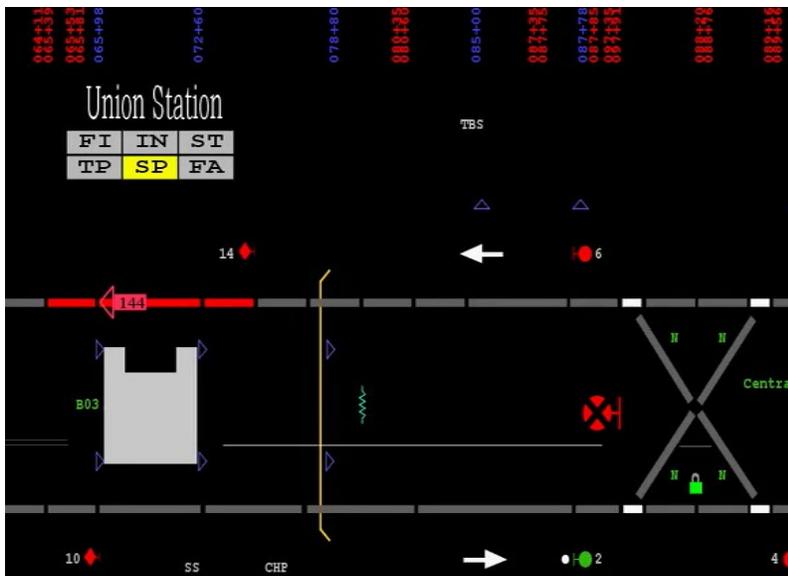
Figure 2 - Train ID 144 is pass the turnback and operating in manual mode at 13:49 hours.

Upon reaching the canceled turnback, the train lost speed commands as expected. The RTC observed via AIMS that the RVO switched from ATO (Mode 1) to manual (Mode 2 Level 1) and moved the train without proper authorization to Union Station platform. The RVO then switched the train back to ATO upon arrival.

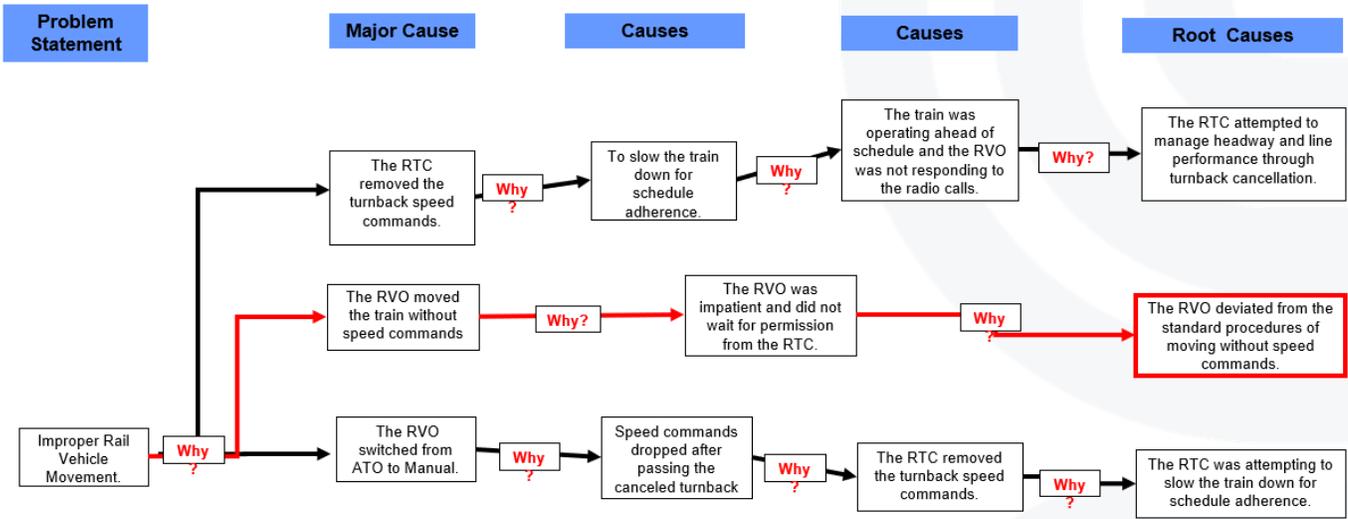
Appendix B – Why-Tree Analysis

The probable cause of the Improper Rail Vehicle Movement event was operator error. Specifically, the RVO manually moved the train without speed commands and without obtaining proper authorization from the RTC after the loss of speed commands approaching Union Station.

Corrective Action Code	Description	Responsible Party	Estimated Completion Date
125199_SAFE CAPS_RTRA _001	The RVO will receive refresher training with ROQT Training. (Reinstructed on moving without speed commands on Mainline)	SRC RTRA	Completed
125199_SAFE CAPS_RTRA _002	Video Campaign “Staying Focused: Preventing Red Signal Overruns and Zero Speed Command Violation”.	SRC RTRA	Completed
