## **W-0418 – Evacuation for Life Safety Reasons at Potomac Avenue Station – March 20, 2025**

**FINAL REPORT OF INVESTIGATION A&I E25417**

# Potomac Avenue Station – Evacuation for Life Safety Reasons

March 20, 2025

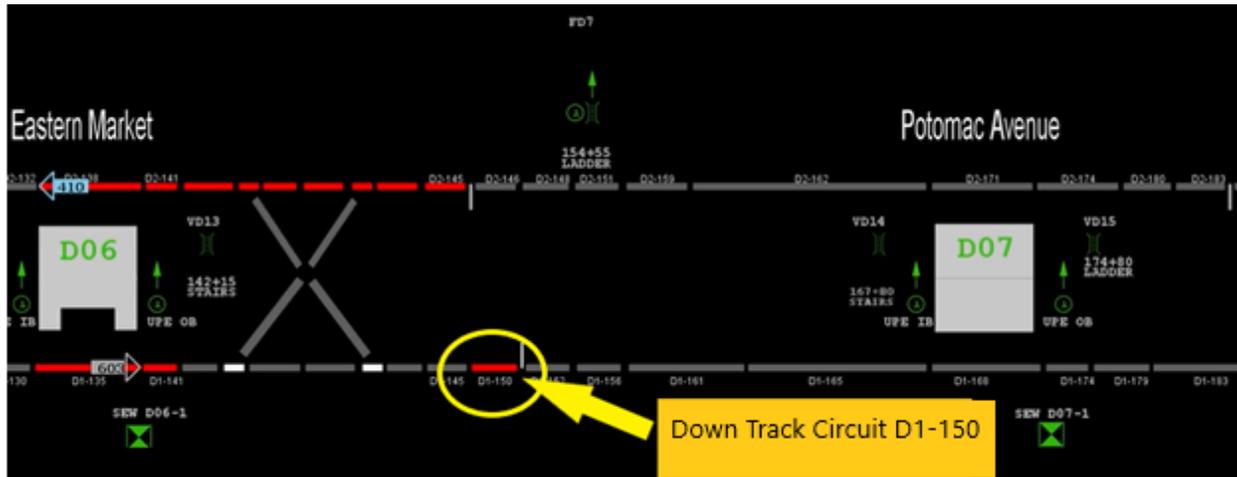
Figure 1 - Depicts down track circuit, D1-150, as Train ID 603 was berthed at Eastern Market Station, Track 1, and Train ID 410 was traveling inbound via Track 2.

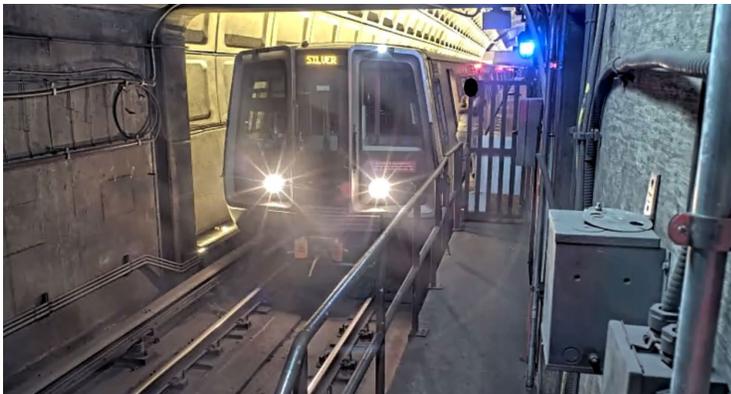
Figure 2 - Depicts Train ID 603 at Eastern Market Station, Track 1. No smoke was observed emanating from the train.

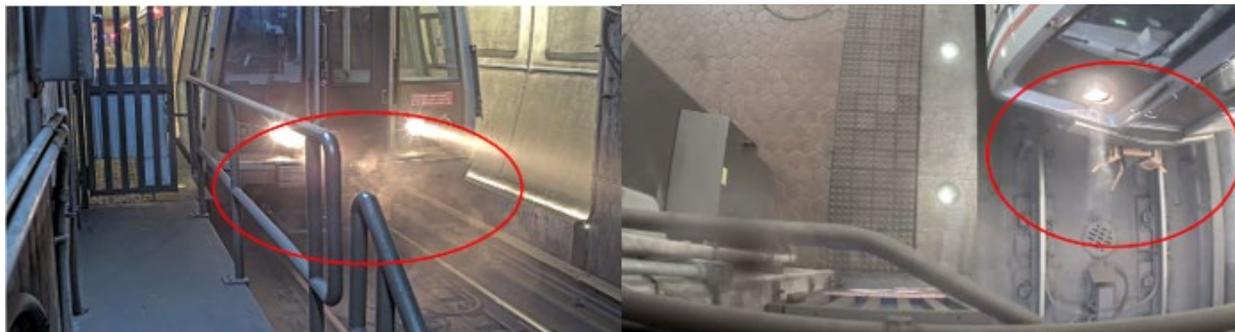
Figure 3 - Depicts Train ID 603 at Potomac Avenue Station, Track 2. Smoke was observed emanating from the train.

- DCFEMS inspected the station and found no signs of an active fire or smoke.
- Station CCTV showed Train ID 603 on Track 2 at Potomac Avenue and Stadium-Armory stations emitting smoke from underneath the lead car.

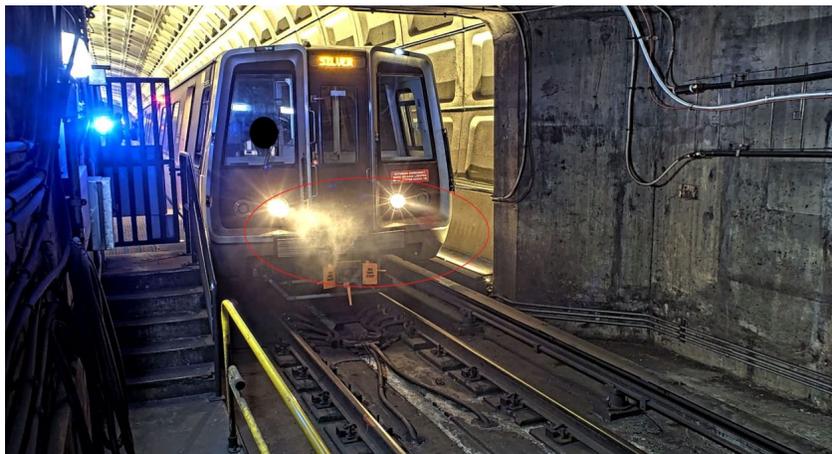
Figure 4 - Depicts Train ID 603 at Stadium-Armory Station, Track 2. Smoke was observed emanating from the train.

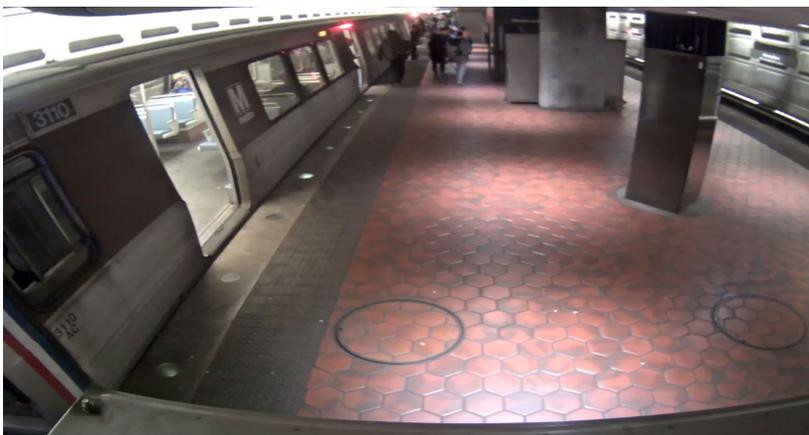
*Figure 5 - Depicts Train ID 603 at Benning Road Station, Track 1. No smoke was observed emanating from the train.*

- No smoke was observed emanating from Train ID 603 as it arrived at Benning Road Station, Track 1.
- Train ID 907 was misidentified as the incident train.

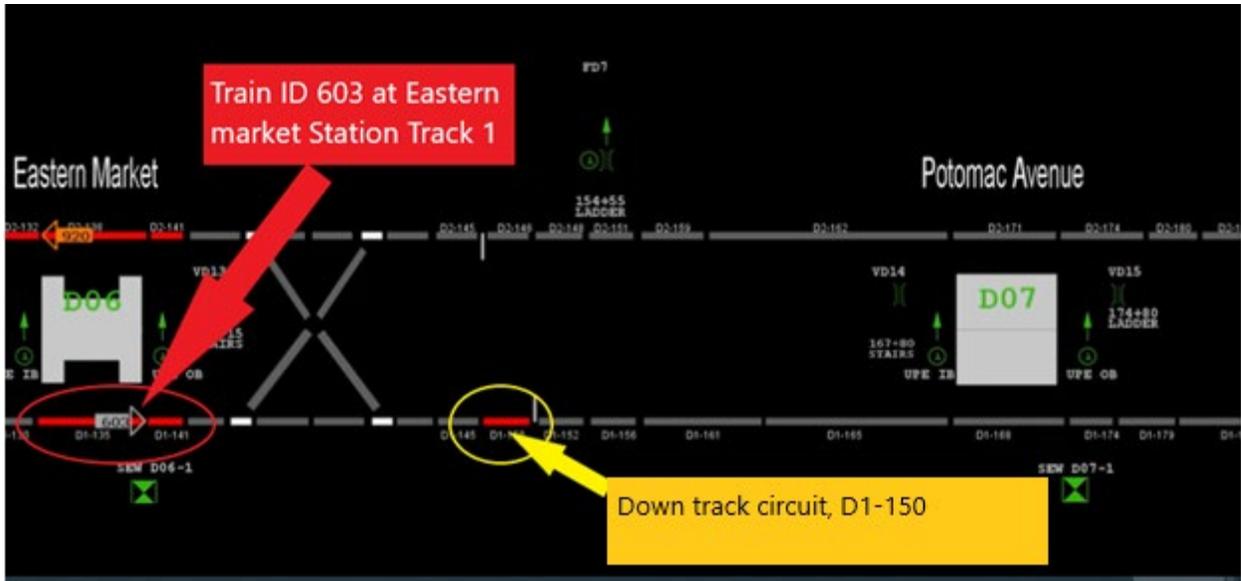
Figure 6 - Depicts Train ID 603 on Track 1 at Eastern Market Station and down track circuit D1-150.

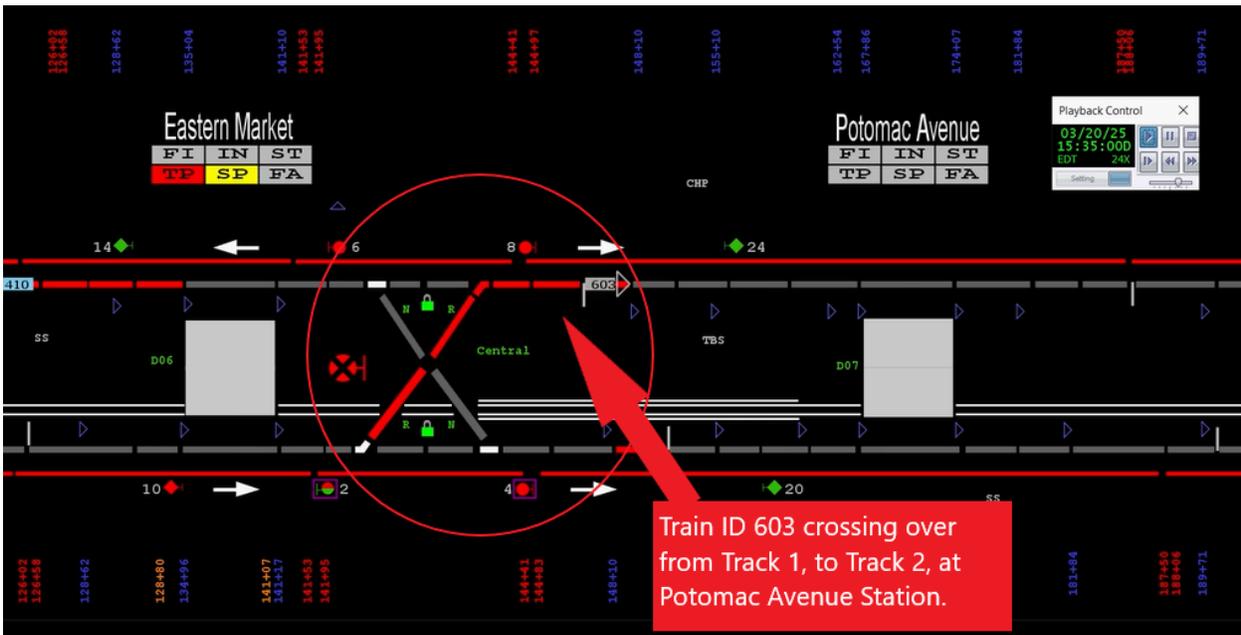
Figure 7 - Depicts Train ID 603 crossing over from Track 1 to Track 2 at Potomac Avenue Station.

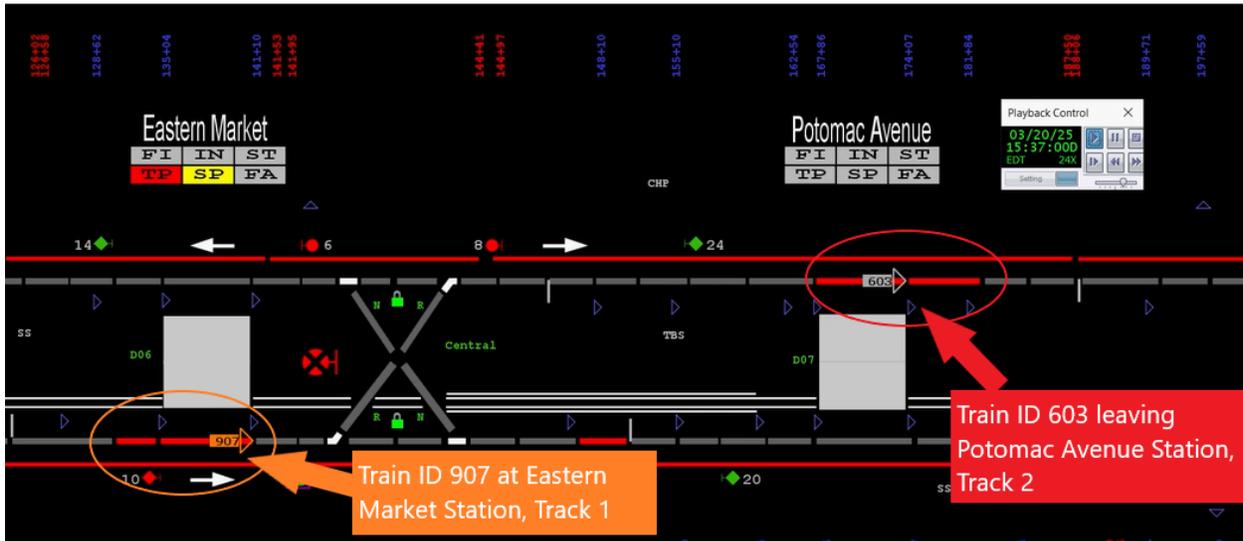
Figure 8 - Depicts Train ID 603 leaving Potomac Avenue Station, Track 2, as Train ID 907 was berthed at Eastern Market Station, Track 1.

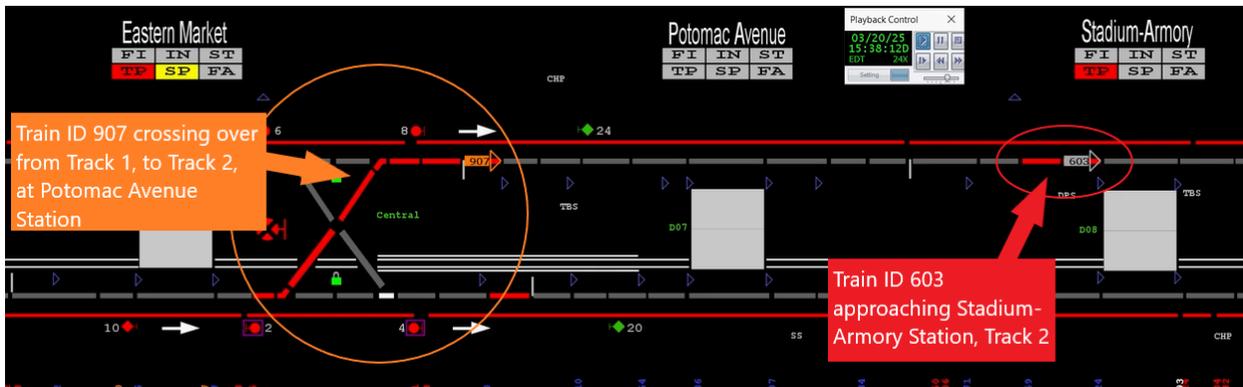
Figure 9 - Depicts Train ID 603 approaching Stadium-Armory Station, Track 2, as Train ID 907 crossed over from Track 1 to Track 2, at Potomac Avenue Station.

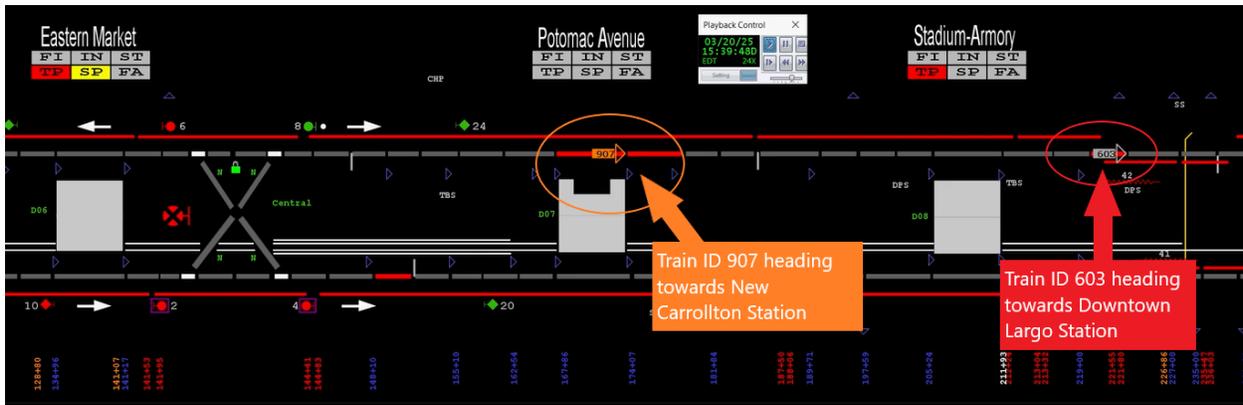
Figure 10 - Depicts Train ID 907 at Potomac Avenue Station, Track 2, as the smoke in the station was initially reported.

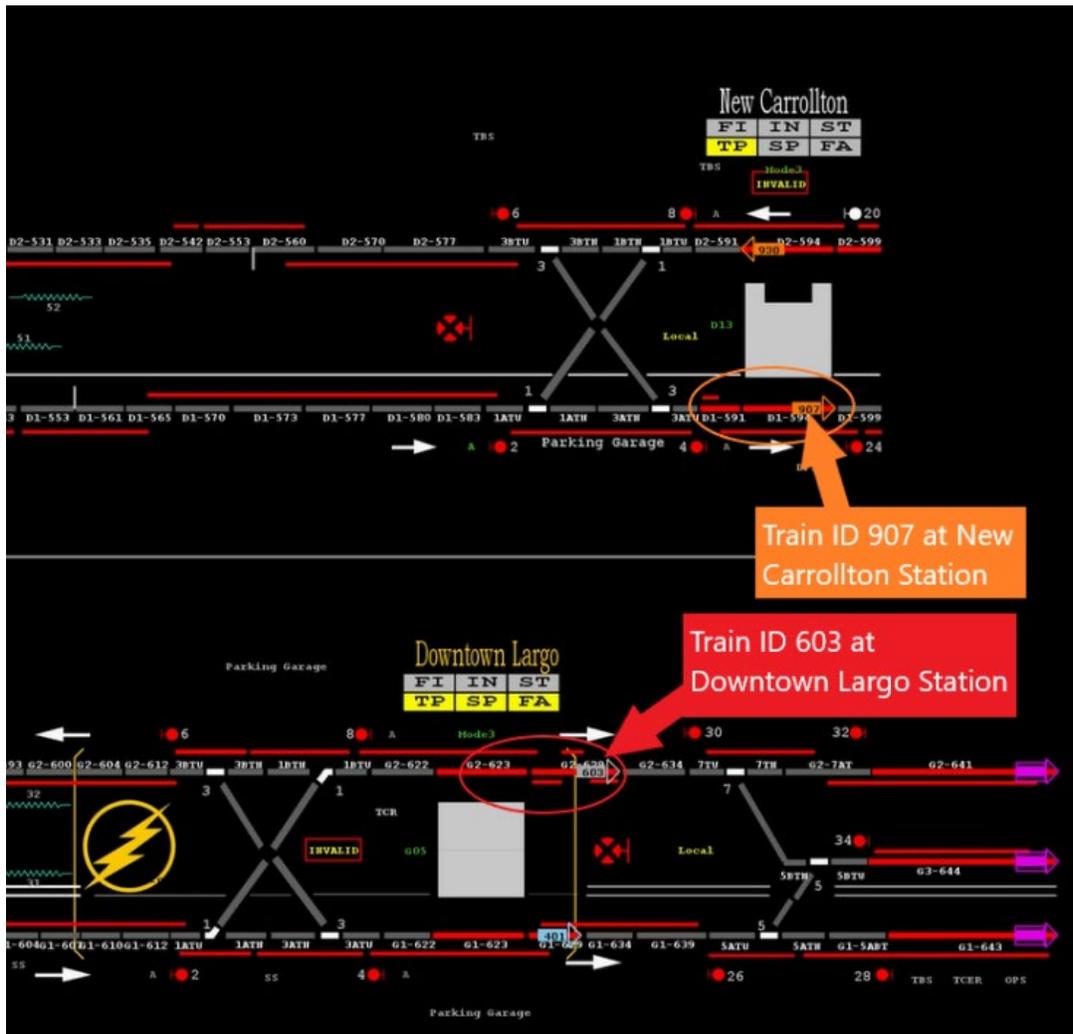
Figure 12 - Depicts Train ID 603 at Downtown Largo Station, Track 2, as Train ID 907 arrived at New Carrollton Station, Track 1.
