WMSC Inspection Report 20260226

Title: Vibration Inspection

Location: Ballston-MU Station (K04) to West Falls Church Station (K06) Tracks 1 and 2, and Spring Hill (N04) to Reston Town Center (N07) Tracks 1 and 2

Date of Inspection: 2/26/2026

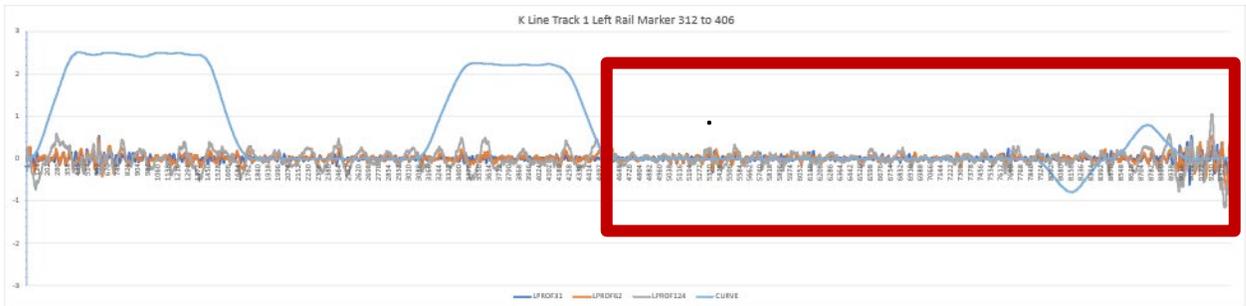
Photo 1: TGV data of the left rail showing no irregularities on the tangent track from K1 312+00 to 406+00.

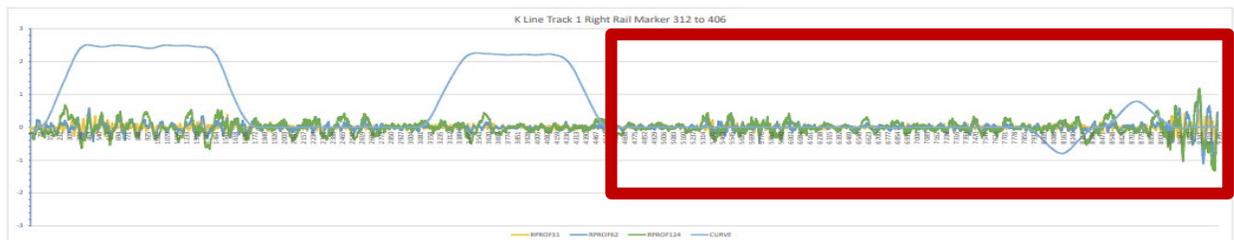
After riding the trains, WMSC Inspectors reviewed the track geometry vehicle (TGV) data from May 5, 2025 (most recent TGV run through this area). WMSC Inspectors identified what appears to be a cause of the vibration on Track #1's right rail, between East Falls Church (K05) and Ballston-MU (K04). Although the analysis revealed no track defects (all anomalies are within the "green" range, which Metrorail standards indicate as +/- 1.5 inches, the data *does indicate* a ride quality concern on the right rail even though the deviation is less than 1 inch. (Metrorail's track standards "yellow defect" threshold is 1.5 inches, TRST-1000 Table 106.4(a).) In the subject area, trains are currently permitted to run at a maximum allowable speed of 65 miles per hour (MPH), which can make conditions that are "green" noticeable to passengers. TGV data is below.

Photo 2: TGV data of the right rail showing lateral irregularities compared to the left rail on the tangent track from K1 312+00 to 406+00.

Hazard Rating: 3B
