WMSC Inspection Report 20260302A

Title: Glenmont Roadway Worker Protection Inspection

Location: Glenmont (B11)

Date of Inspection: 3/3/2026

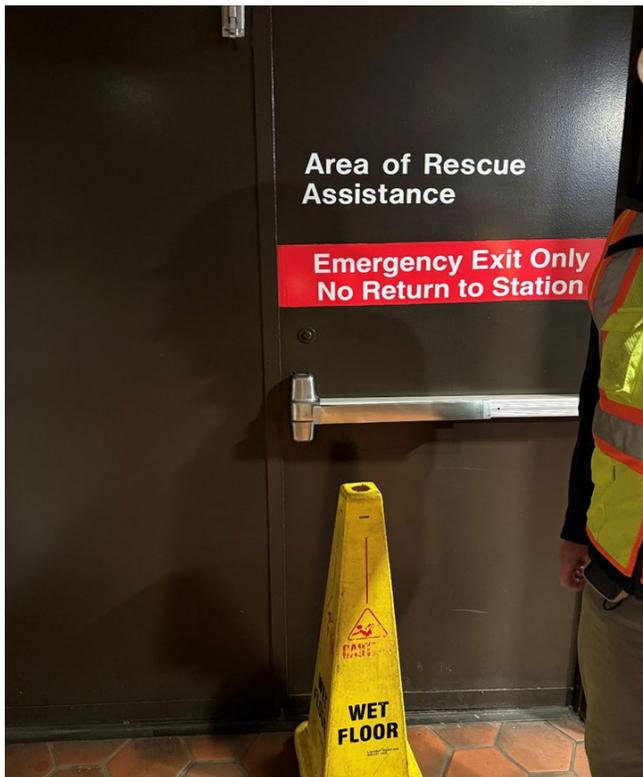
While at Glenmont (B11), the station's area of rescue assistance⁴ was also inspected. This is an area that consists of double doors with a push bar, signs, and is labelled "Area of Rescue Assistance" and "Emergency Exit Only No Return to Station." Additionally, no camera or motion sensors were identified within the area of rescue assistance.

Photo 1: Double door latched by push bar.

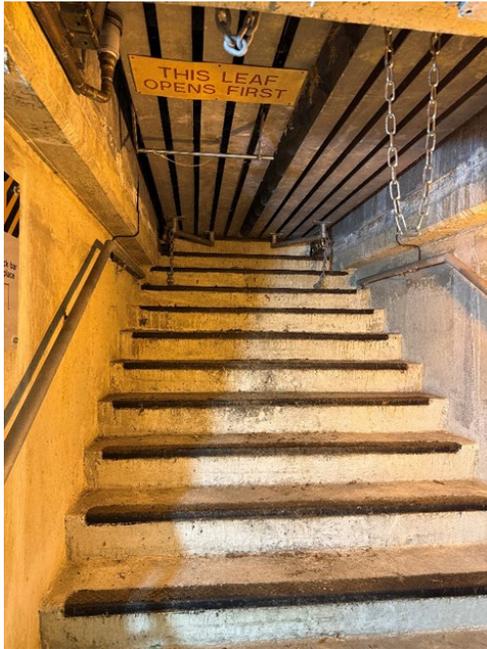
The area of rescue assistance includes a double door that leads outside in case of emergency. The Metrorail Department of Safety specialist opened the double doors leading outside. WMSC Inspectors noted opening these doors required great effort and a noticeable application of strength. The station manager confirmed this fact and informed WMSC

Inspectors that, in the past, the doors had to be “forced open.” In the event of an emergency the inability to open the door to the exit, with reasonable effort, could present a trampling hazard or other safety risks.

Photo 2: horizontal doors to the street in case of emergency.

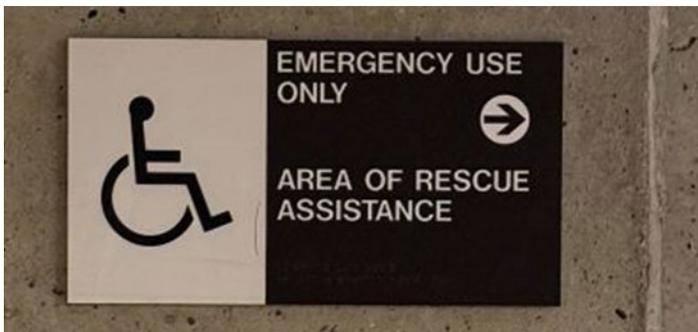
Photo 3: Signage for area of rescue assistance.

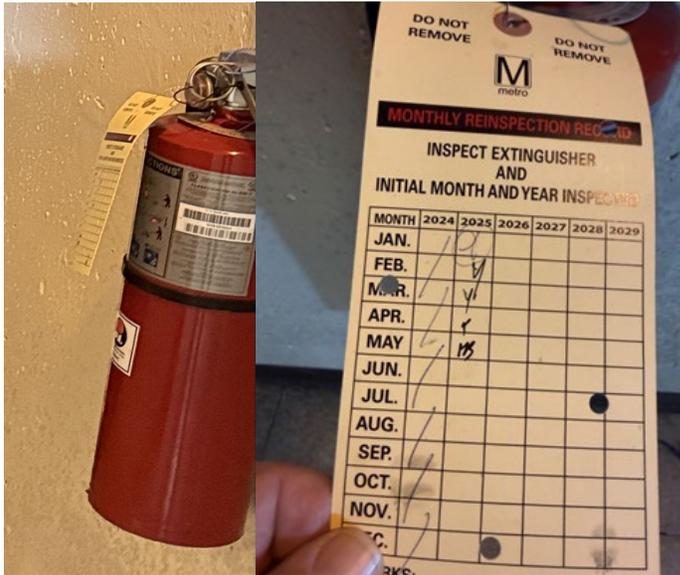
A fire extinguisher that had not been inspected since May 2025 (inspections required monthly) was identified in the area of rescue.

IFC (International Fire Code) Section 906.2 – Portable fire extinguishers shall be selected, installed, and maintained (In accordance with NFPA (National Fire Protection Association) standard 10).

Photo 4 (left) the fire extinguisher and photo 5 (right) the out-of-date inspection card.

Hazard Rating: 1D

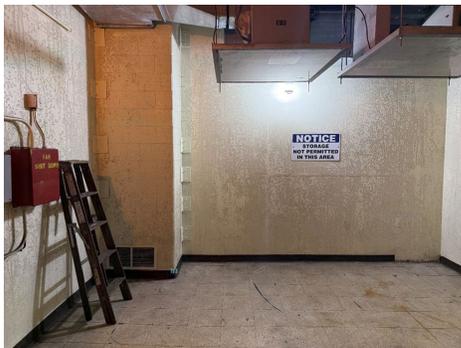
A ladder was observed being stored in the area of rescue assistance which should not be used as storage space. (NFPA 101, 7.2.12 (Area of Refuge) and 7.1.10 (Means of Egress Reliability))

Photo 6: A ladder stored in the non-storage area of rescue.

Hazard Rating: 1D
